Virginia Military Base Case Study for AEHS

Clarkson University

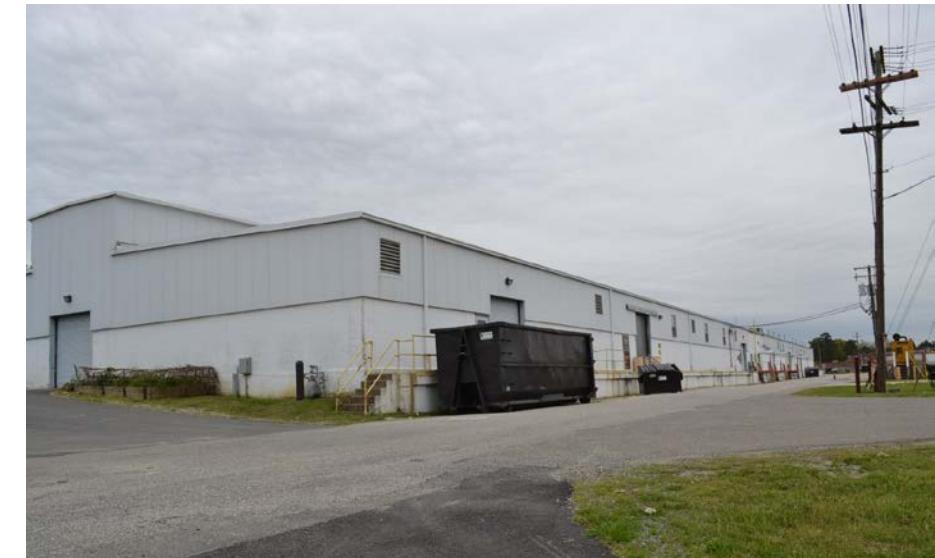
Conceptual Site Model Building A

- Constructed of concrete blocks on a concrete slab elevated above grade in 1919
- Depth to groundwater ~40 ft
- Degreasers (including TCE) were reportedly used to clean parts
- Soil contamination located immediately adjacent to and beneath the building.
- Spatial variability in subslab soil vapor results ~1 to 3 orders of magnitude. Data consistent with the potential presence of localized pockets of DNAPL and/or elevated soil VOC concentrations beneath portions of the building
- Pipe chases containing dirt floors identified during the HAPSITE and the preferential pathways investigation
- Cracks in the floor sealed in an attempt to mitigate VI - March 2012

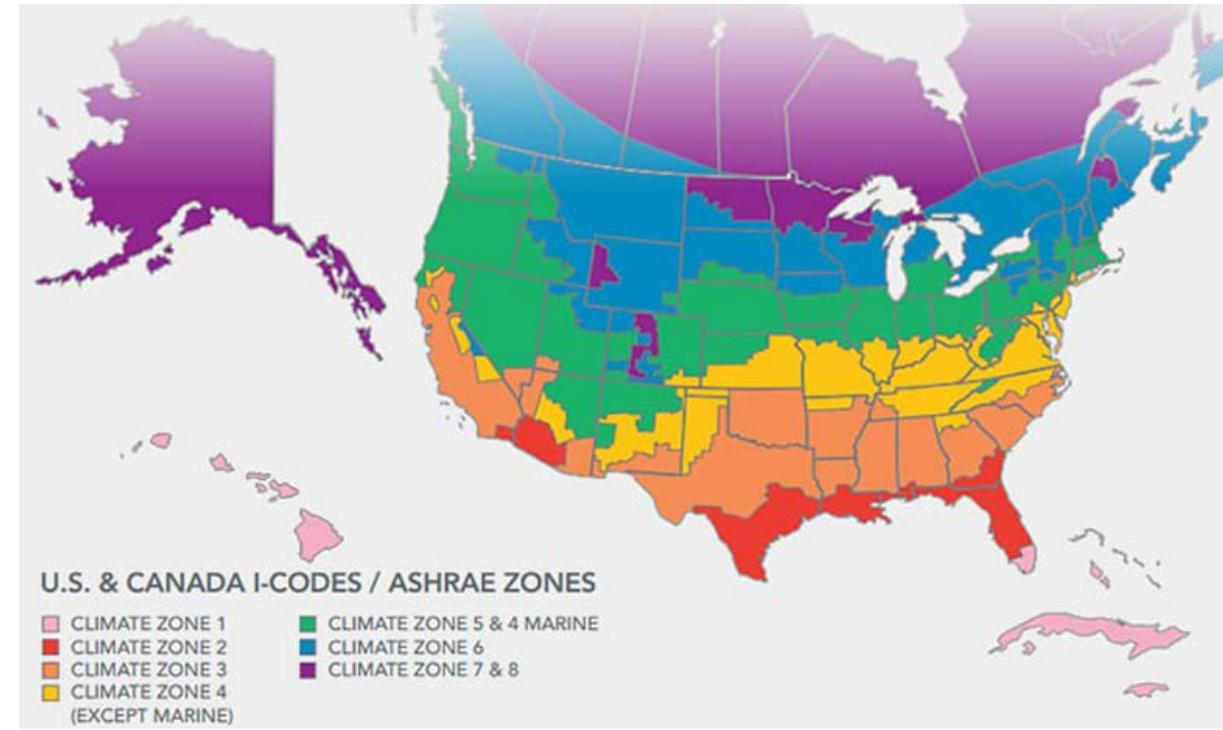
Site Climate Zone (International Energy Conservation Code (IECC))

- Temperature aspect based on degree-days – so a measure of full winter stack effect – and thus exposure. Also includes moisture considerations
- Along a coastal river/bay Climate Zones IECC Zone 4; Koppen CFa humid subtropical
- Groundwater concentrations of TCE up to 5,900 µg/l between buildings A and B

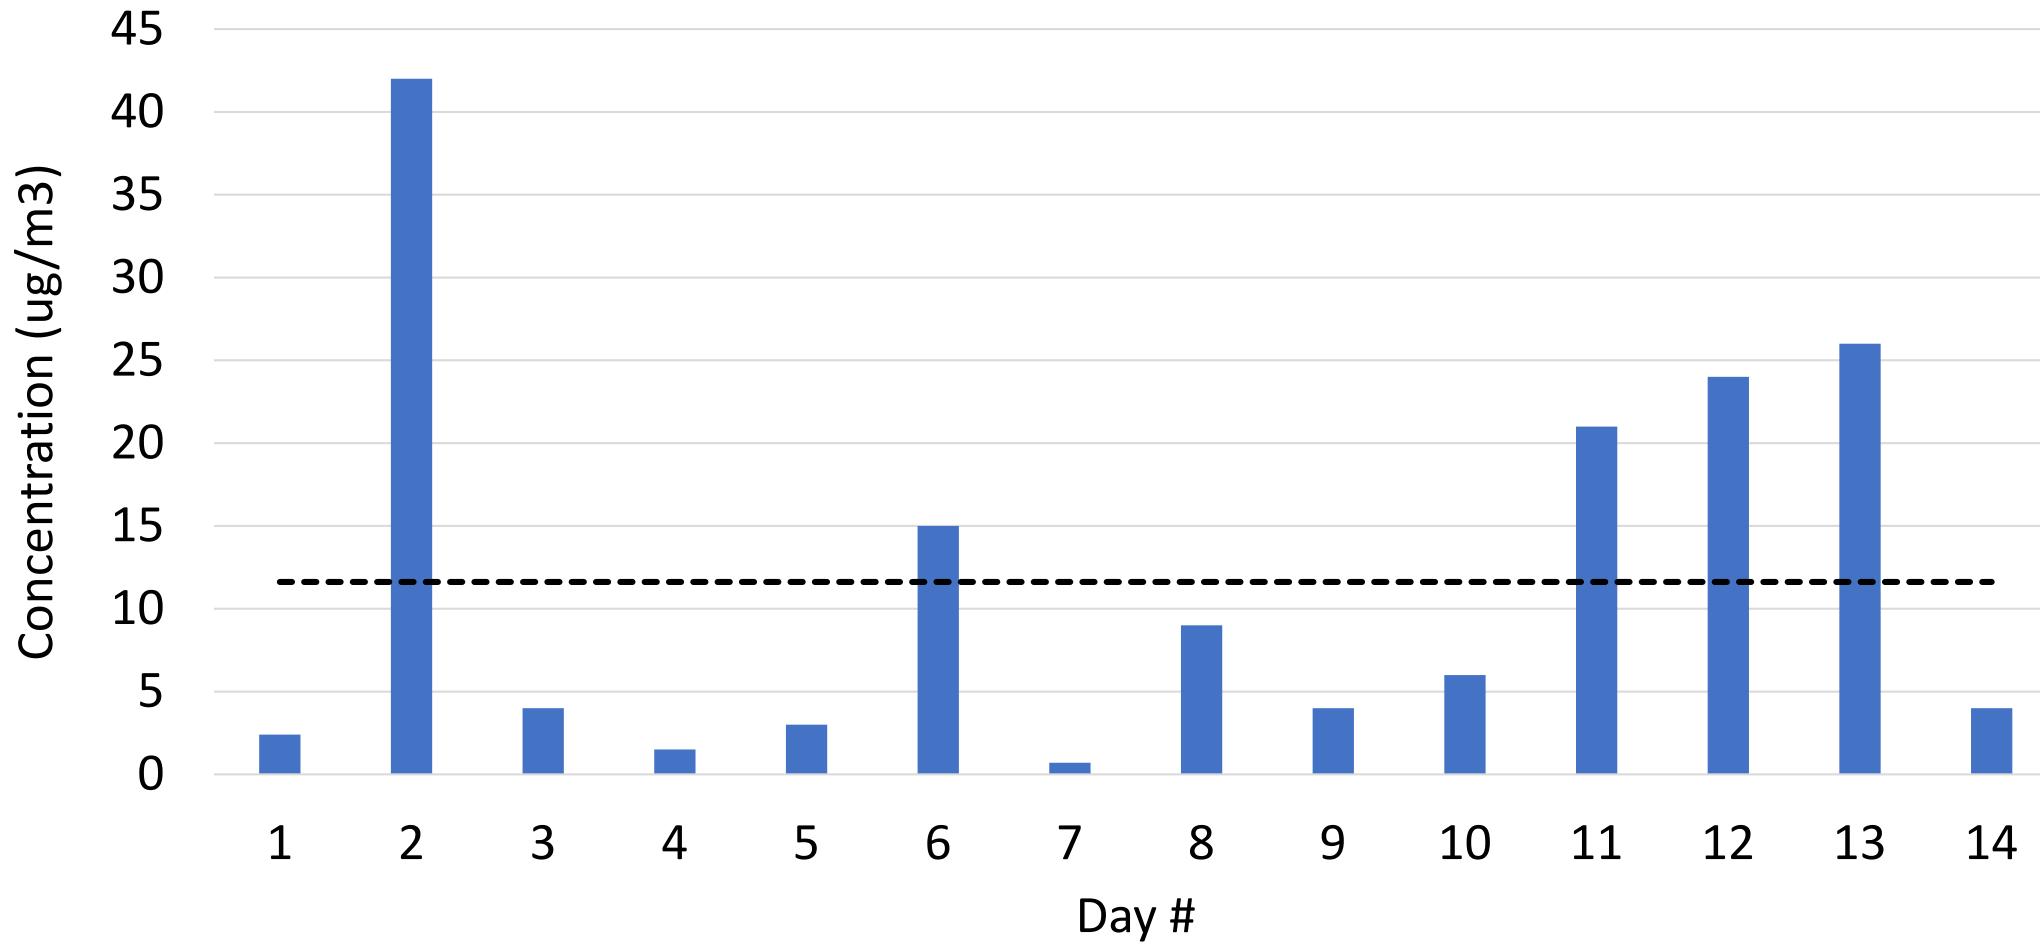
VI Building Indoor Air: Example

- The capillary canister system was used to collect indoor air samples for **2 weeks** in 6L and 15L canisters.
- The capillary-canister system was also used with 1L canisters to collect samples from the sub-slab.
- Performance was assessed by comparing results to daily **24-hr canister** samplers and passive diffusion samplers.
- Seasonal impacts on performance was evaluated.
- The results have been at least as accurate, precise, and complete as current standard practices at lower sampling cost and sample analytical cost.
- Capillary Canister system has been tested with 400mL and 1L canisters for 24 and 72 h respectively.

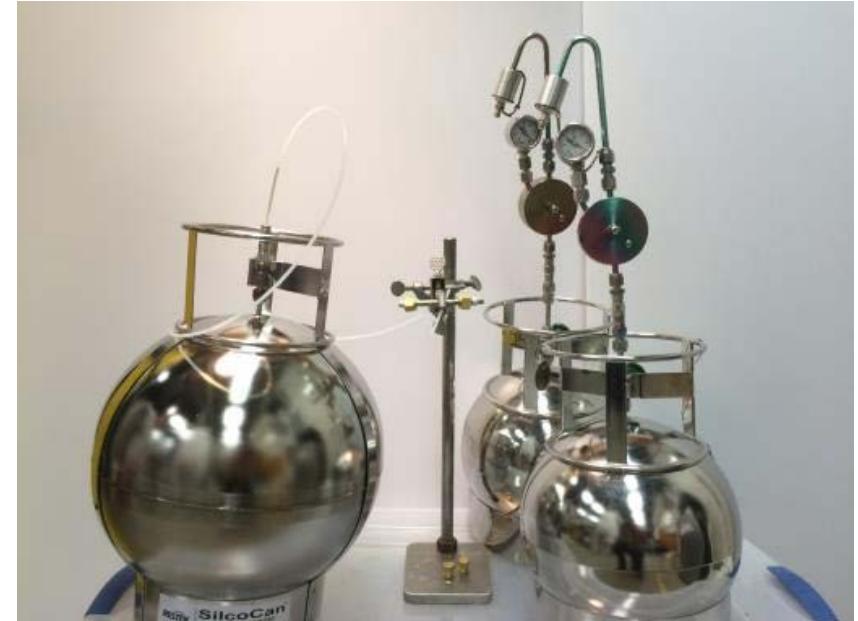
Test Design: Design & Layout

- Two buildings - 2 locations per building
- Two-week sampling period; ~quarterly, 6 rounds
- Sampling devices
 - Canisters with conventional diaphragm flow controllers (**24-hr sample time**)
 - Capillary flow controller providing **2 week integration**
- Other
 - Temperature
 - Relative humidity
 - Cross slab pressure
 - Direct-reading: VOCs

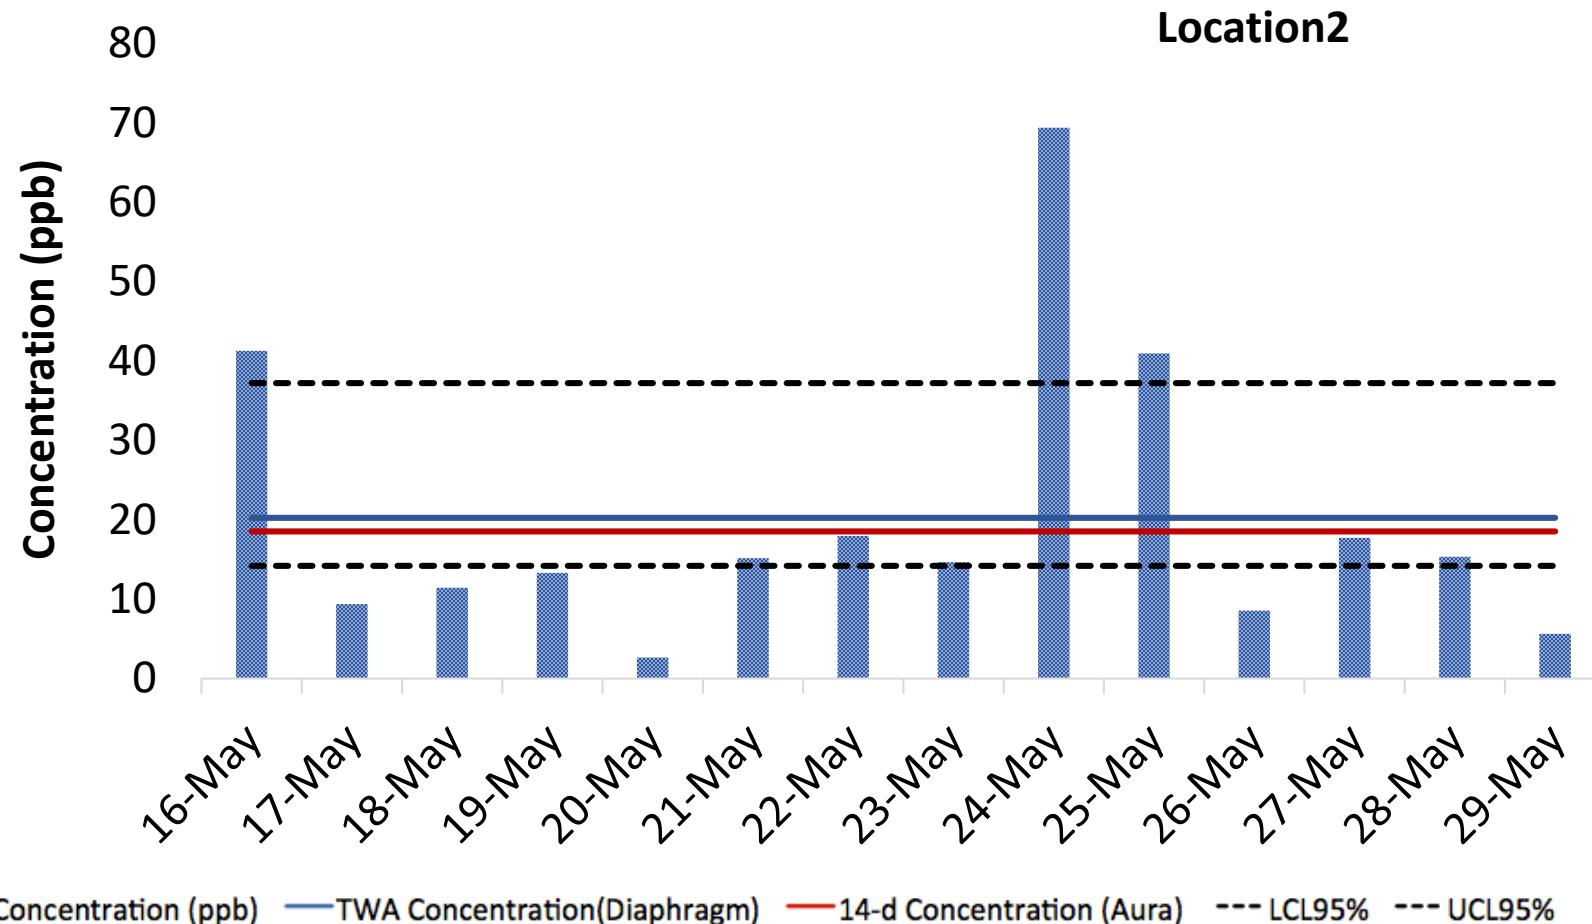
Example Temporal Trend – 24 hour samples May 2017

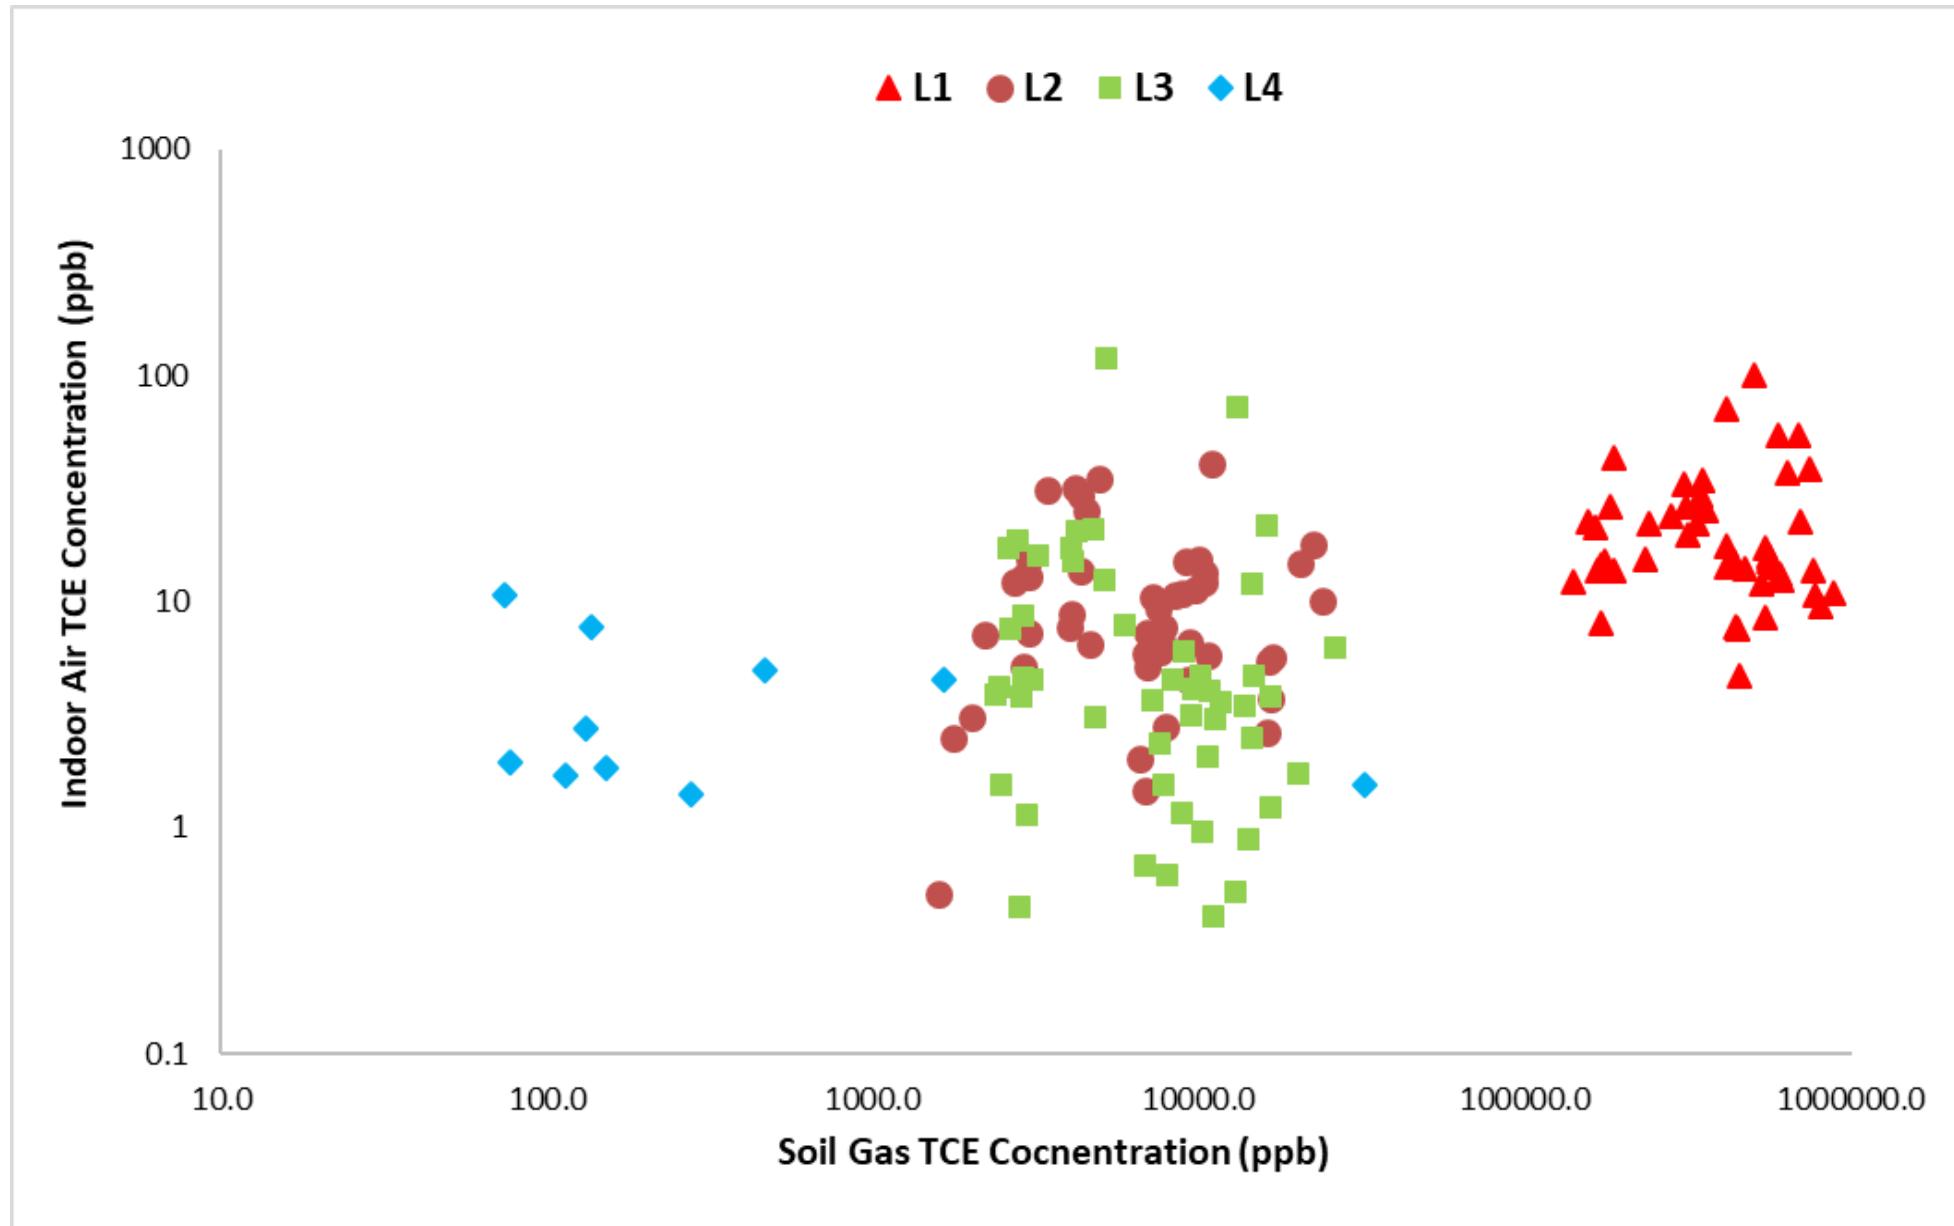
Indoor and sub-slab sample concentrations for all six sampling events

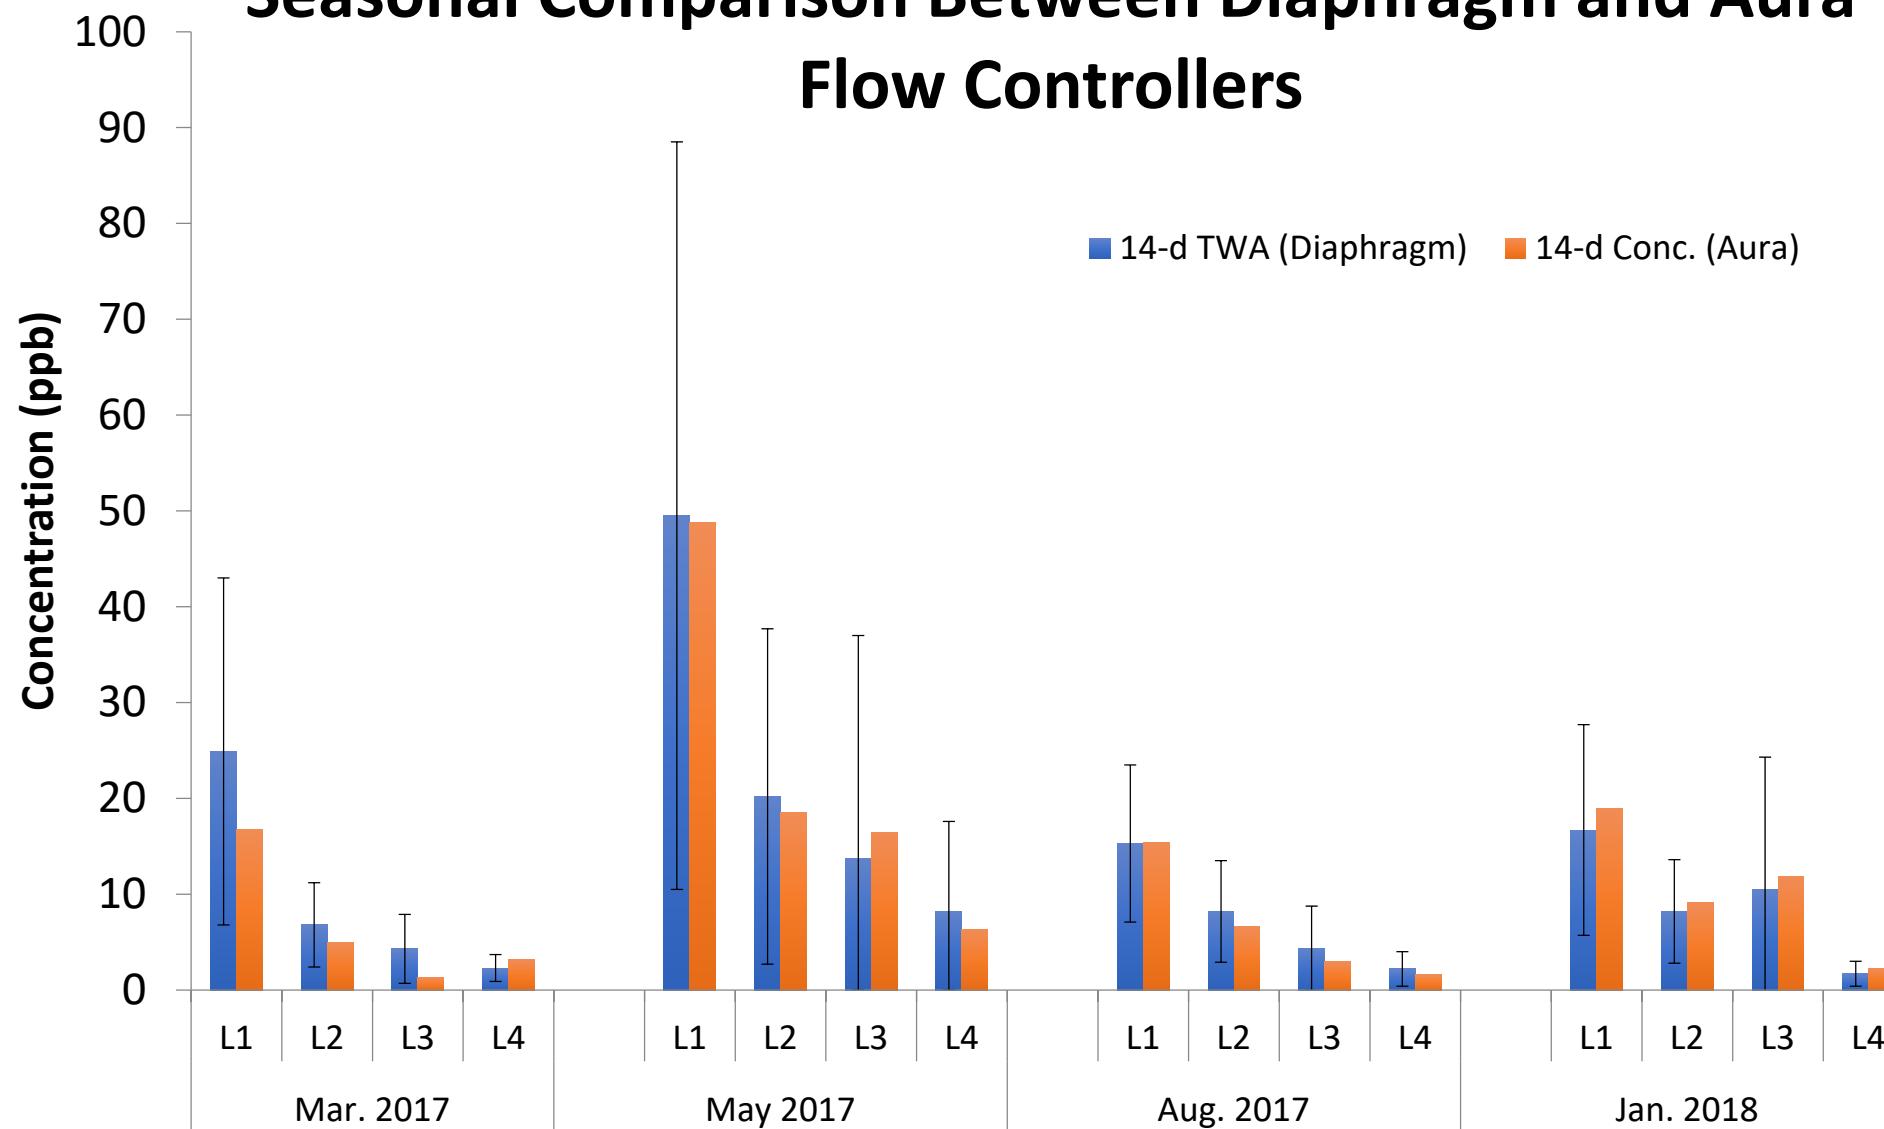
Seasonal Comparison Between Diaphragm and Aura Flow Controllers

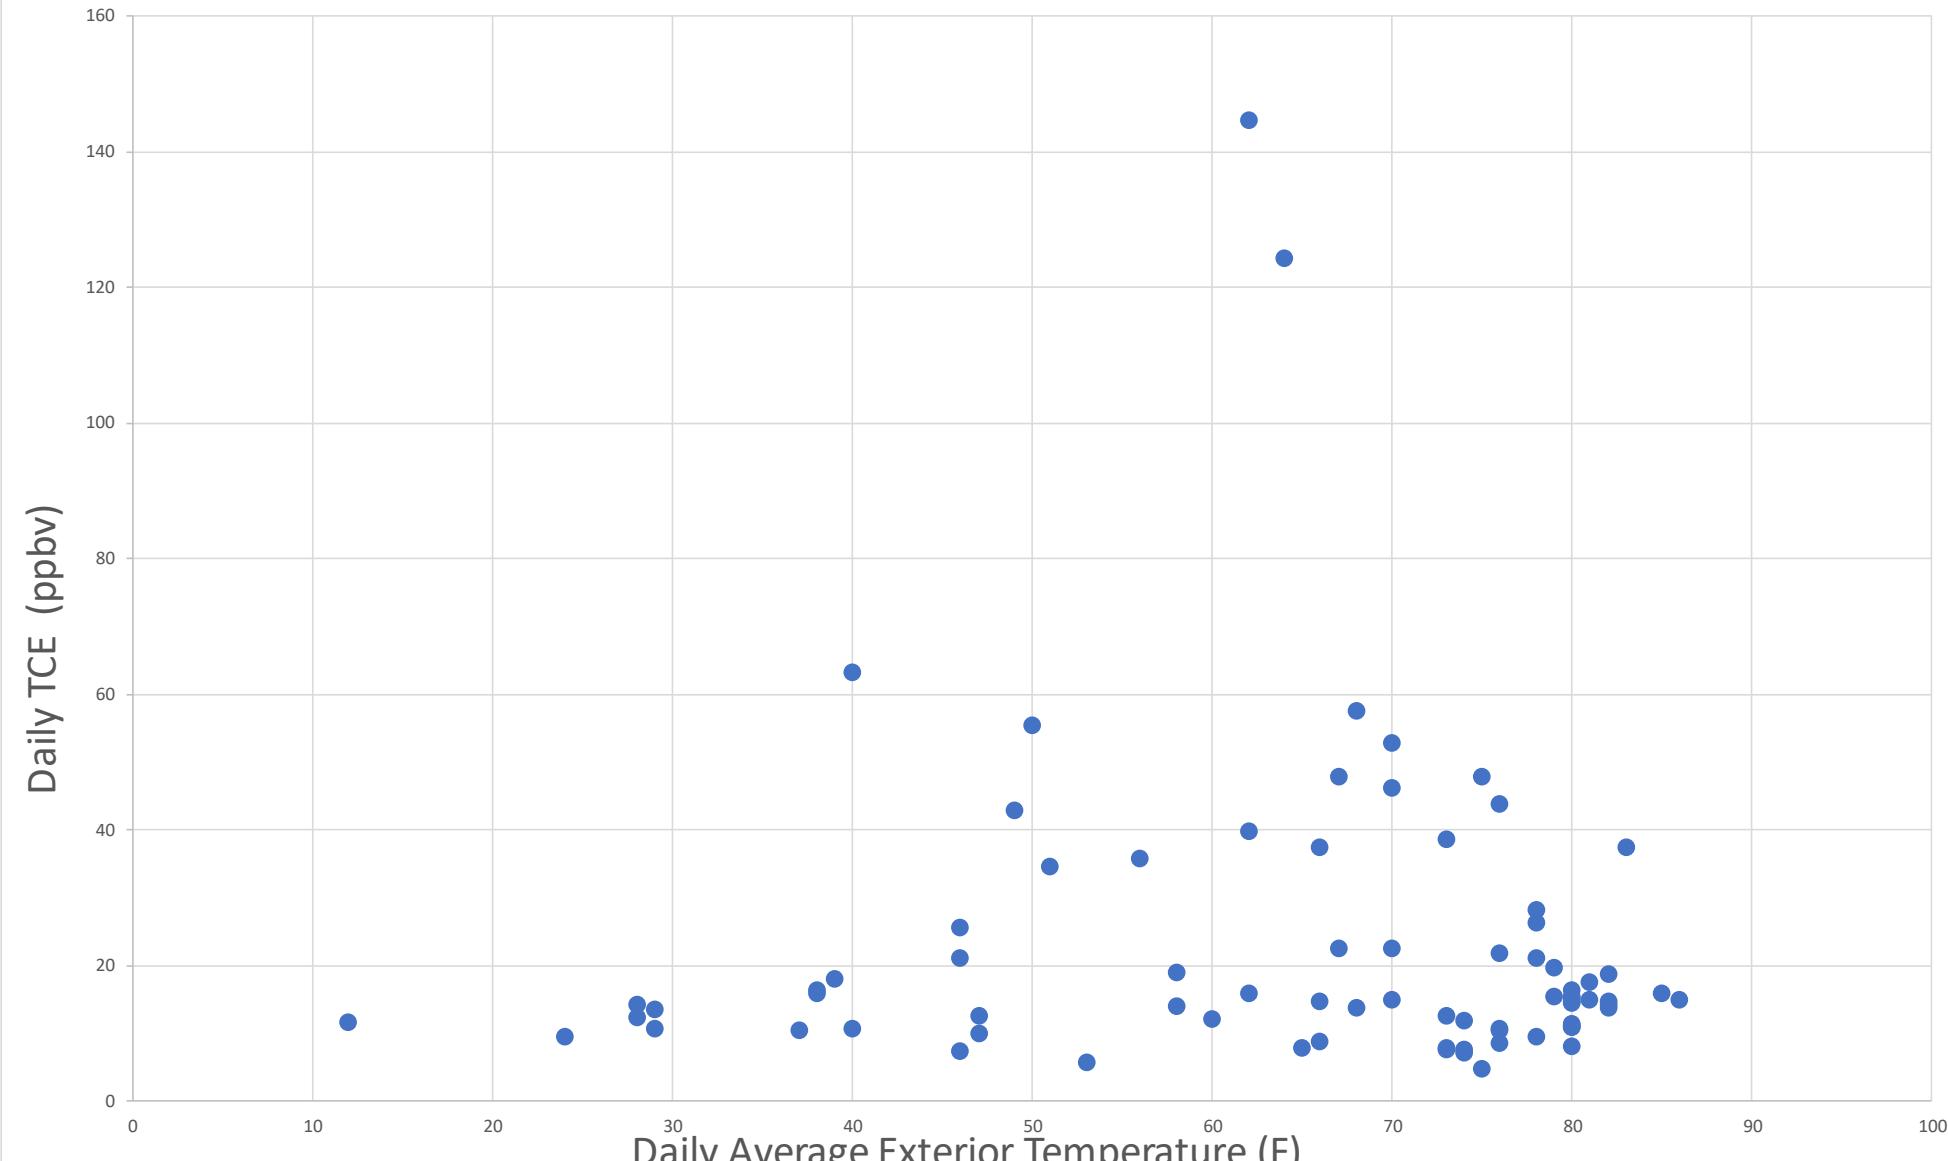
Temperature vs. Daily Average TCE

Indoor Air Building B MW Location 1 TCE (ppb)

- Neither the pattern between seasons, or pattern within one 14 day round of sequential samples fits the model of stack effect control (winter worst)
- Thermal mass of the building floor resulted in less fluctuation for the indoor versus outdoors temperatures.
- Apparent rainfall effect on indoor concentration at least in one case

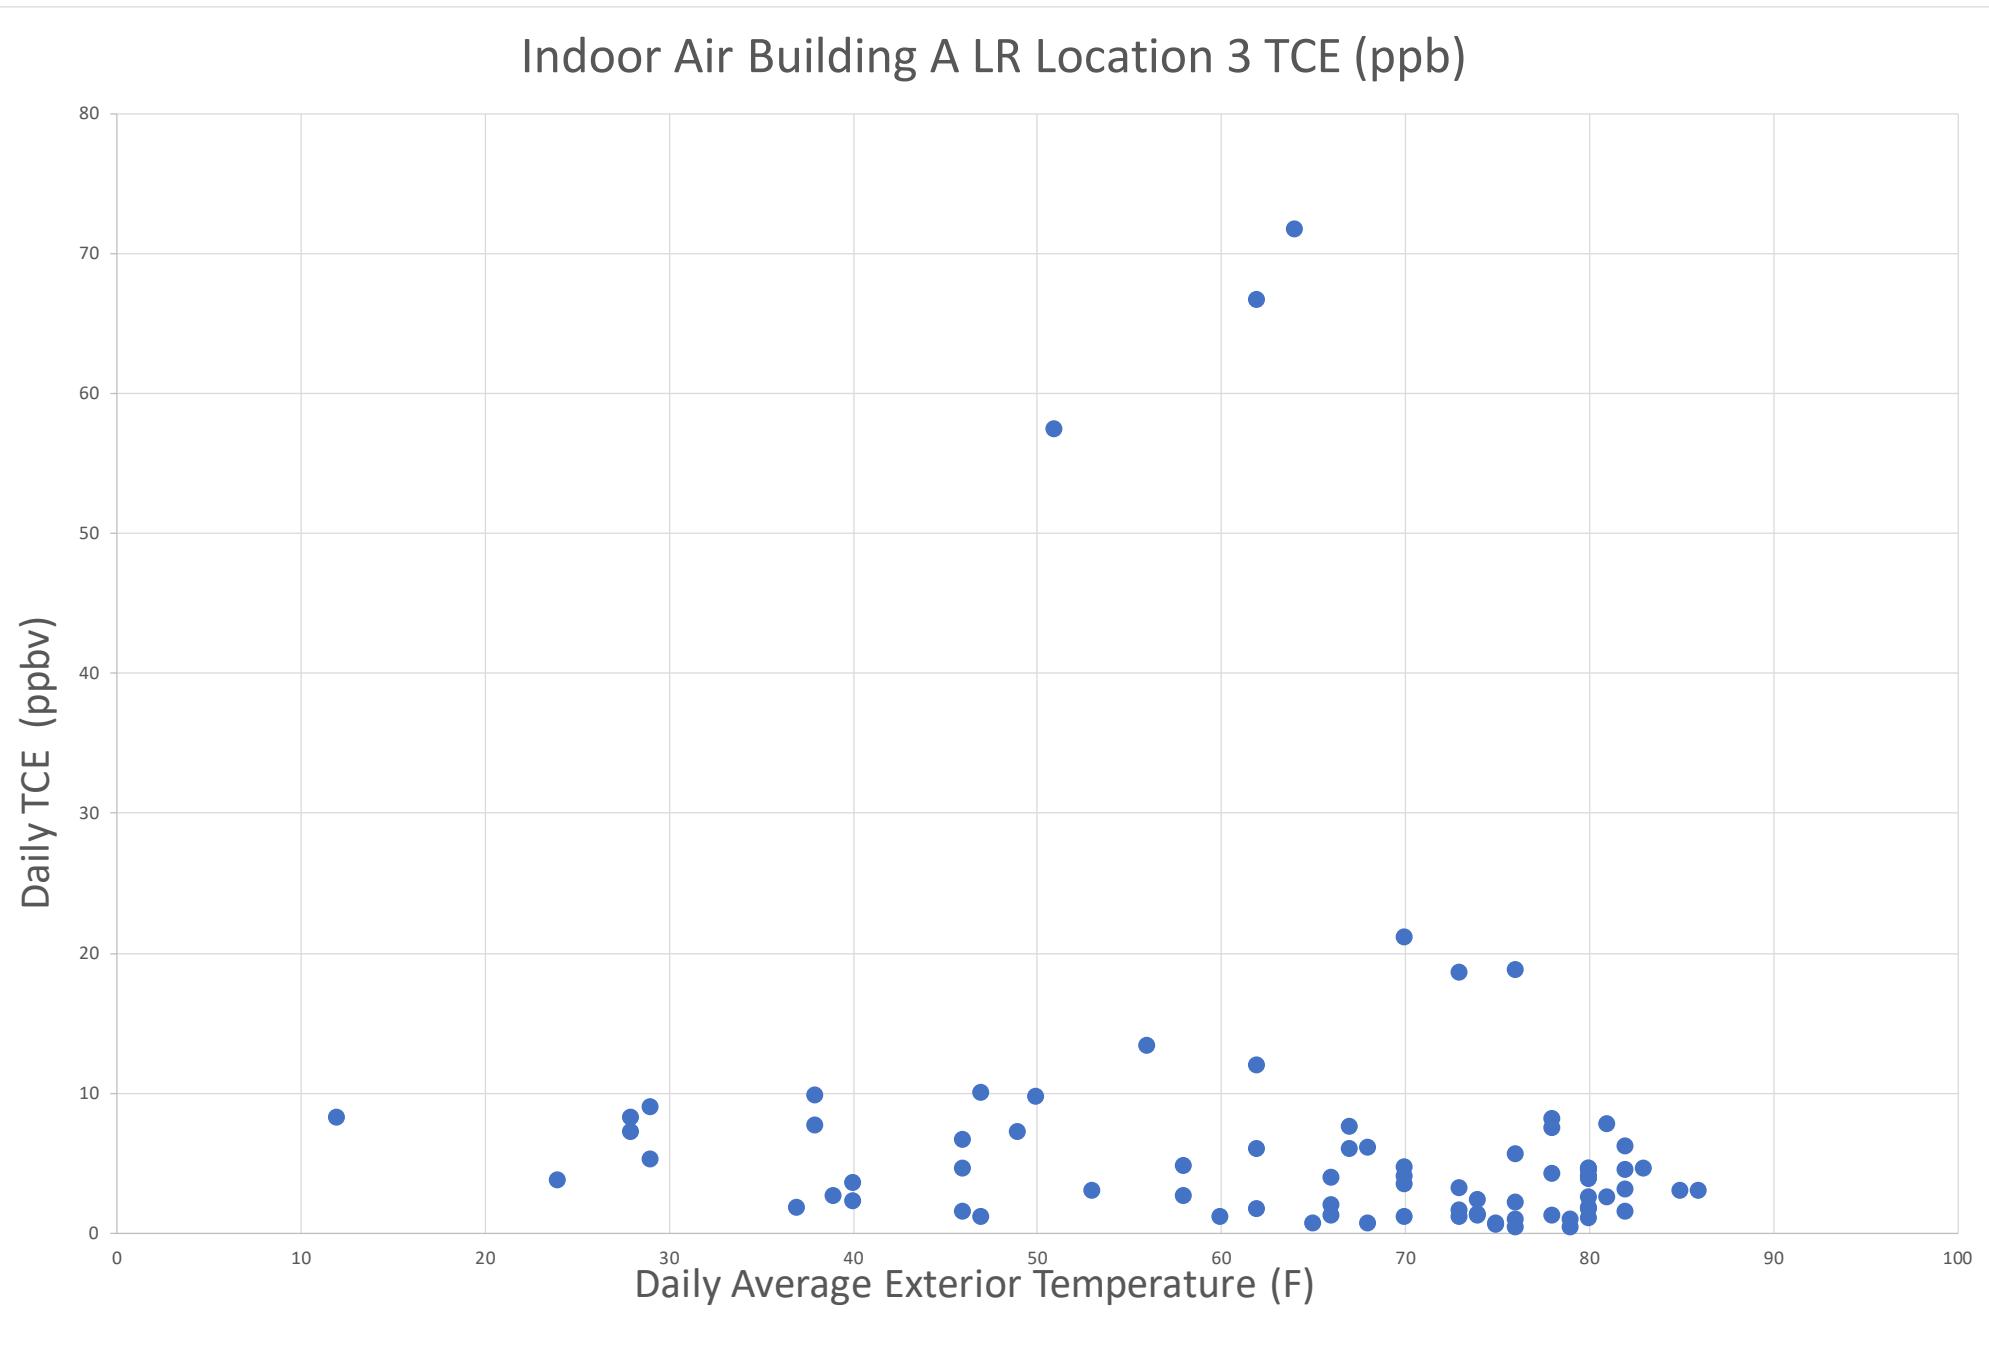
Temperature vs. Daily Average TCE

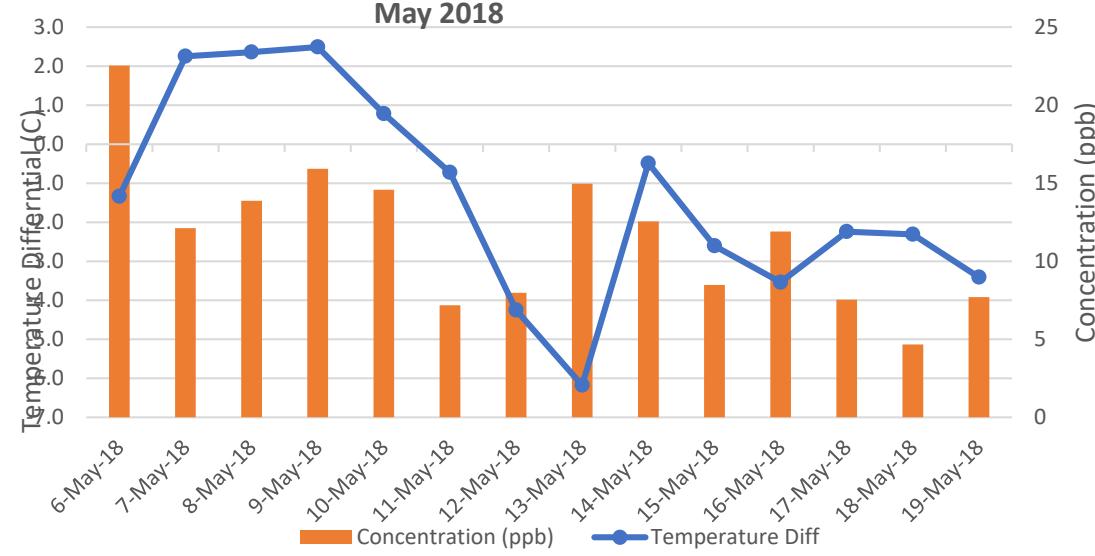
Temperature Differential and Concentration by Date: Location 1

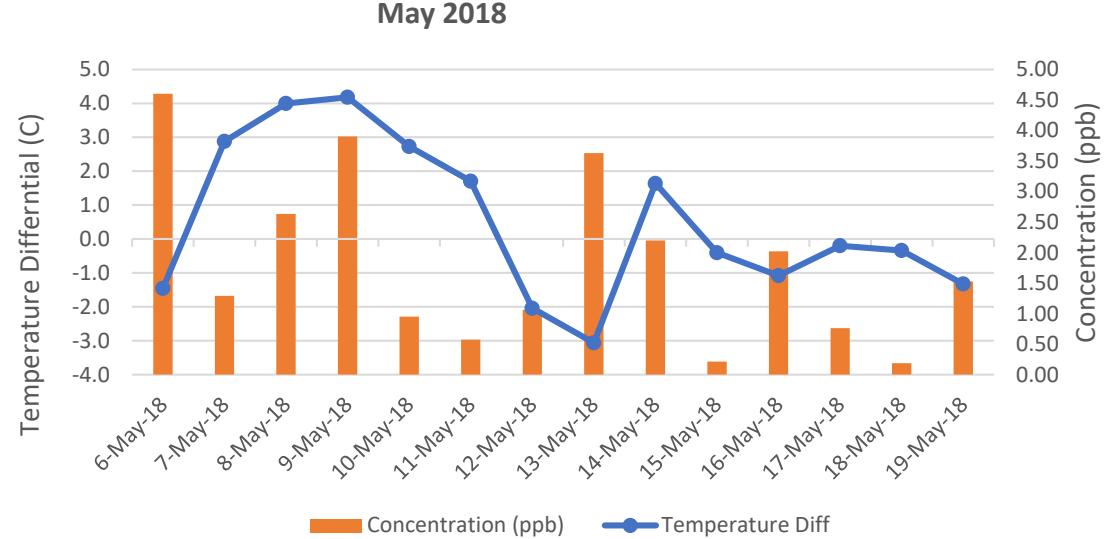
Temperature Differential and Concentration by Date: Location 3

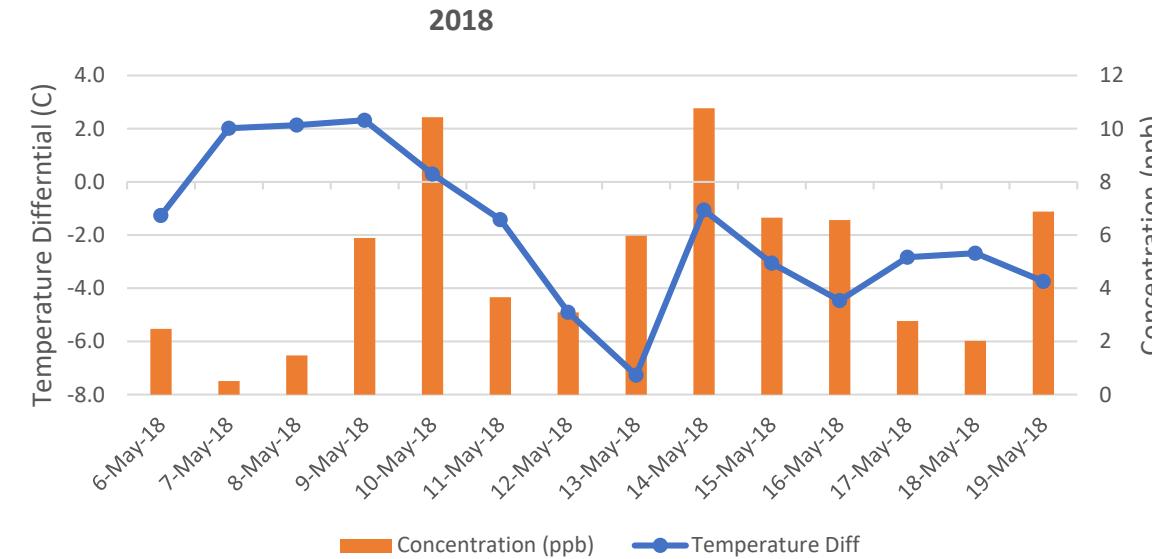
Temperature Differential and Concentration by Date: Location 2 May

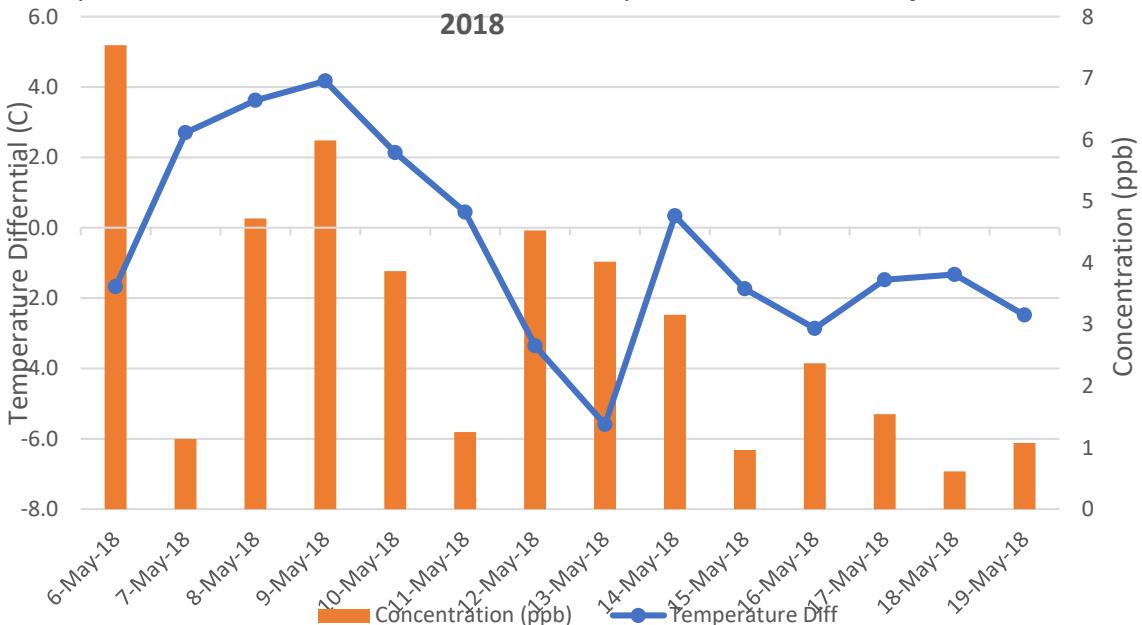
Temperature Differential and Concentration by Date: Location 4 May

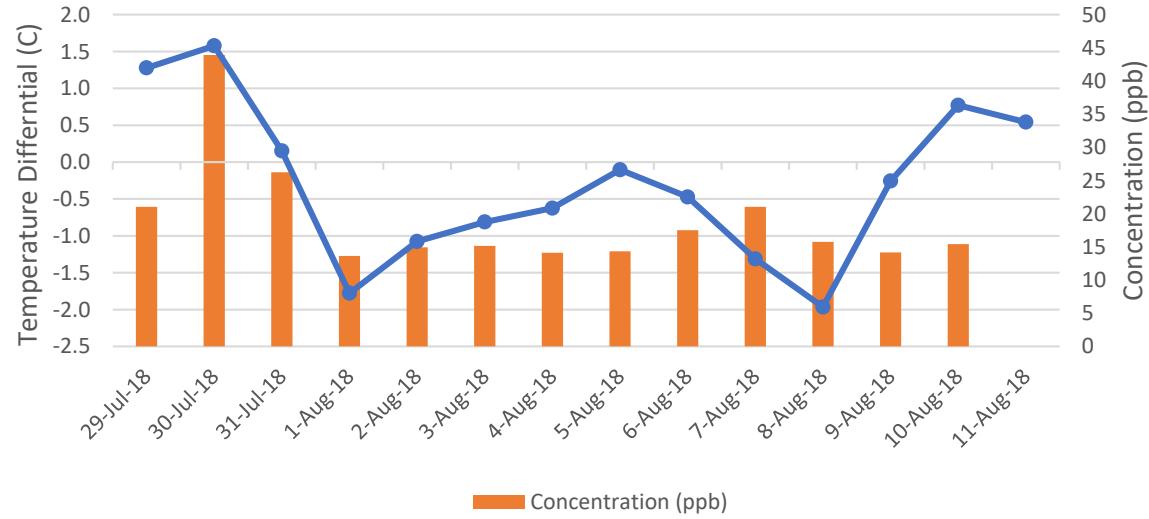
Temperature Differential and Concentration by Date: Location 1 August
2018

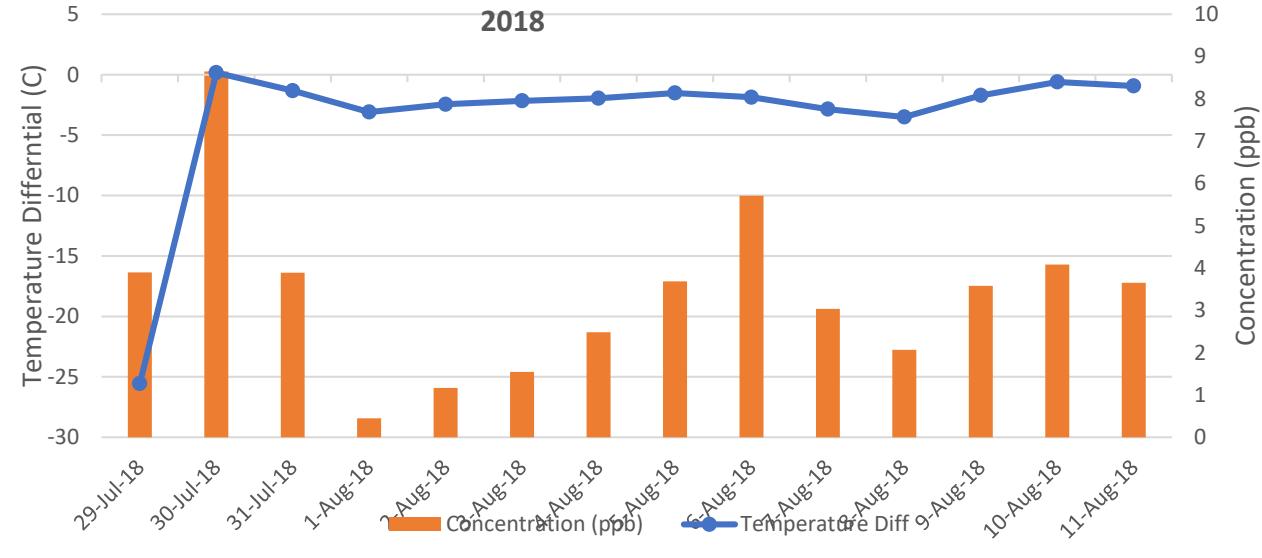
Temperature Differential and Concentration by Date: Location 3 August
2018

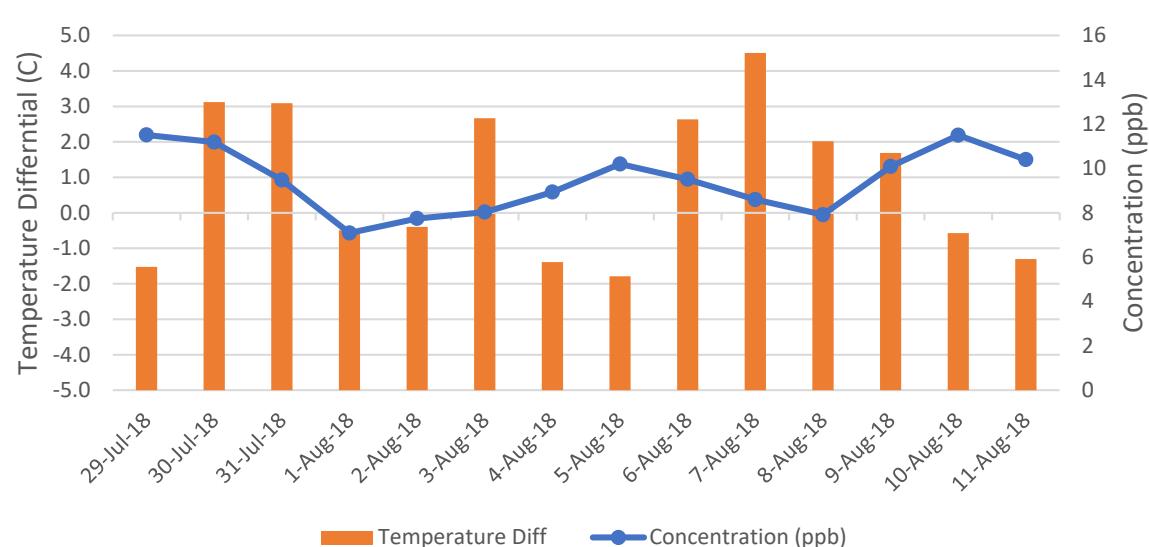
Temperature Differential and Concentration by Date: Location 2 August
2018

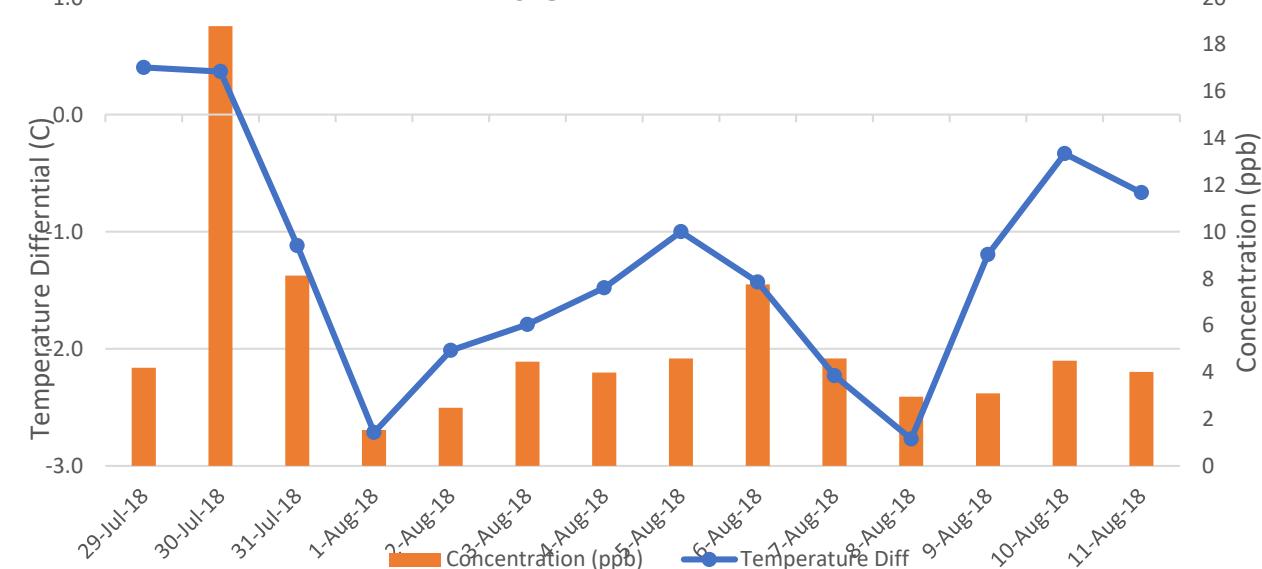
Temperature Differential and Concentration by Date: Location 4 August
2018
