Virginia Military Base Case Study for AEHS

Clarkson University

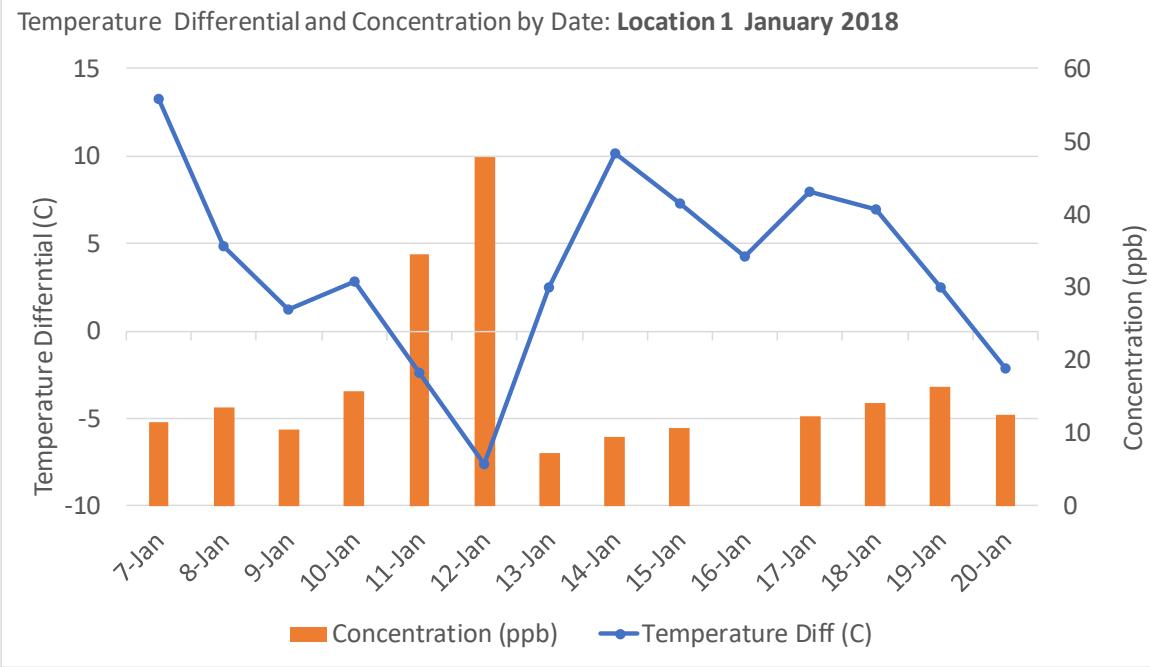
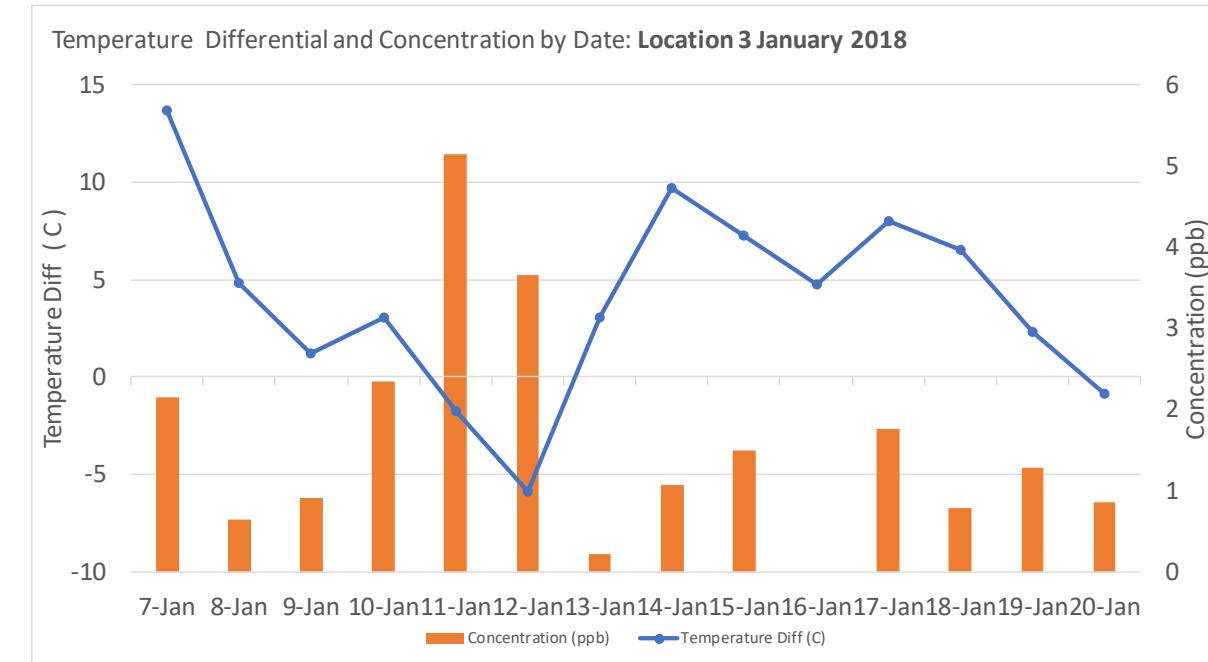
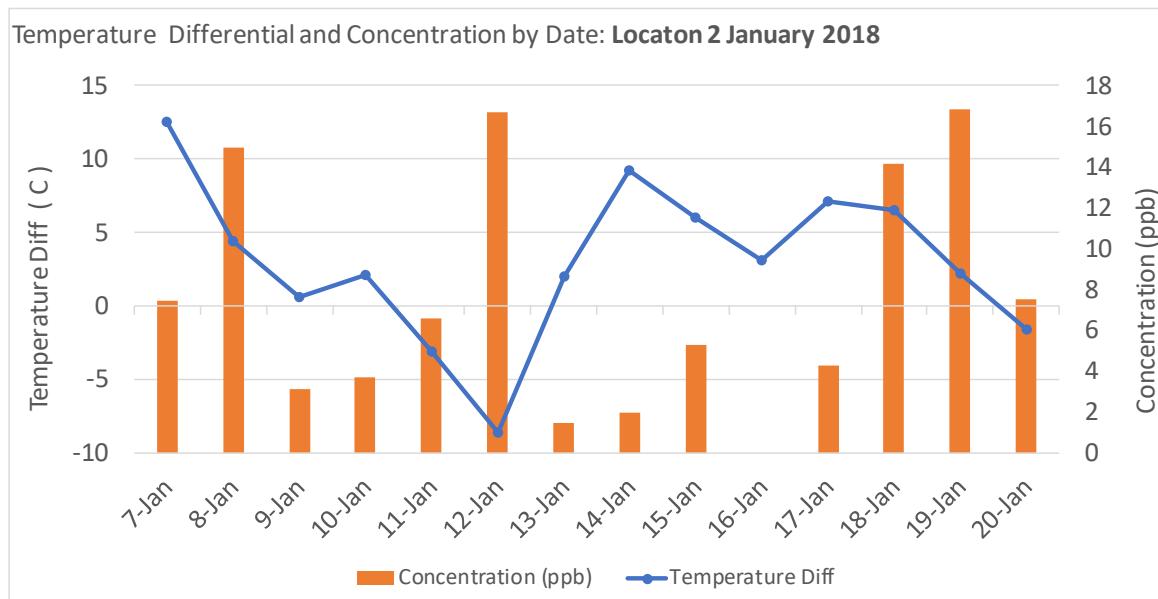
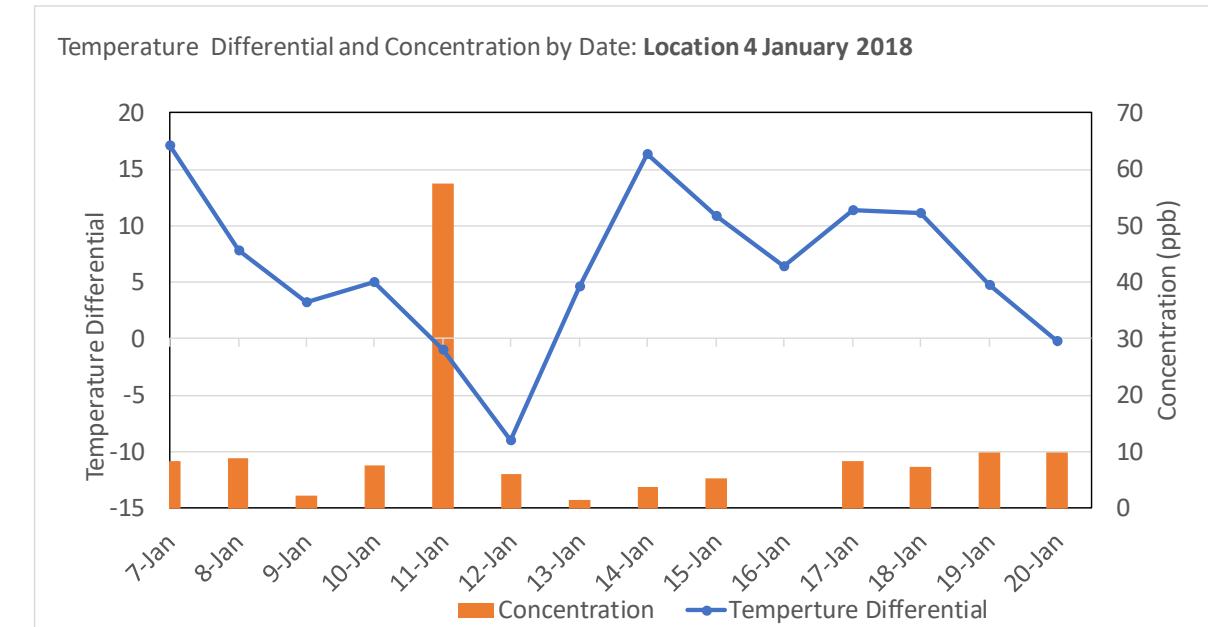
Four Locations, 14 Days, Jan 2018 TCE Concentration and Temperature Differential (inside-outside)

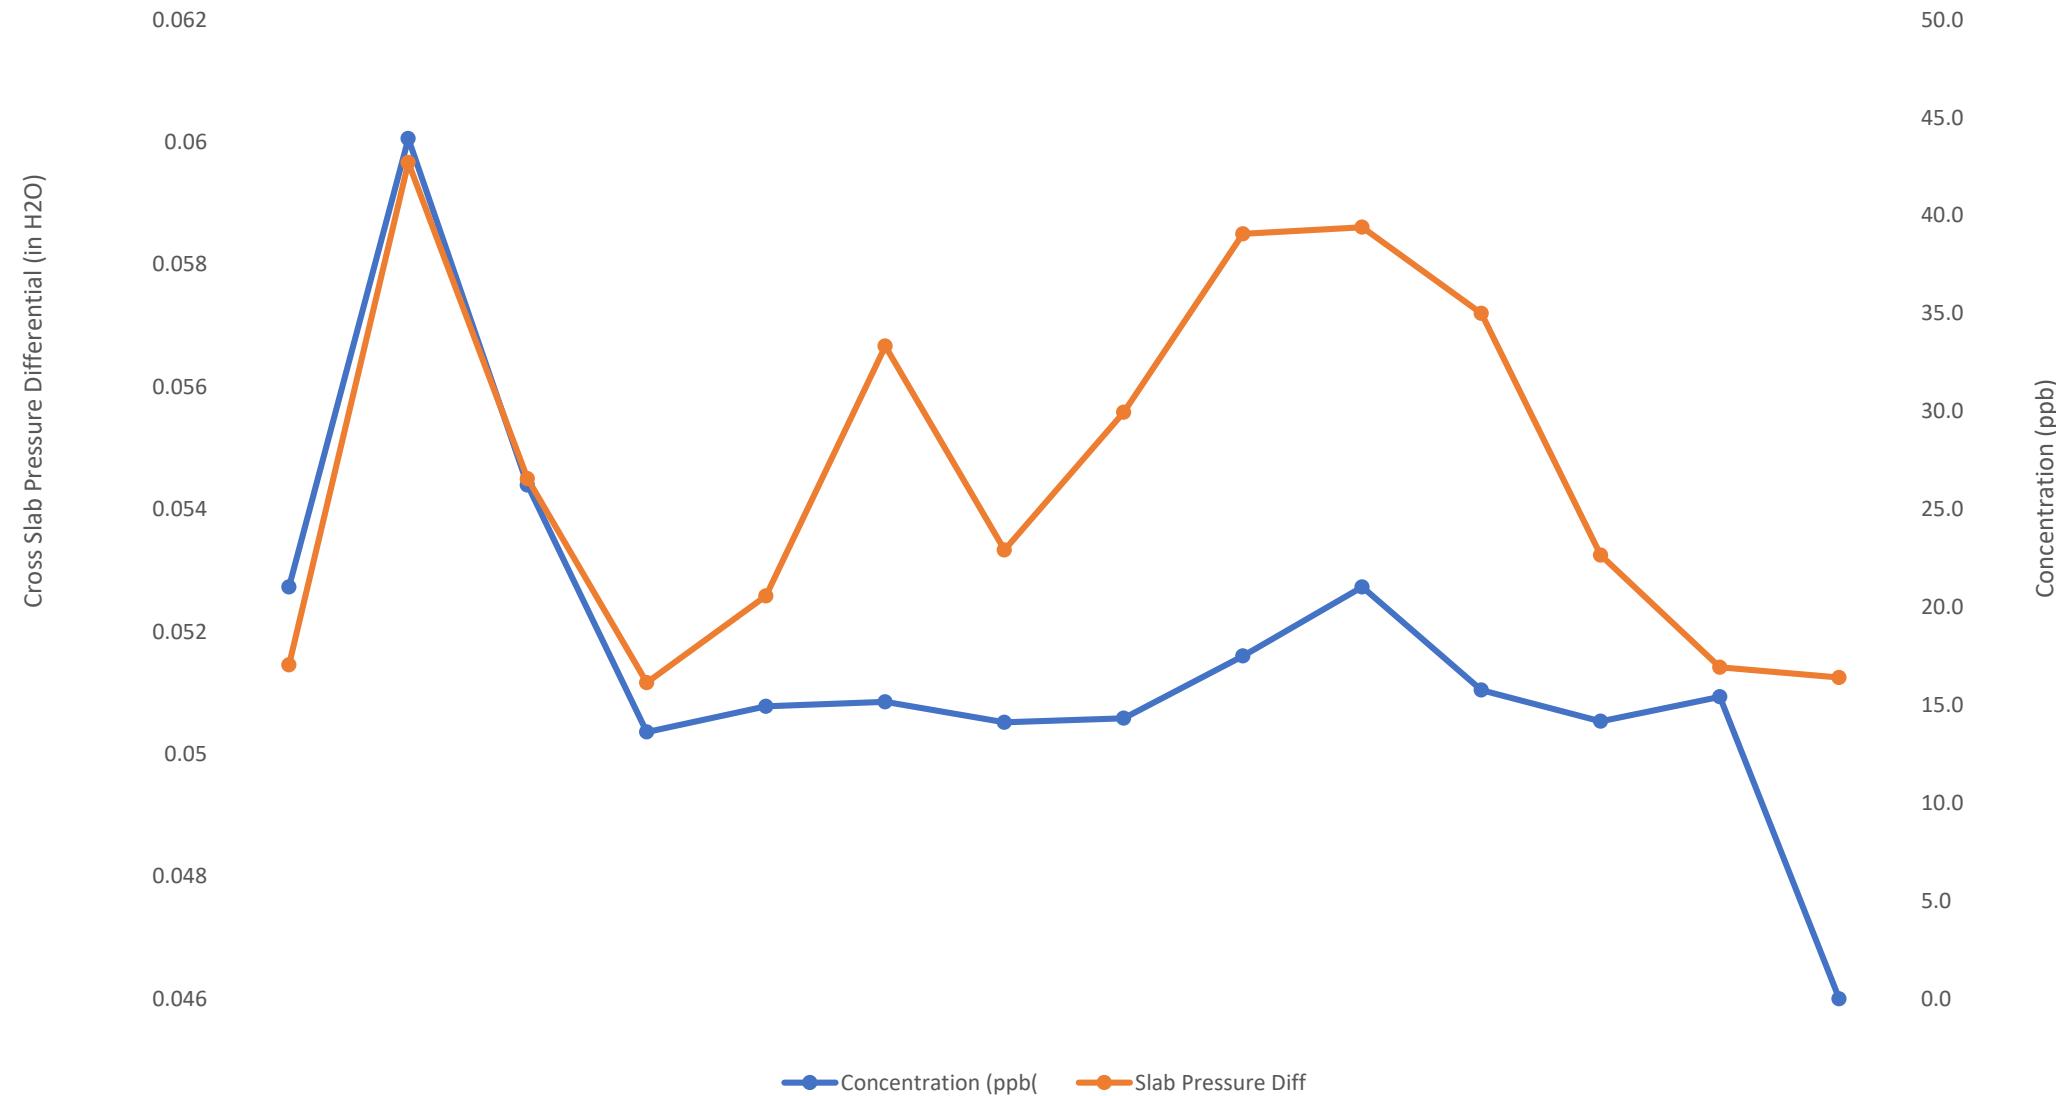
August 2018 L1 Cross Slab Pressure vs TCE concentration

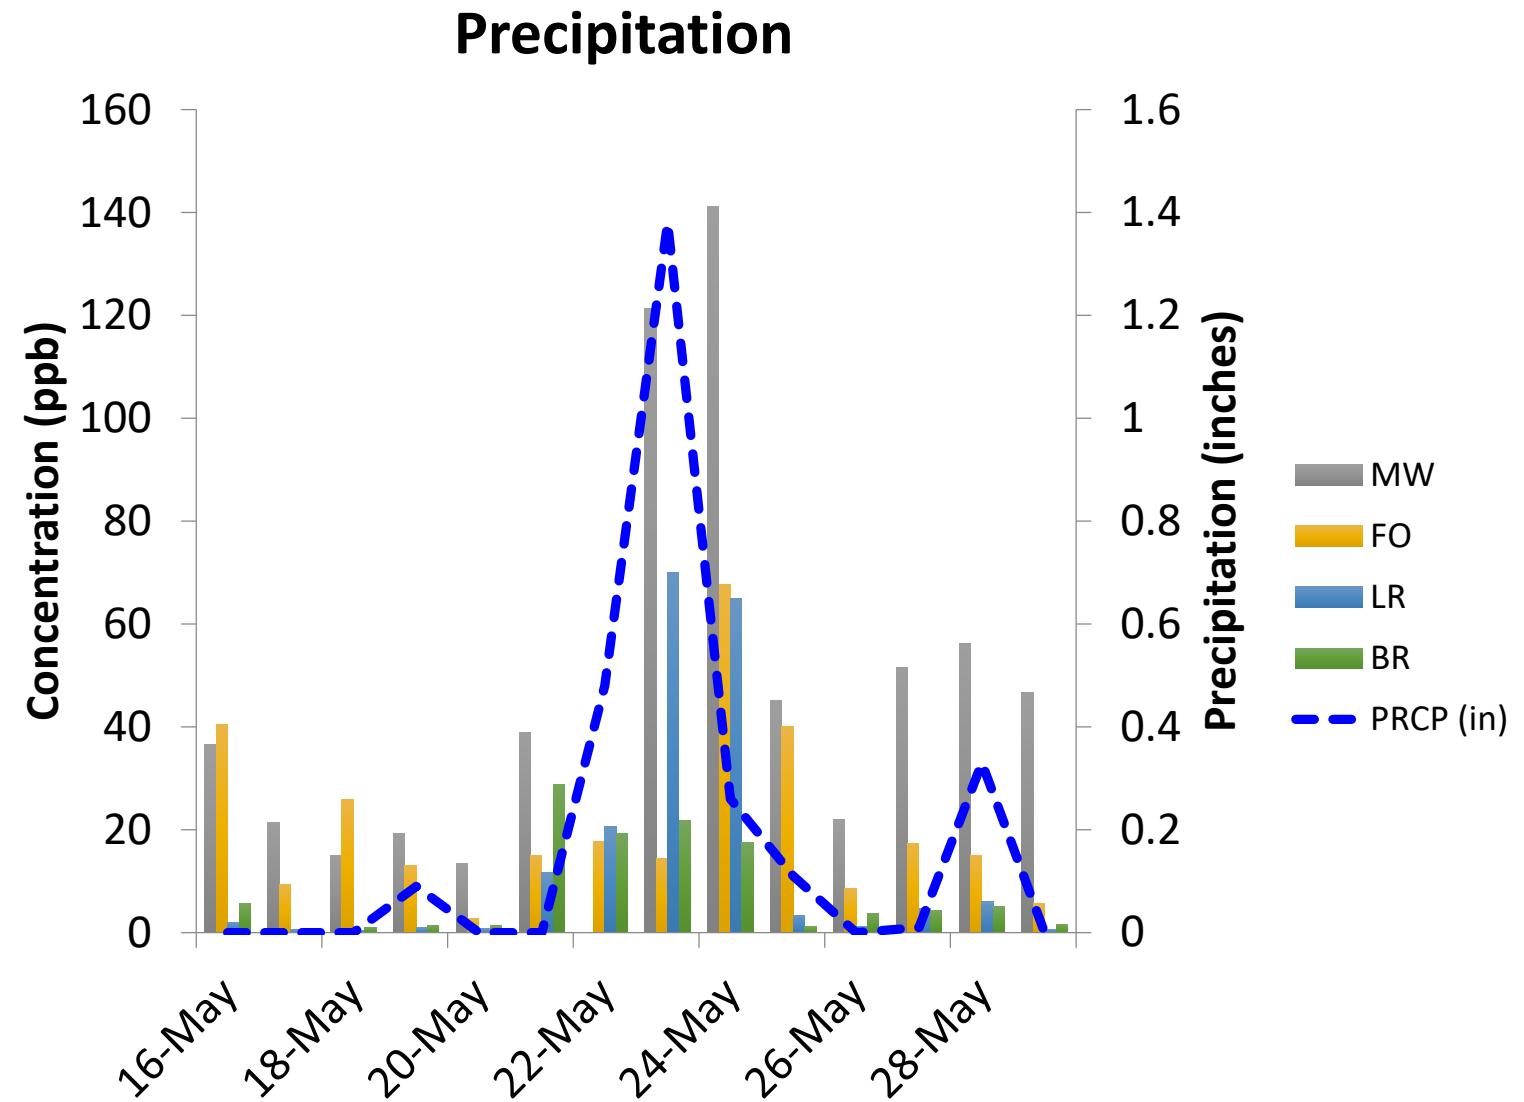
Precipitation vs. TCE
Concentration in Highest
Round (May 2017)

- Neither the pattern between seasons, or pattern within one 14 day round of sequential samples fits the model of stack effect control (winter worst)
- Thermal mass of the building floor resulted in less fluctuation for the indoor versus outdoors temperatures.
- Apparent rainfall effect on indoor concentration at least in one case

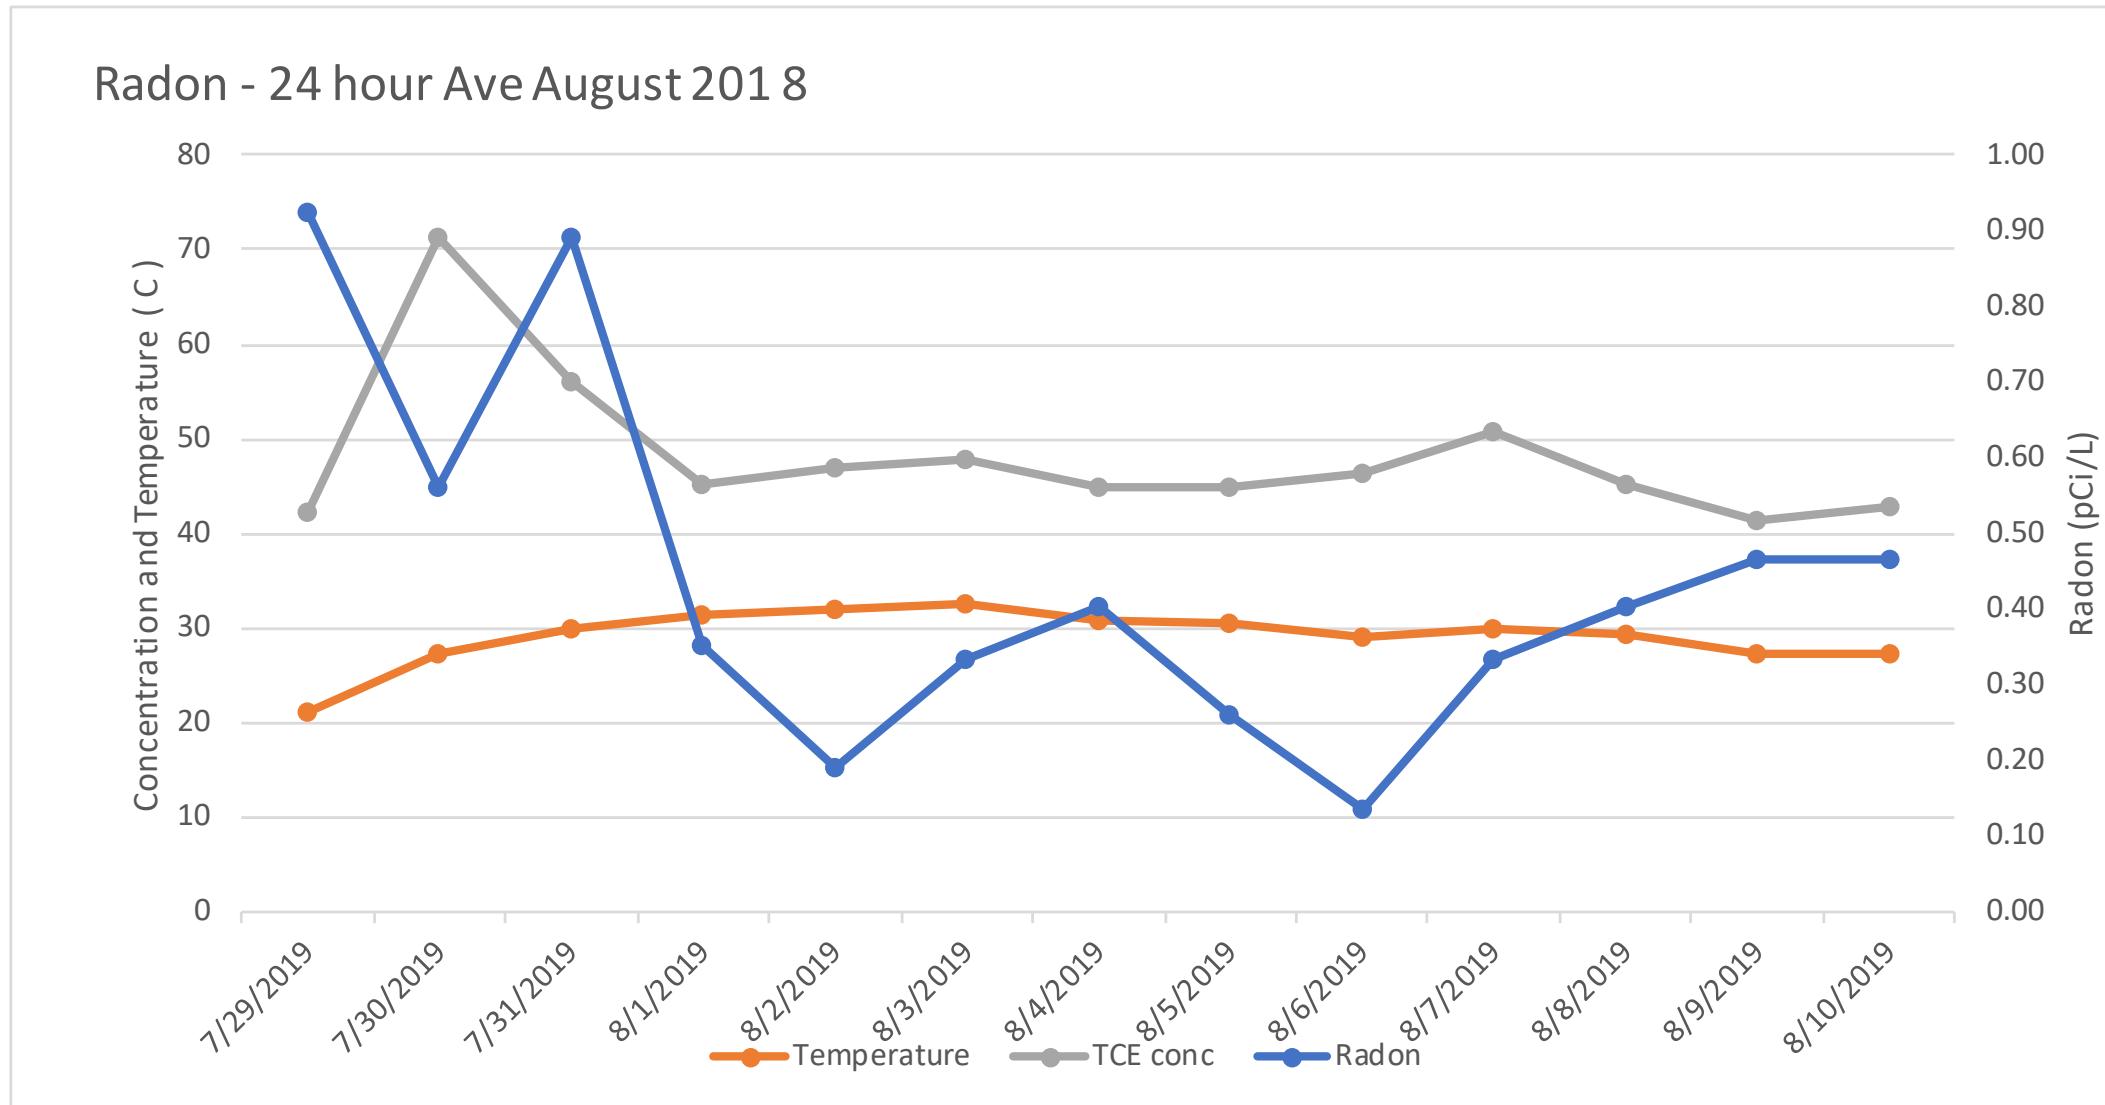
Radon Vs. TCE and Temperature, Building B Location L1, August 2018
