**EPA Vapor Intrusion Workshop**  
***Measurement-Based Methods for Protective &  
Defensible Chlorinated VI Exposure Determinations***

Wheeler and SEND Buildings In Indianapolis – Radon and Differential  
Pressure Data in VOC Site Management  
IECC Climate Zone 5A

Chris Lutes, Jacobs

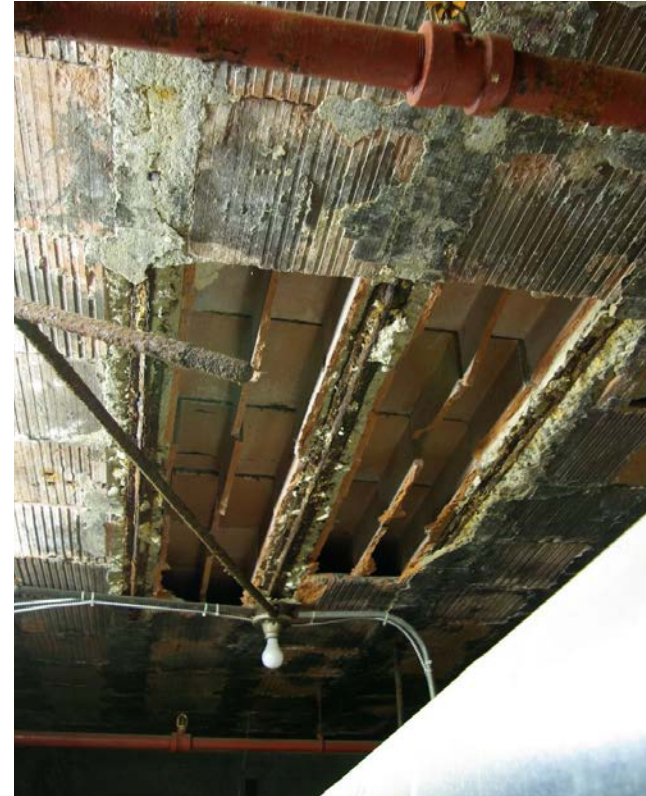
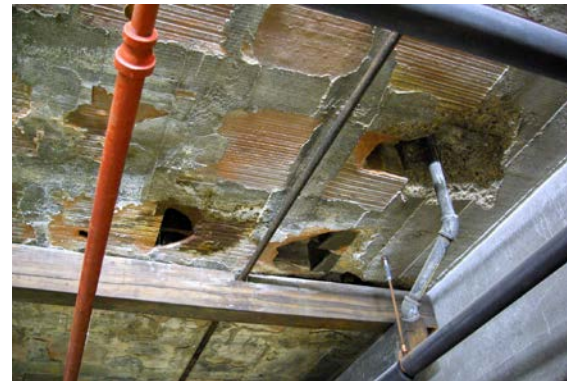
Hollow Tile  
Construction in  
Wheeler  
Basement Ceiling  
Provides Complex  
Flow Paths

Gaps in Wheeler  
Basement Ceiling

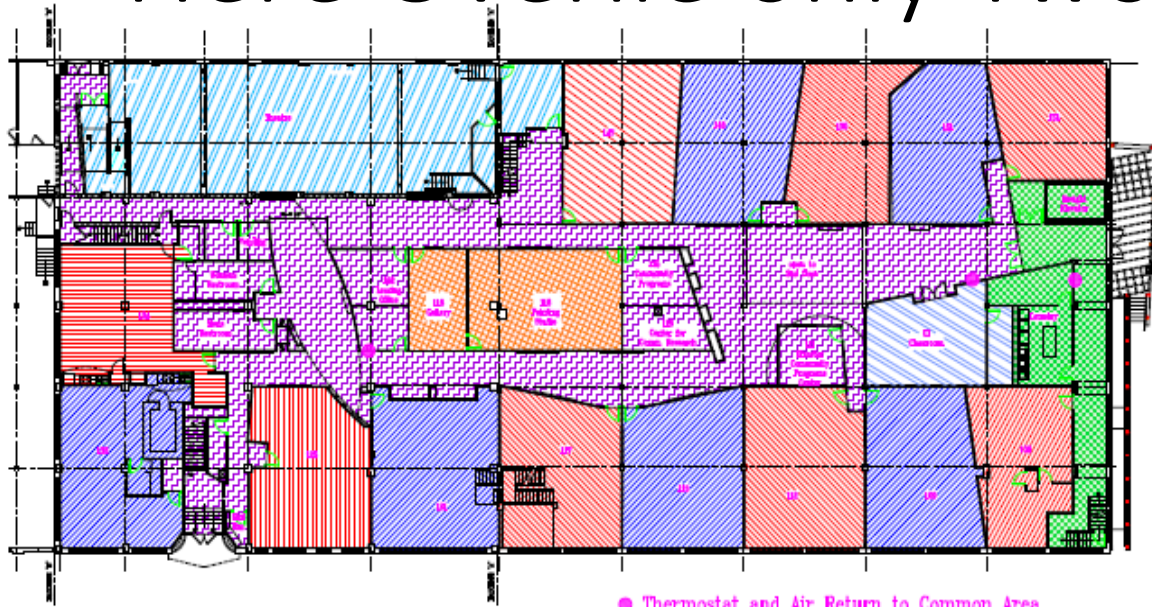
# Complex HVAC Zones – Upper Floors Shown Here Overlie only Two Basement Zones

● Thermostat and Air Return to Common Area

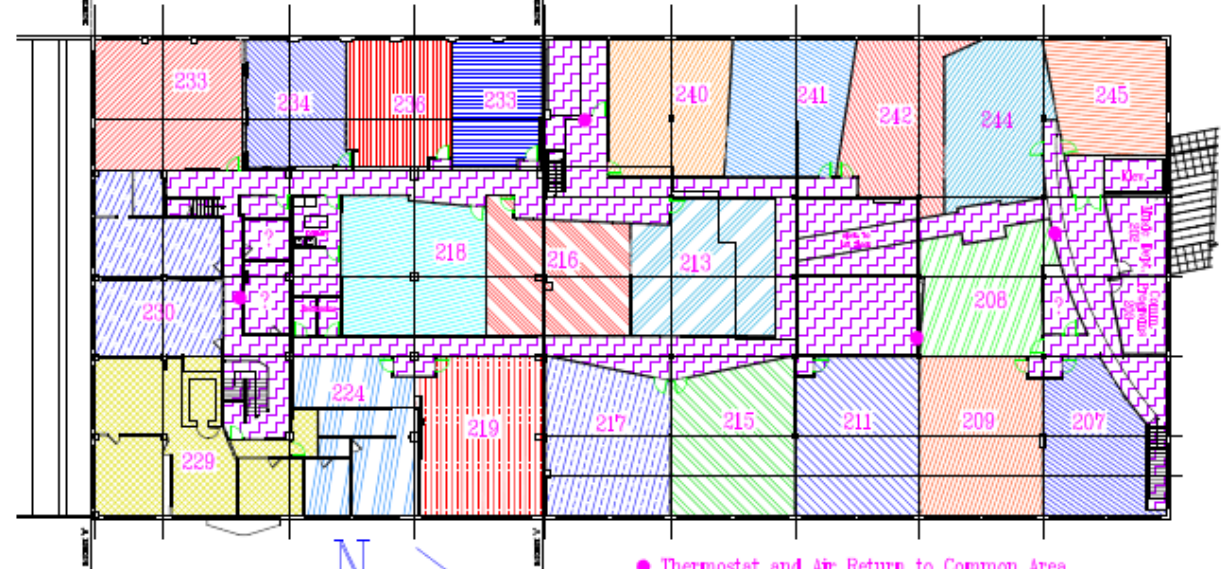
19 First Floor HVAC Zones

25 Second Floor HVAC Zones

● Thermostat and Air Return to Common Area

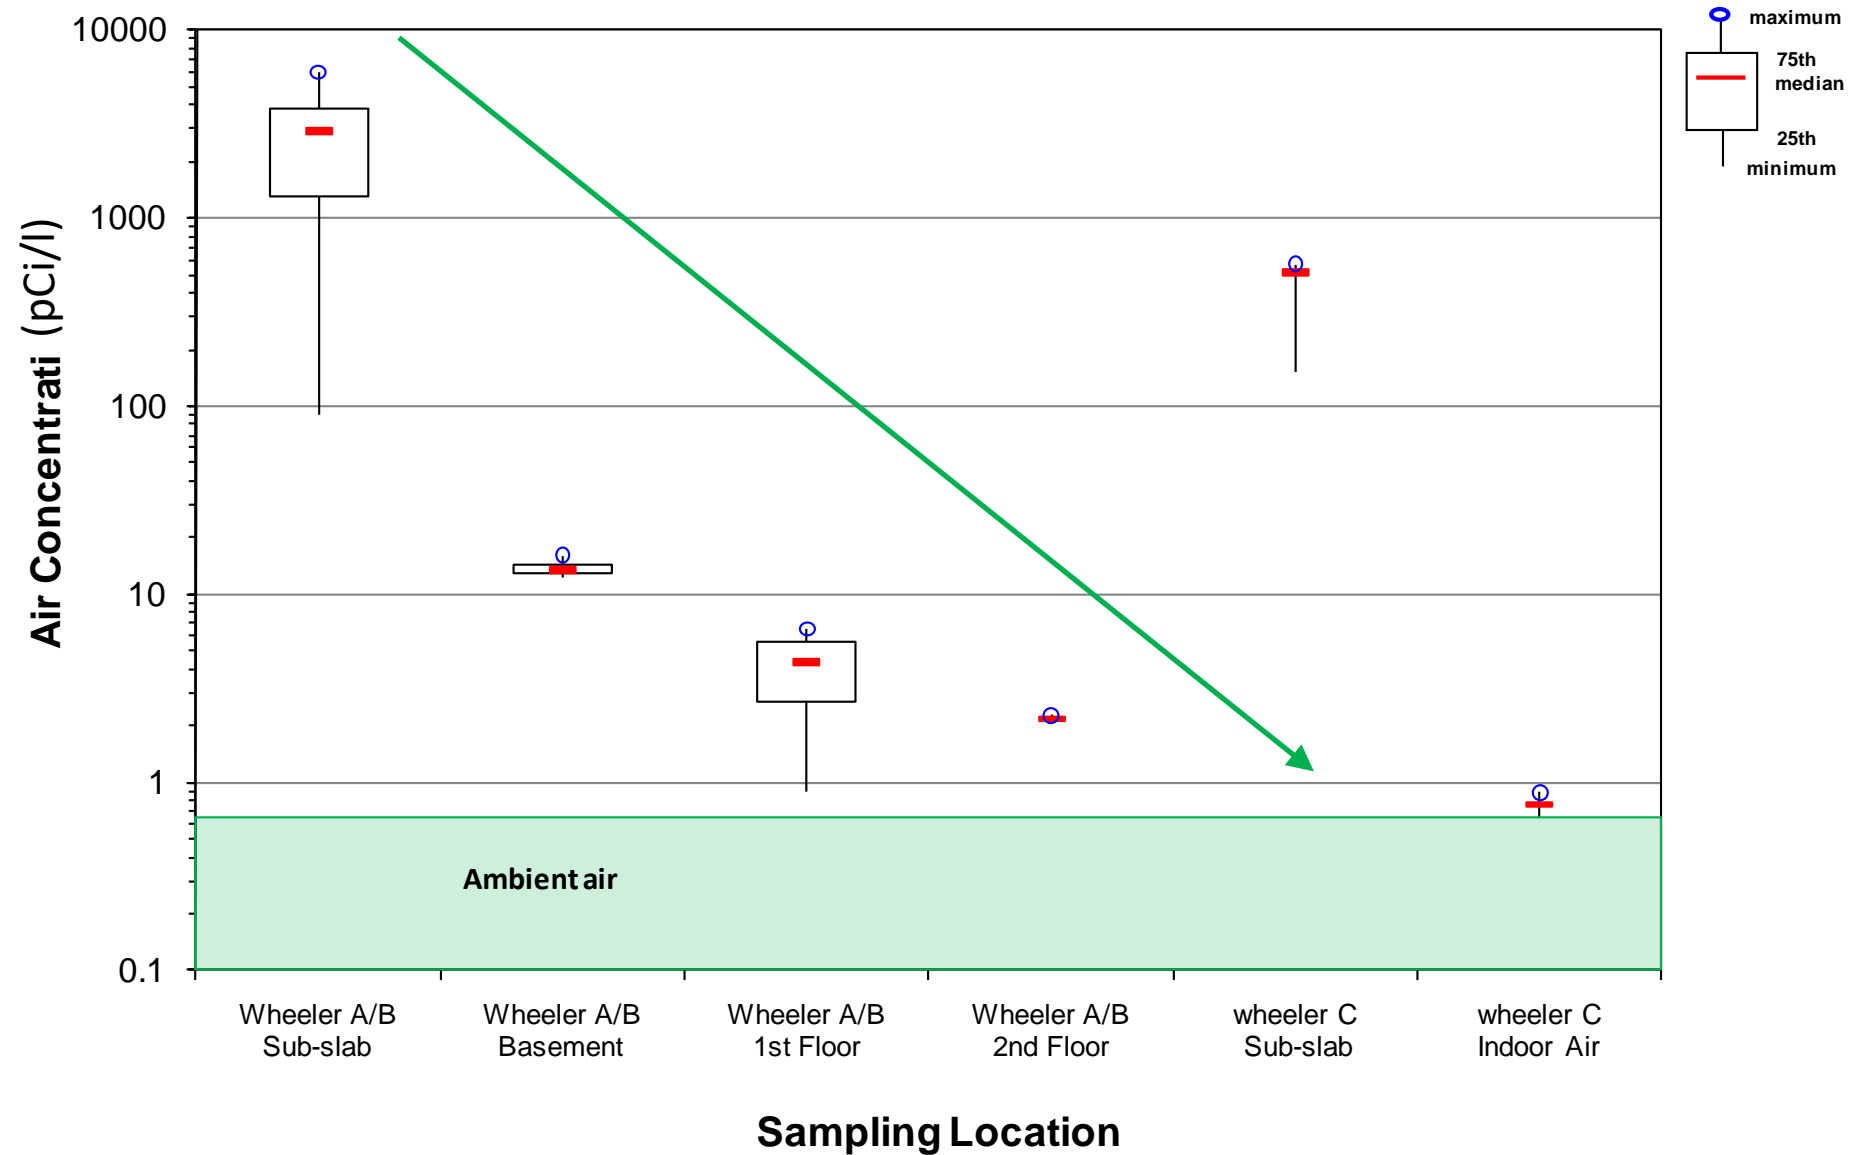
# Radon Distribution Among Floors – Suggests VI

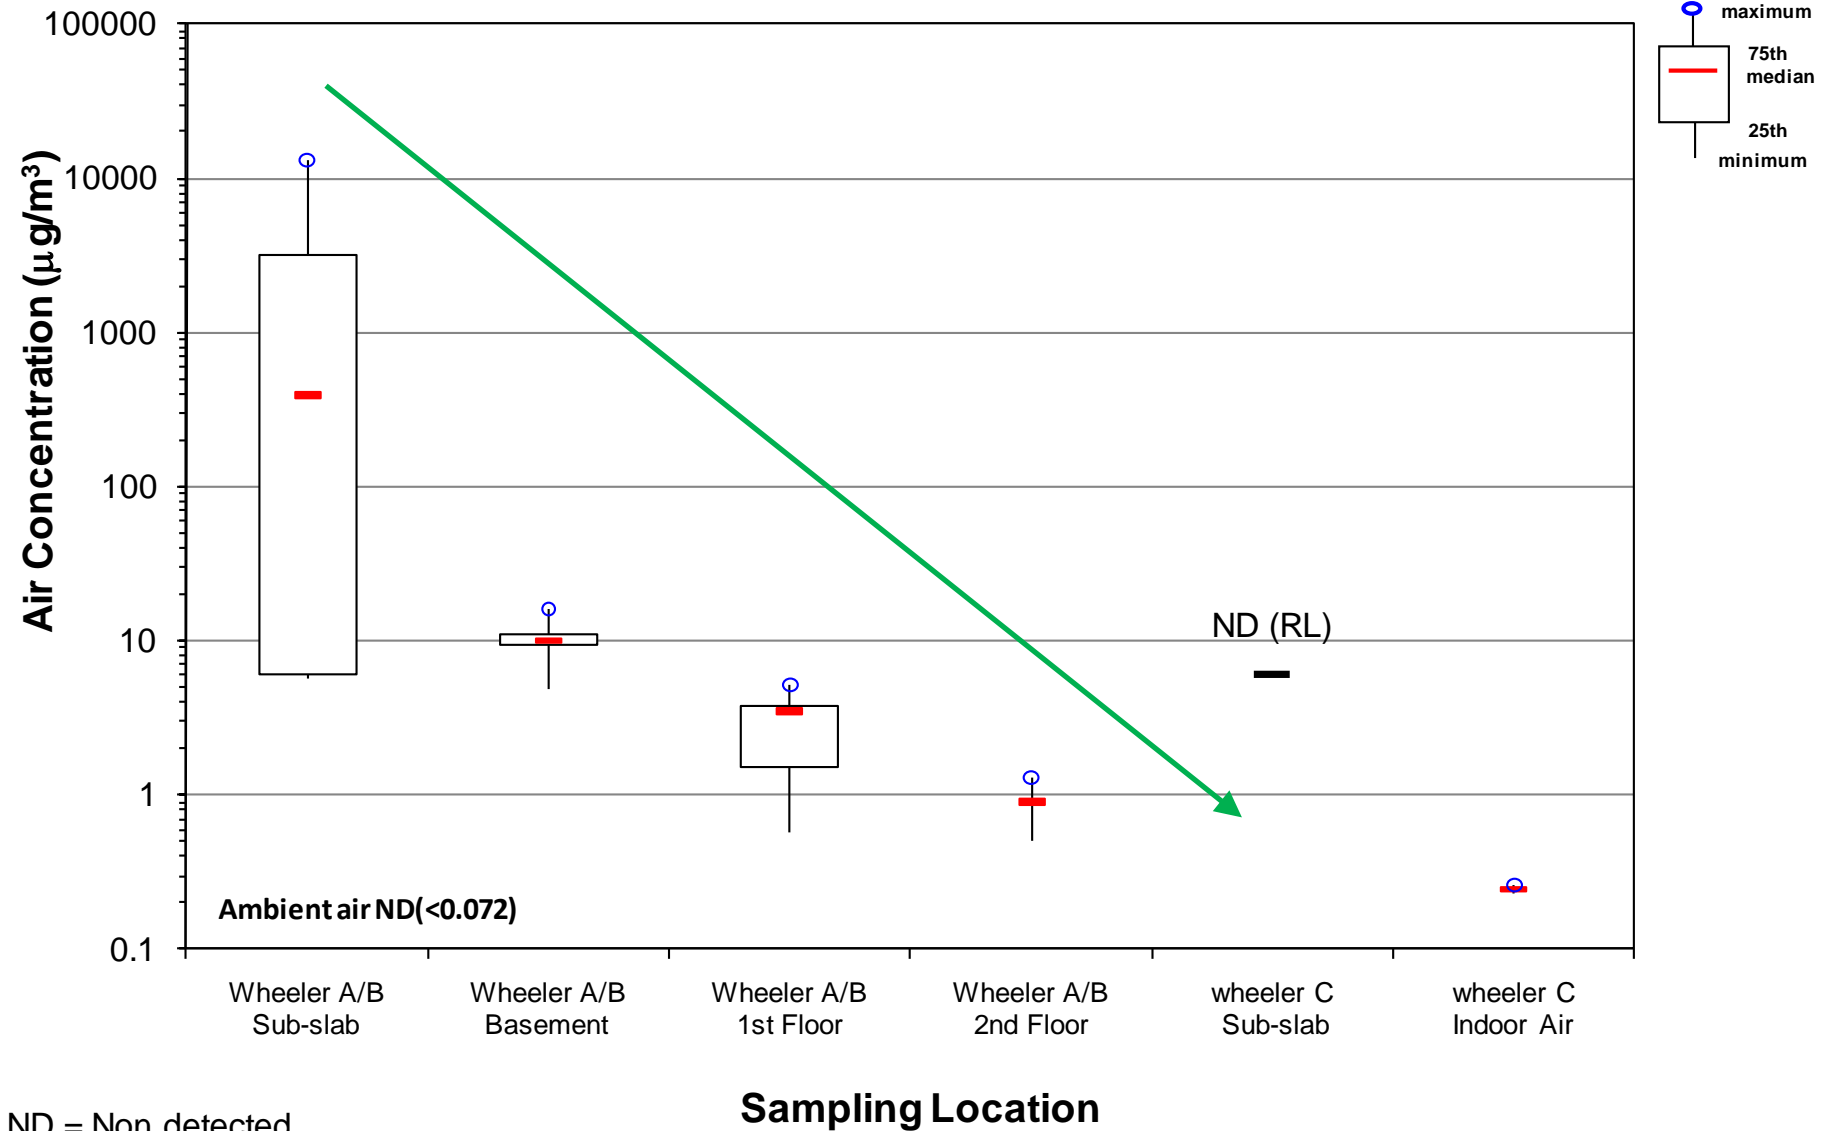
# TCE Concentration Among Floors – Suggests VI

ND = Non detected  
RL = Reporting limit

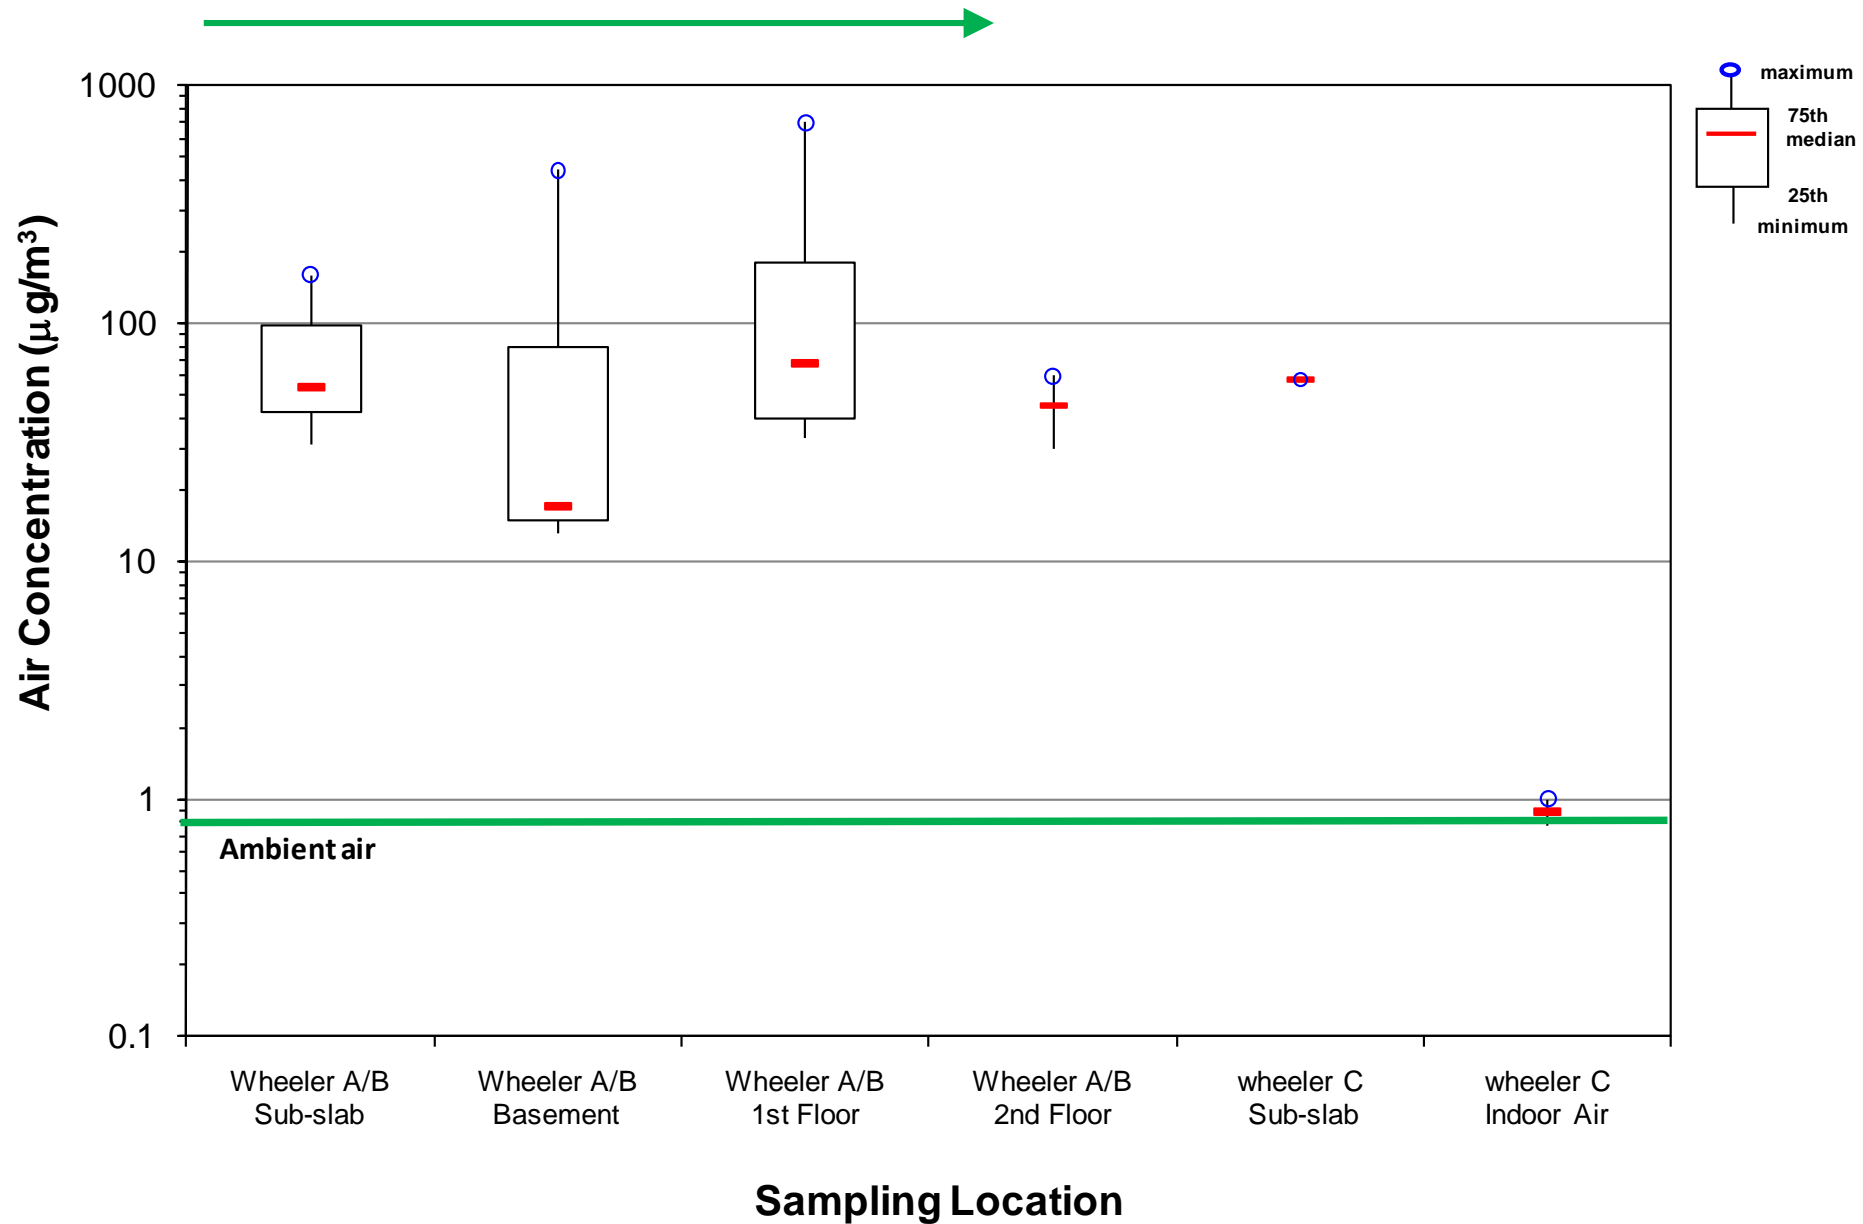
# Acetone Distribution Among Floors – Suggests Indoor Source

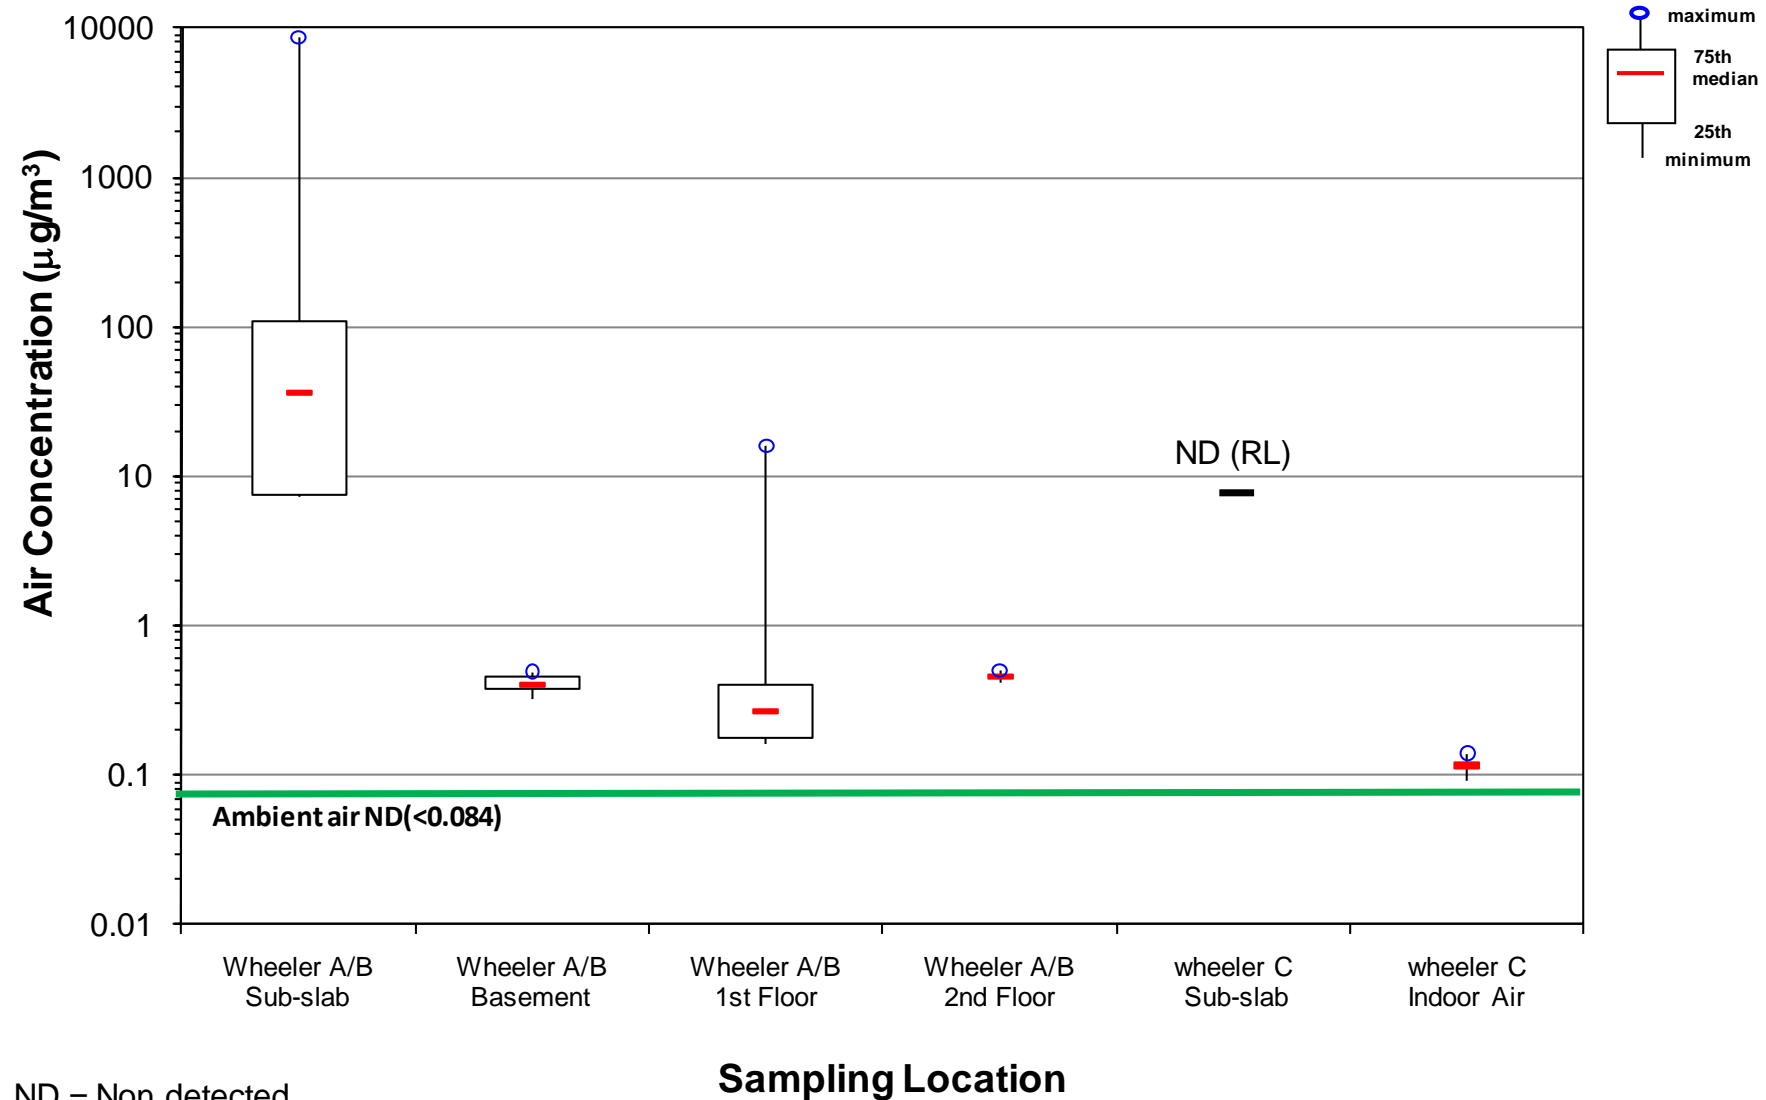
# PCE Distribution Among Floors – Suggests VI Plus Indoor Source

ND = Non detected  
RL = Reporting limit

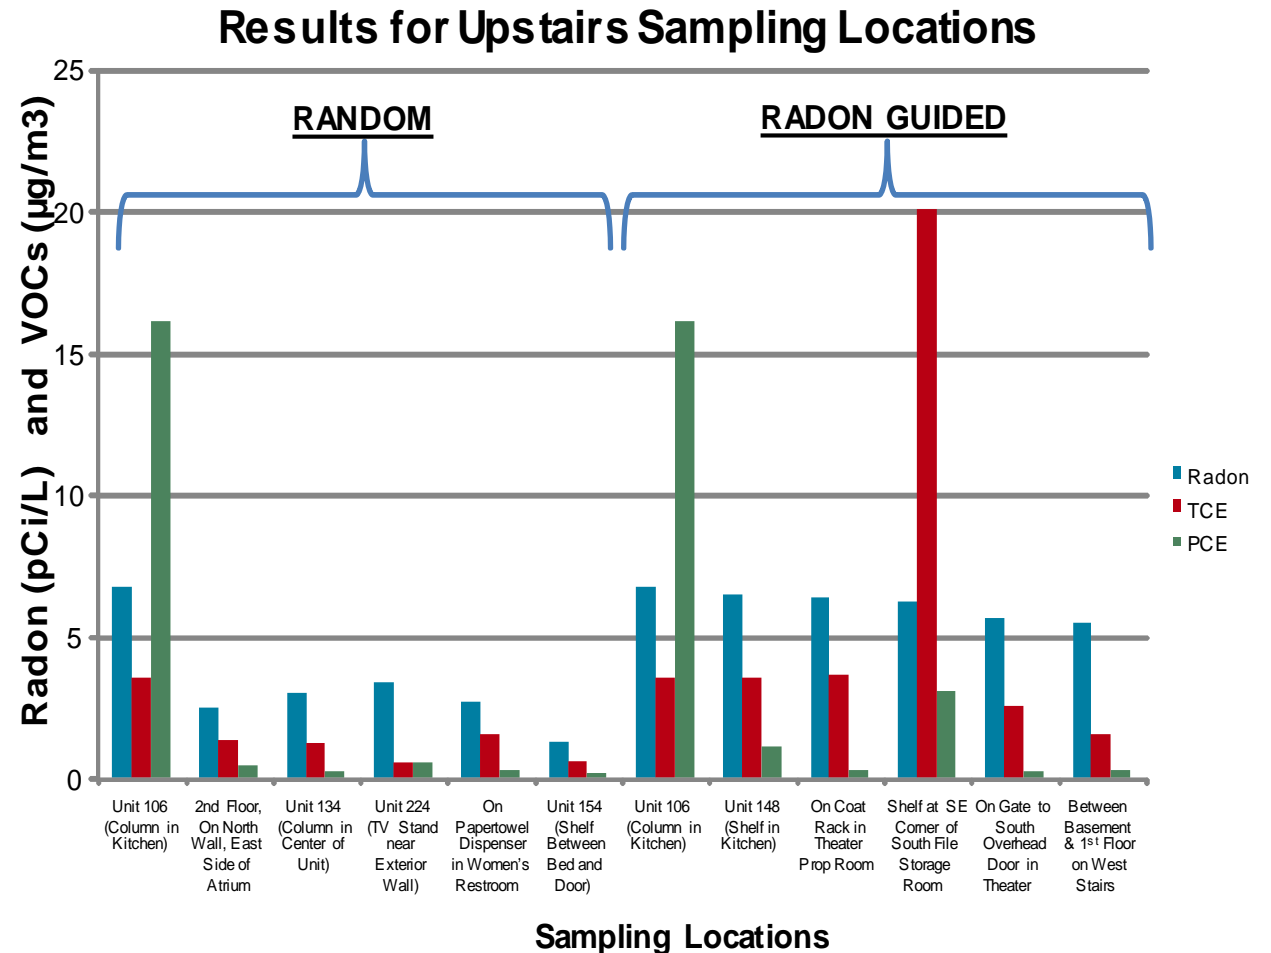
# Example: Randomized Trial of Radon Tracer for Spatial Sampling Application

- Fifty locations within the Wheeler complex were screened for radon
- Then two subsets of these sample locations were selected for passive VOC sampling, one randomly and the other based on the radon.
- The upstairs radon guided samples were significantly higher in trichloroethene (TCE) than the randomly selected locations
- t-test shows that the two mean concentration values for the guided and randomly collected data are statistically different for the data collected at the 95 percent confidence level.

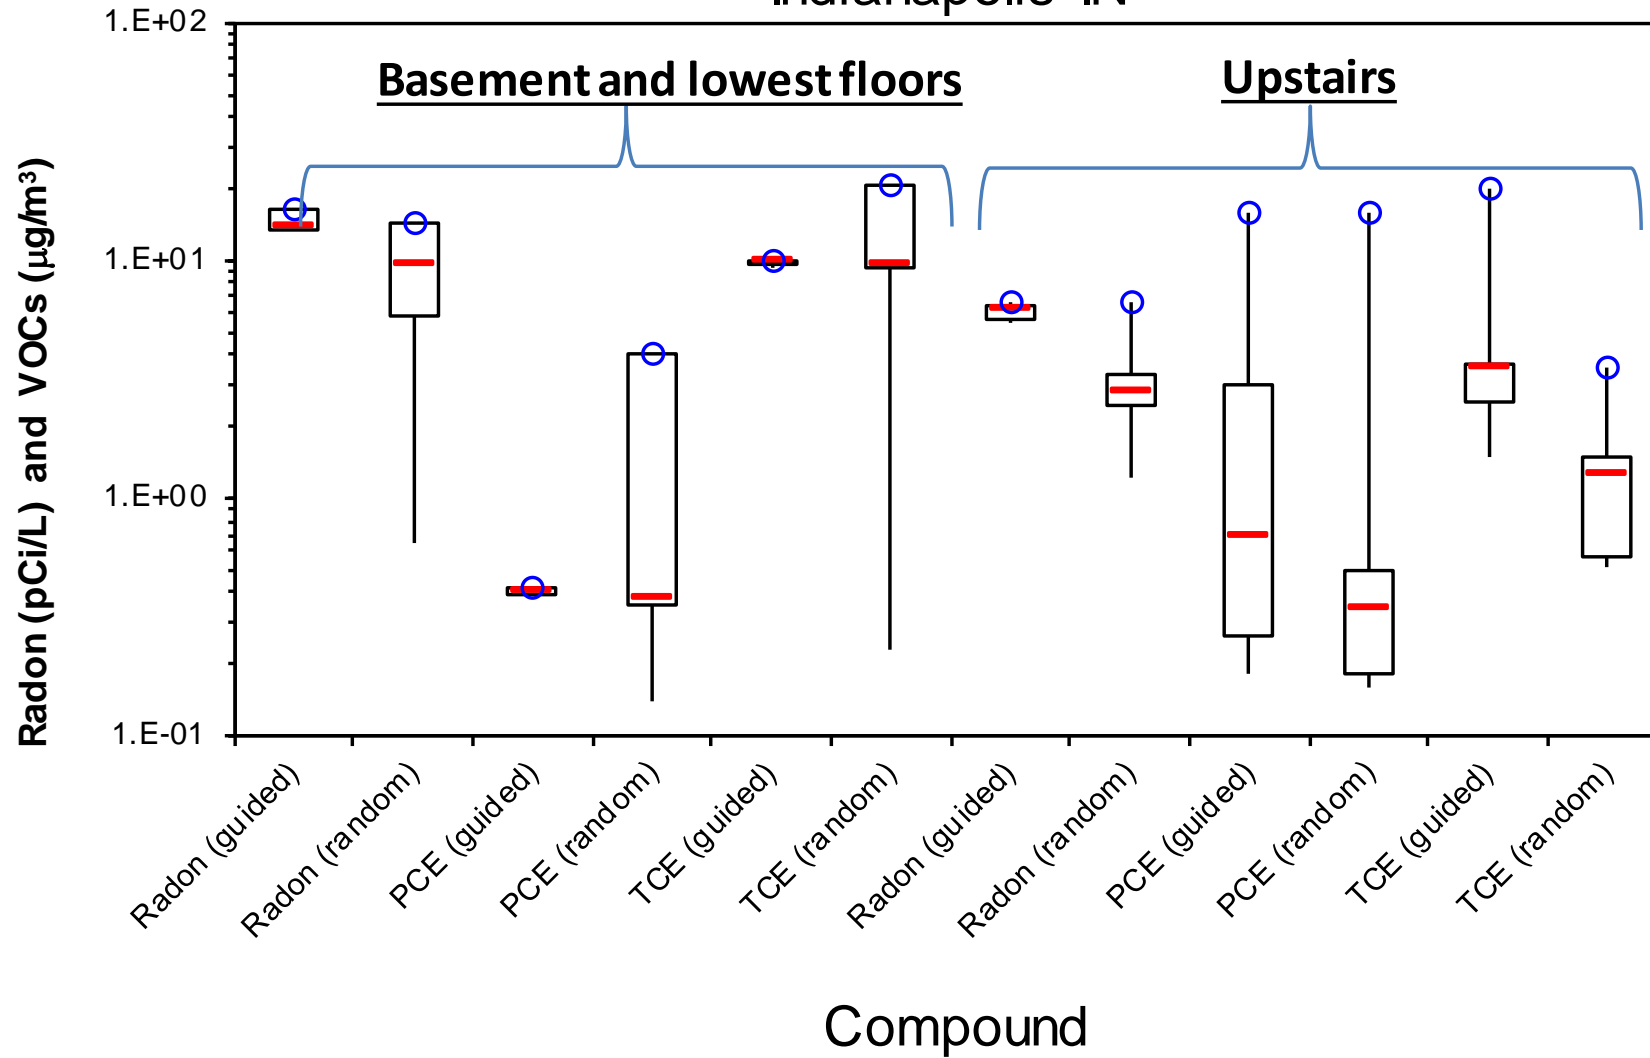
# Statistics for Guided and Random VOC Sampling Results Indianapolis IN

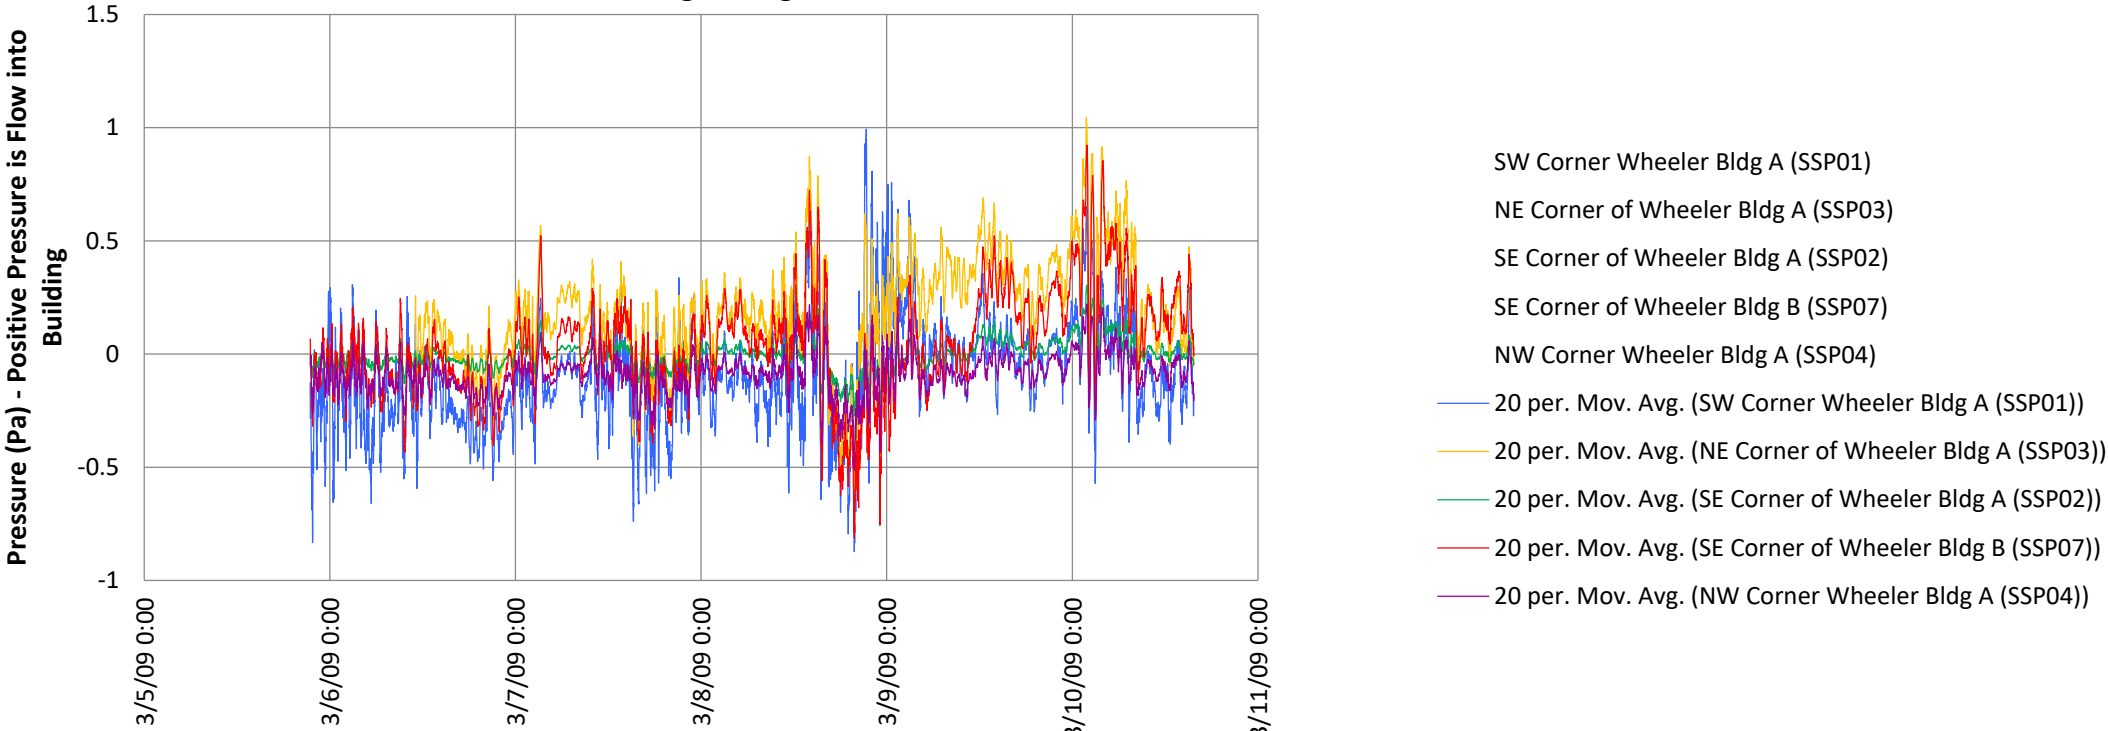
Falling barometer produces flow into the building at some but not all locations.

Moving Averages for Sub-slab Pressure Differentials for 3/5 - 3/10

- SW Corner Wheeler Bldg A (SSP01)
- NE Corner of Wheeler Bldg A (SSP03)
- SE Corner of Wheeler Bldg A (SSP02)
- SE Corner of Wheeler Bldg B (SSP07)
- NW Corner Wheeler Bldg A (SSP04)
- 20 per. Mov. Avg. (SW Corner Wheeler Bldg A (SSP01))
- 20 per. Mov. Avg. (NE Corner of Wheeler Bldg A (SSP03))
- 20 per. Mov. Avg. (SE Corner of Wheeler Bldg A (SSP02))
- 20 per. Mov. Avg. (SE Corner of Wheeler Bldg B (SSP07))
- 20 per. Mov. Avg. (NW Corner Wheeler Bldg A (SSP04))

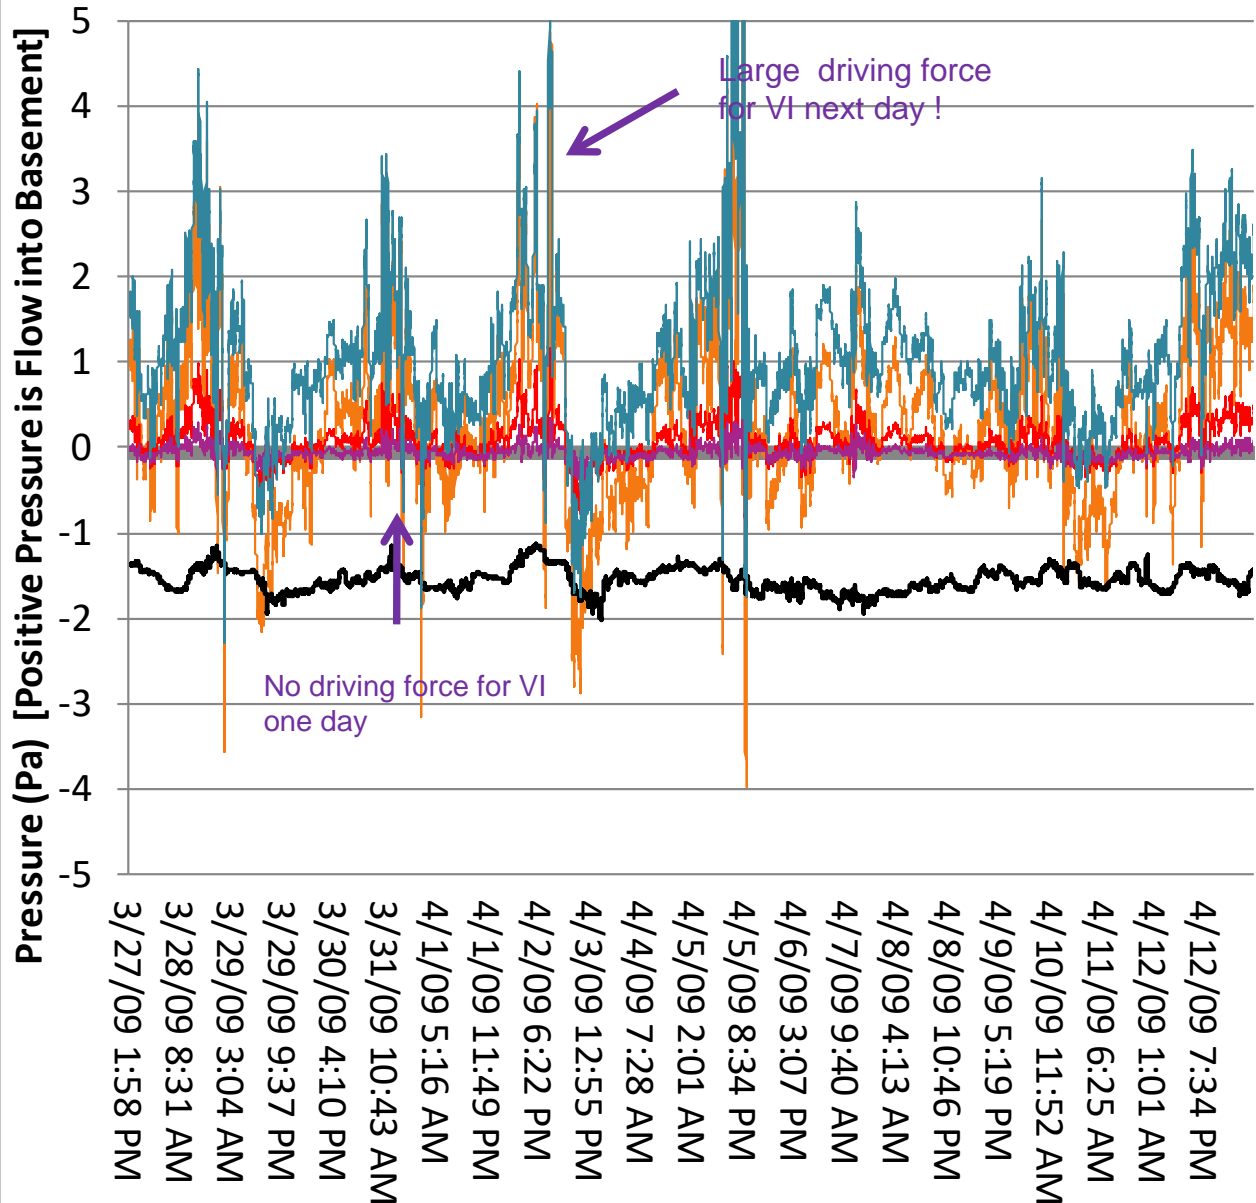
# Moving Average of Pressure Differentials for 3/27/09 - 4/13/09

- South-Center Wheeler Bldg A (SSP05)
- SE Corner Wheeler Bldg B (SSP07)
- NW Corner Wheeler Bldg A (SSP04)
- UPSTAIRS (w/respect to Basement)
- North-Center Wheeler Bldg B (SSP06)
- North-Center Wheeler Bldg A (SSP08)
- 30 per. Mov. Avg. (South-Center Wheeler Bldg A (SSP05))
- 30 per. Mov. Avg. (SE Corner Wheeler Bldg B (SSP07))
- 30 per. Mov. Avg. (NW Corner Wheeler Bldg A (SSP04))
- 30 per. Mov. Avg. (UPSTAIRS (w/respect to Basement))
- 30 per. Mov. Avg. (North-Center Wheeler Bldg B (SSP06))

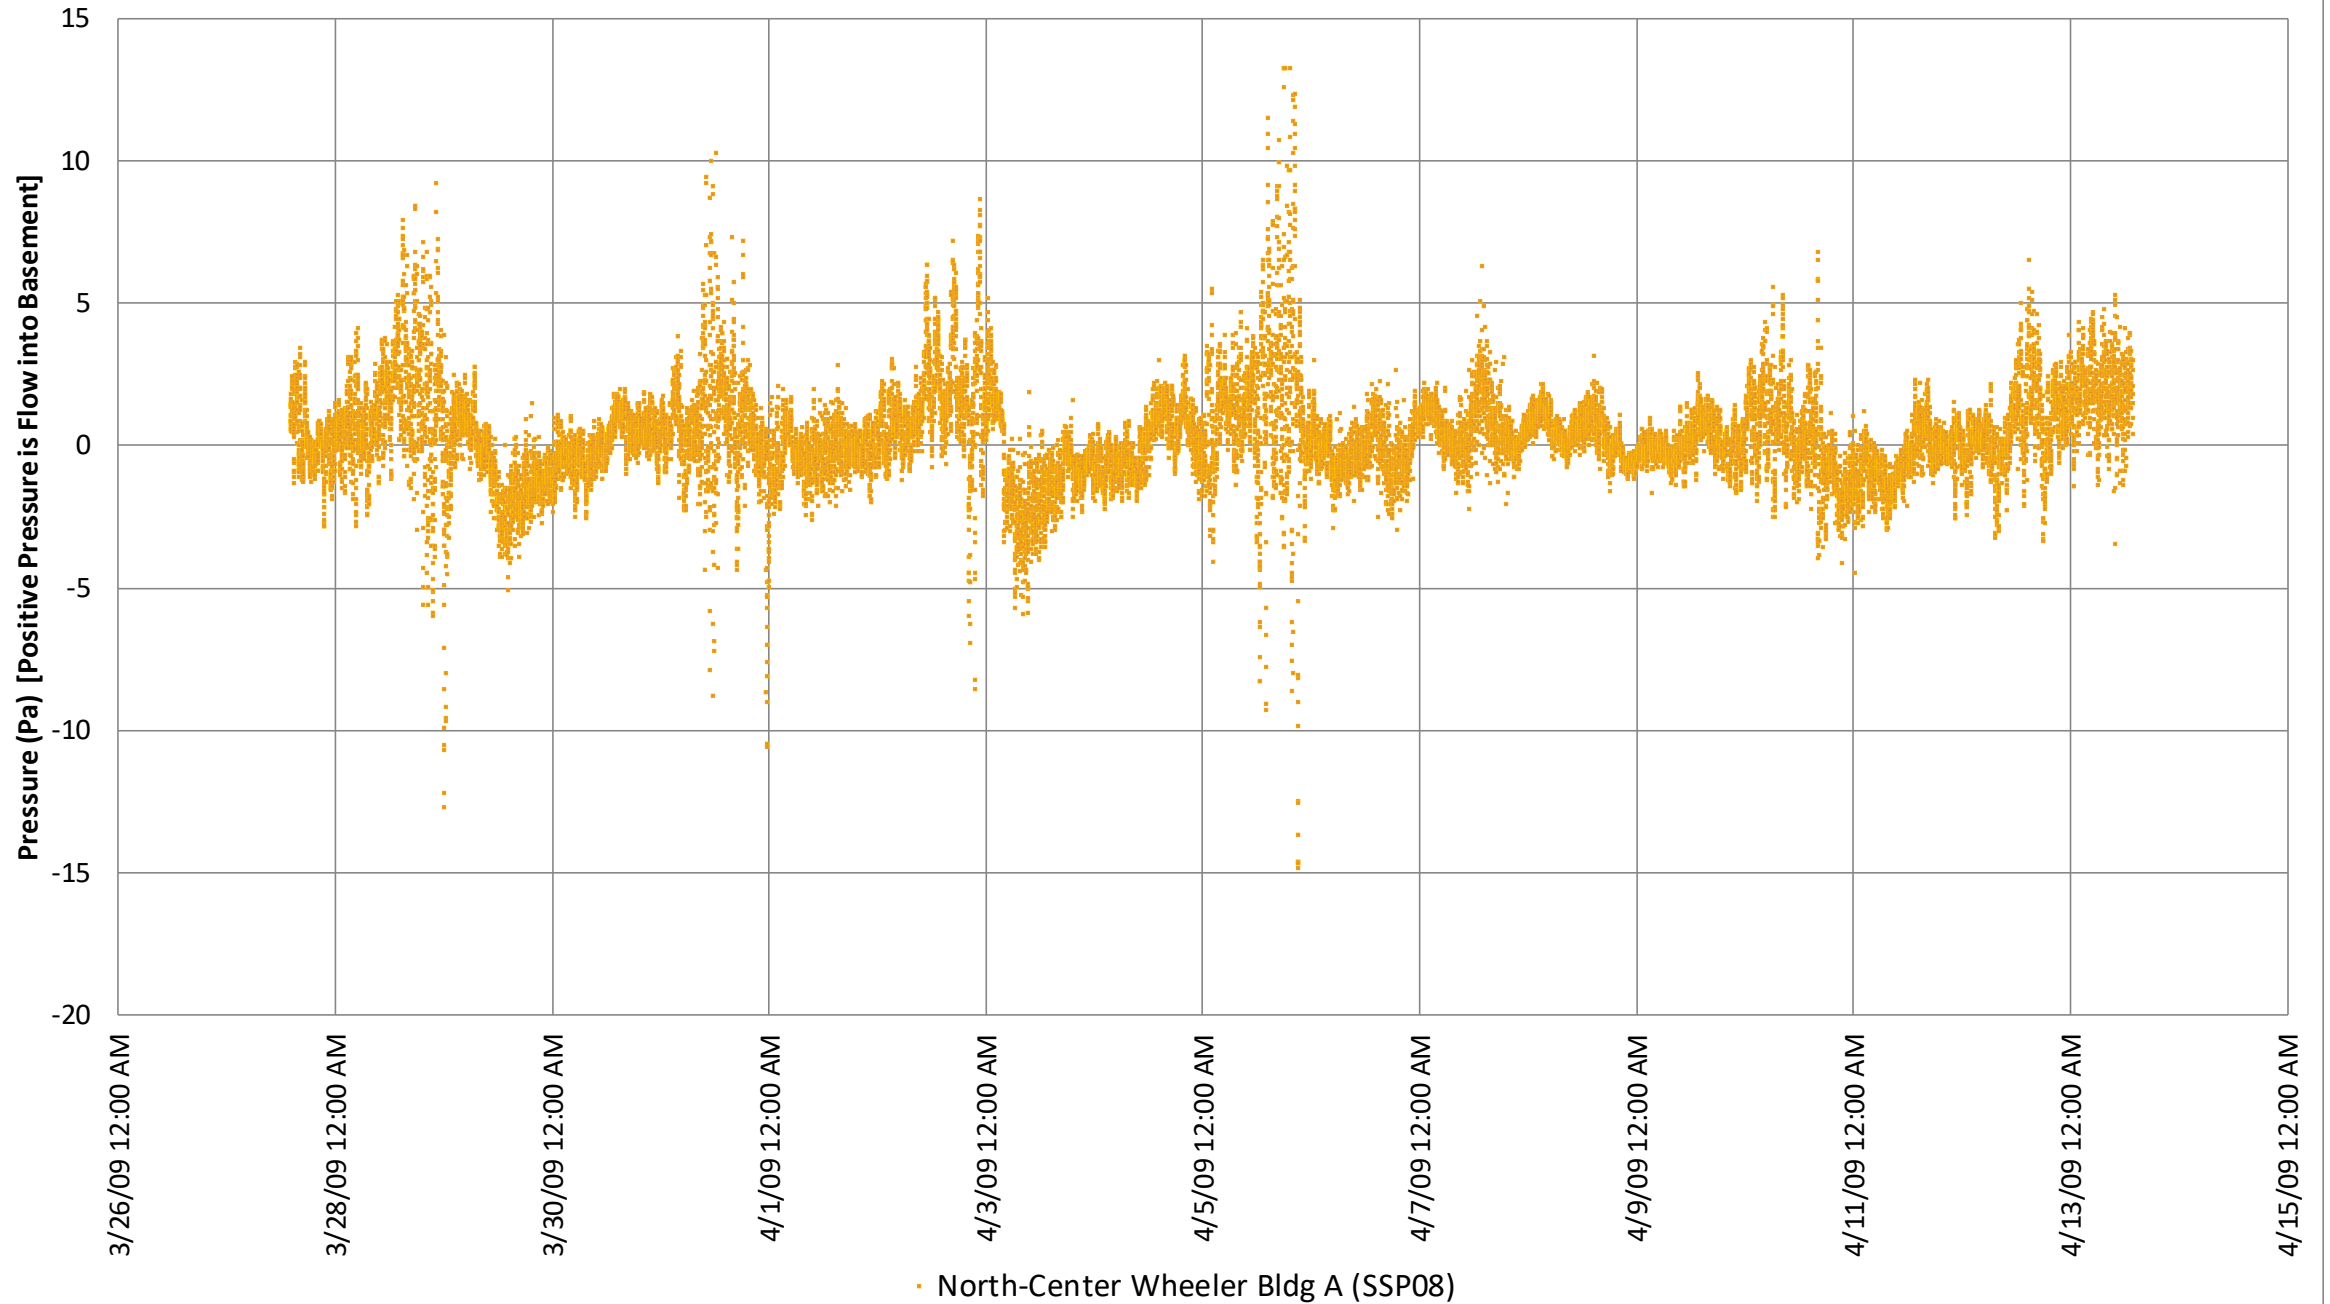
Subslab-  
interior  
Differential  
Pressures  
(Black is  
basement  
to upstairs)

# Pressure Differentials for March 27 - April 13
