**EPA Vapor Intrusion Workshop**  
***Measurement-Based Methods for Protective &  
Defensible Chlorinated VI Exposure Determinations***

Wheeler and SEND Buildings In Indianapolis – Radon and Differential  
Pressure Data in VOC Site Management  
IECC Climate Zone 5A

Chris Lutes, Jacobs

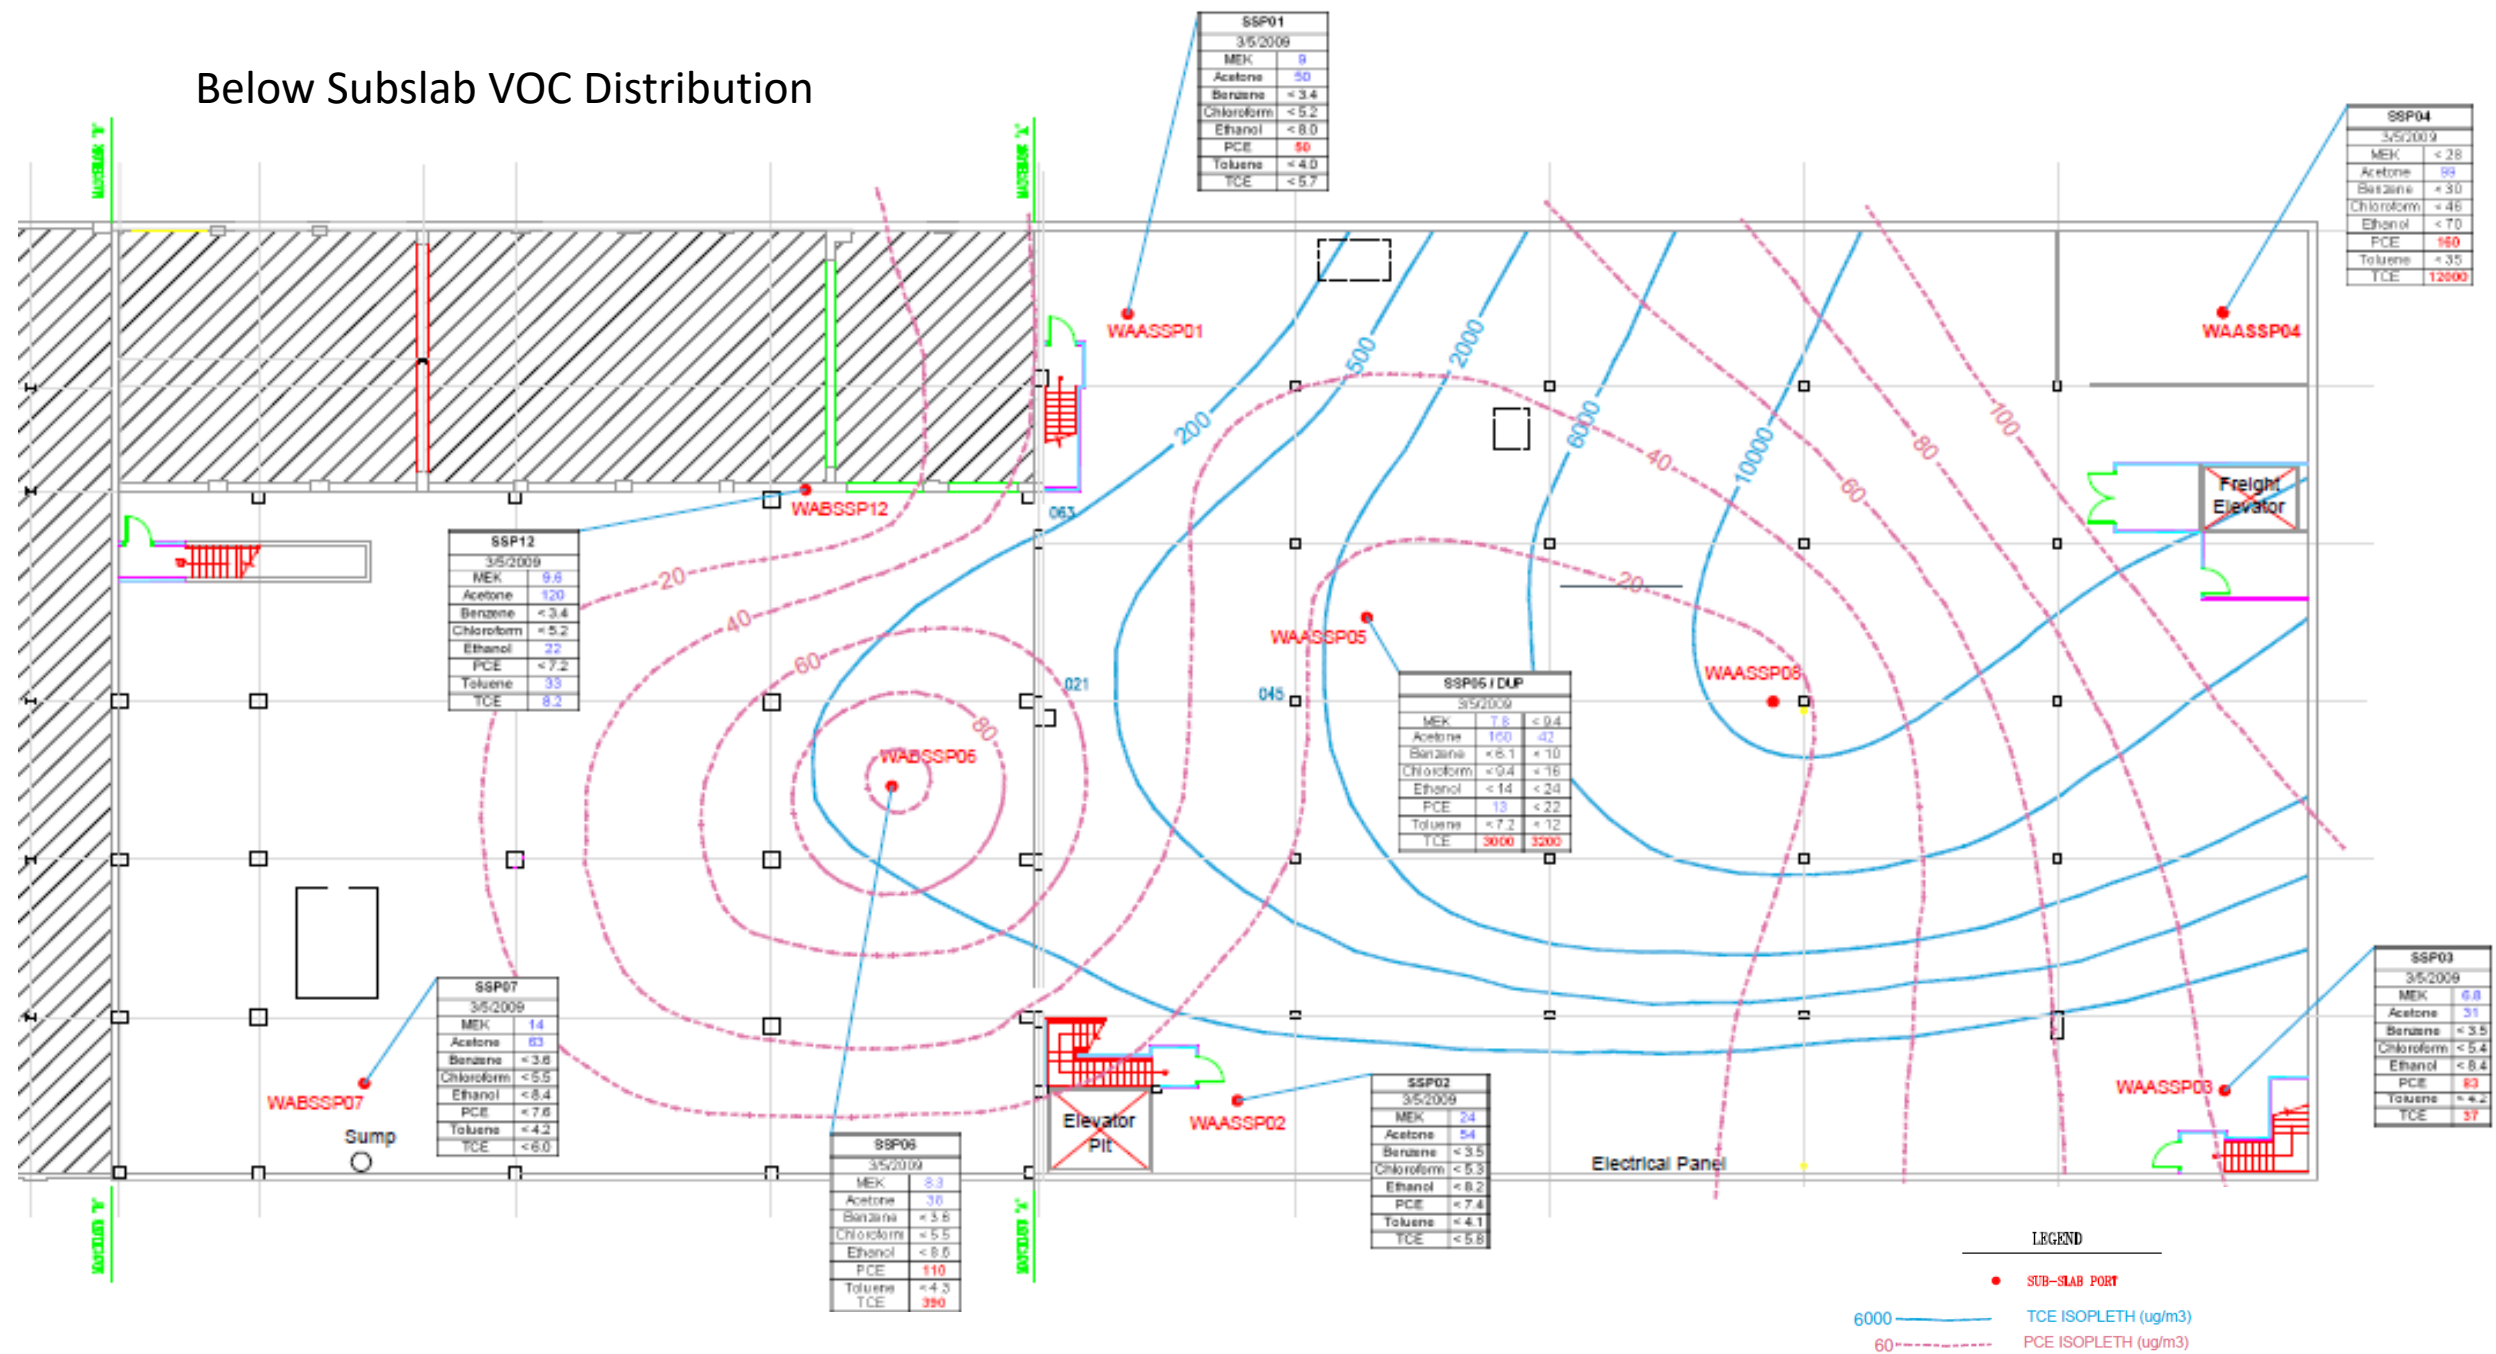
# Below Subslab VOC Distribution

- SUB-SLAB PORT
- 6000 ——— TCE ISOPLETH (ug/m3)
- 60 - - - - - PCE ISOPLETH (ug/m3)
