In-Depth Discussion of a Case Study of Long-Term Vapor Intrusion Site Management

Gaffney PCE Investigation Context

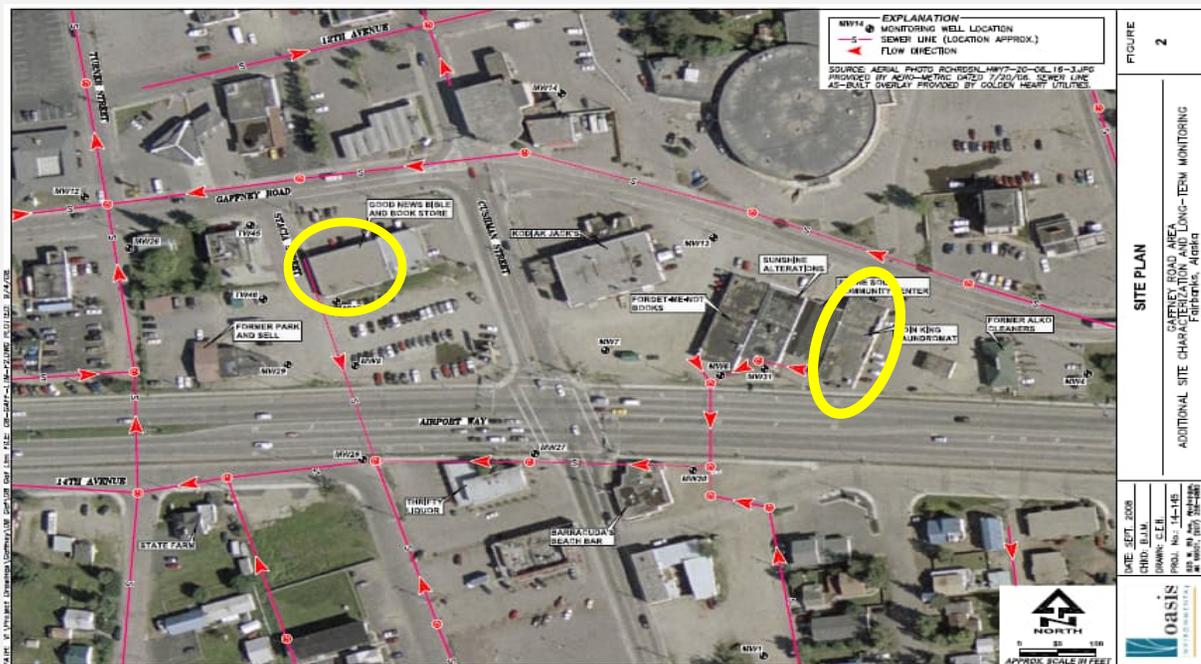
Gaffney PCE History: 1993-97

First indication: groundwater detection during a gas station investigation in 1993.

Former Dry Cleaners identified as sources

- Eastern Sources

- Coin King ~1959-2015
- ADKO Cleaners ~ 1952-2002

- Western Sources

- Royal Masters Laundrette ~ 1963-1980's
- Sewer line transport

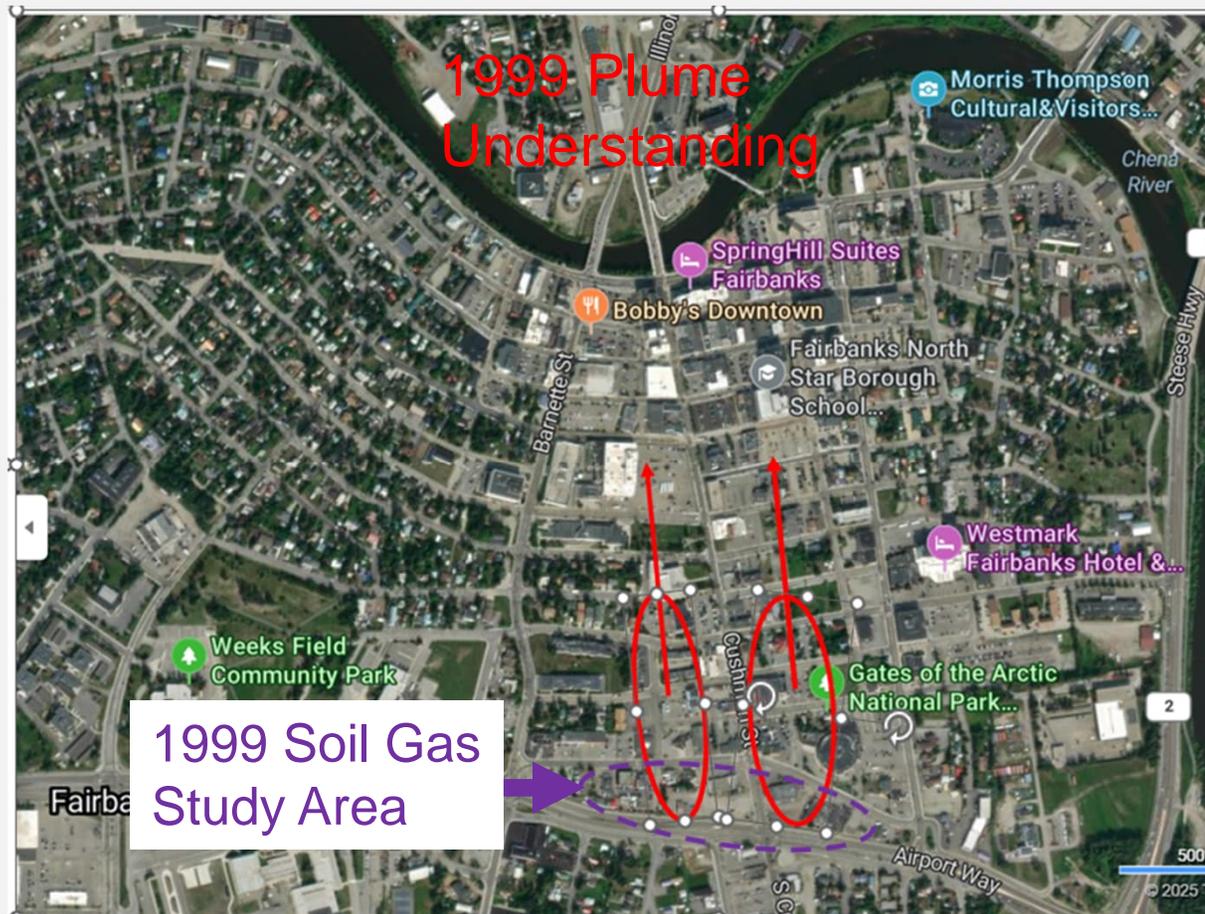
Gaffney PCE History: 1997-99

- 1997: Fifty passive soil gas, 15 temporary wells and three permanent wells
- 1998: Installed 19 temporary wells converted 12 to permanent wells
- 1999: sediment and water from 11 manholes establishes importance of wood stave sewers; 44 soil gas samples, 22 temporary wells, 8 made permanent

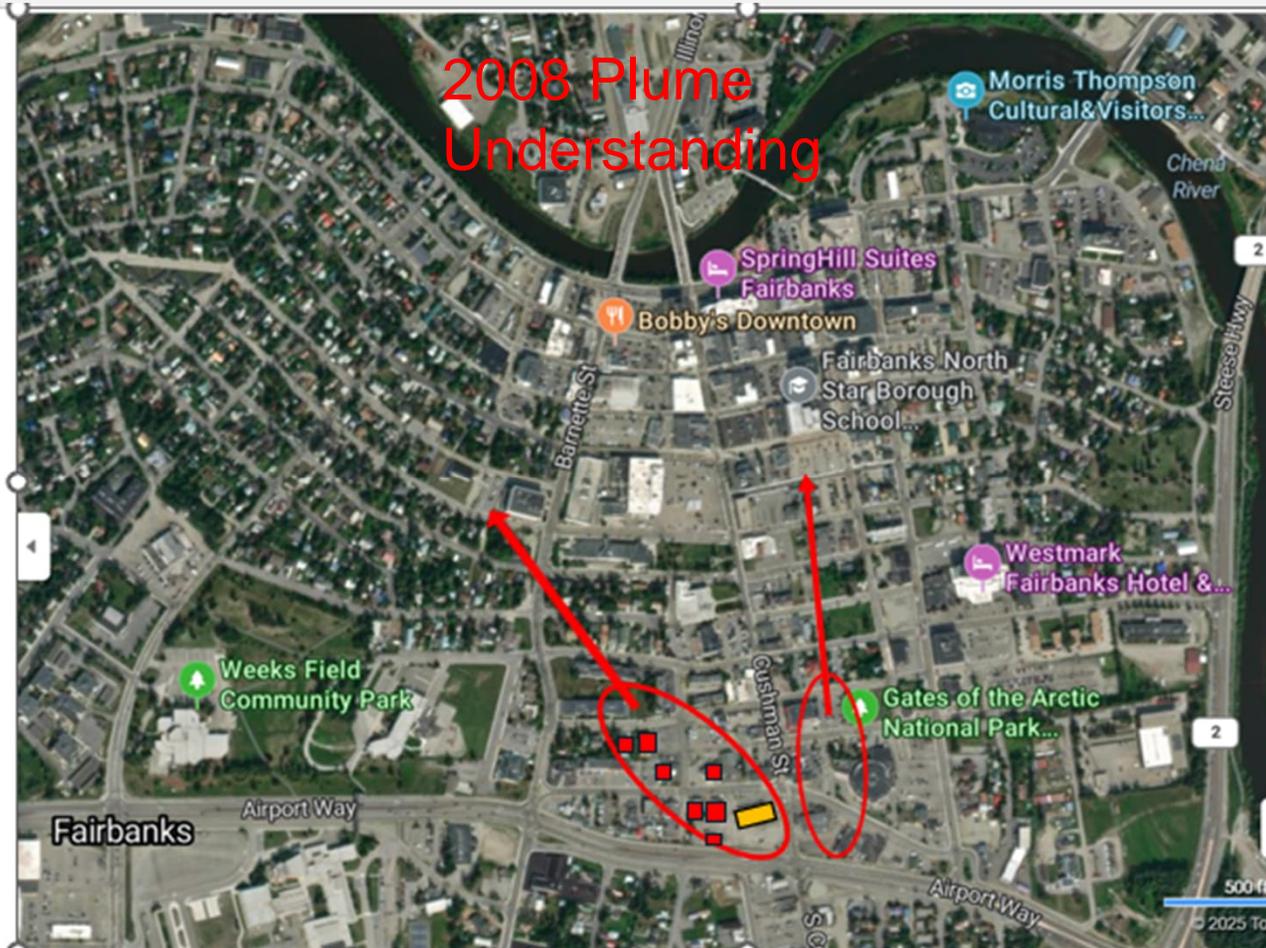
Gaffney PCE History: 2000-07

- Routine groundwater monitoring with Trend analysis and MNA assessment
- Initial vapor intrusion investigation: At least 8 buildings indoor air investigated between 2000-2007 (red squares)
- Source area investigation behind East source building (orange) in 2004 caused breach in sewer line.
 - Led to removal of 9 yd³ of PCE-impacted soil

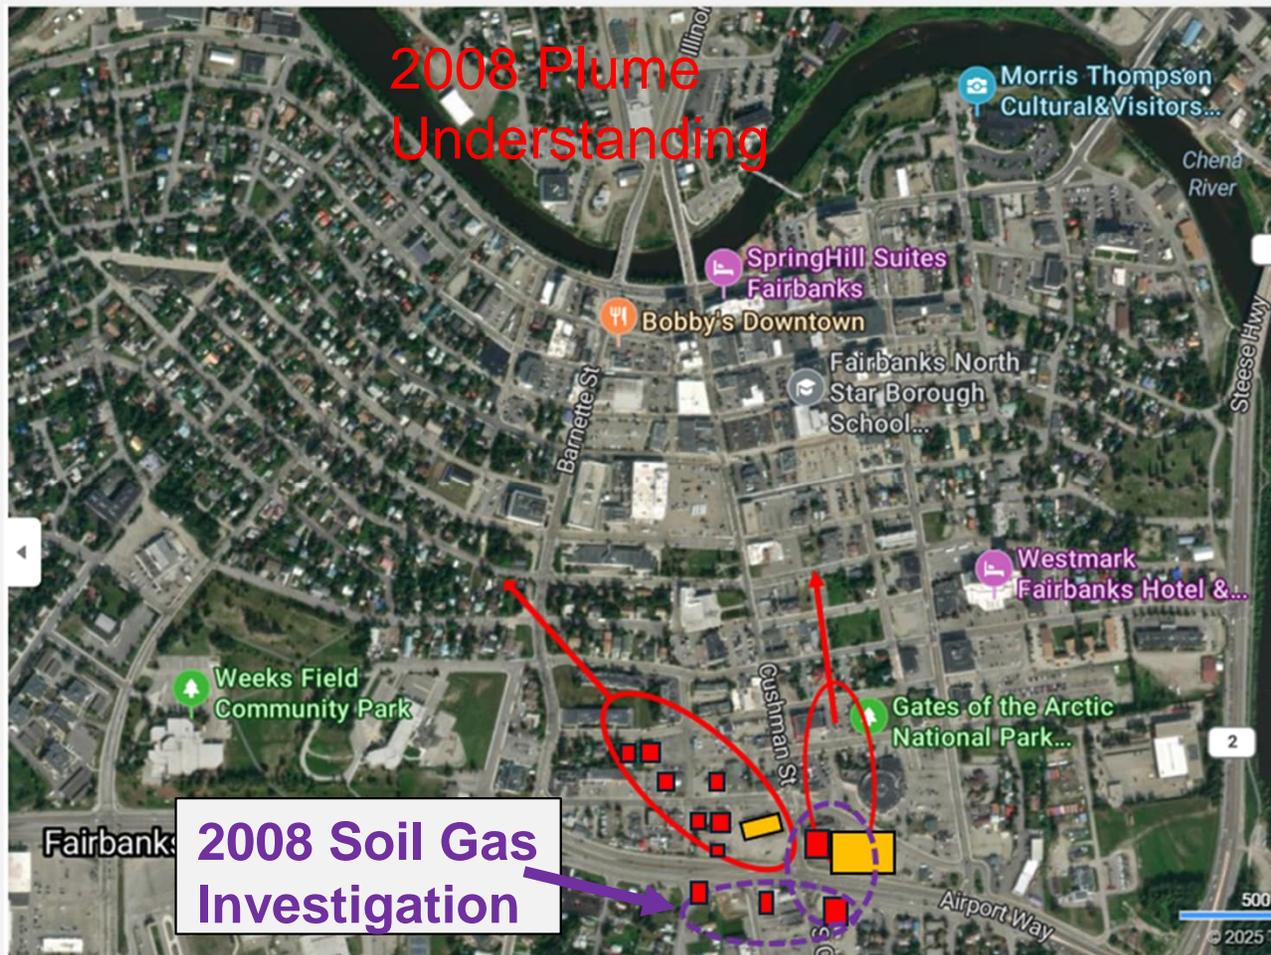
Gaffney PCE History 2008-09

- Source characterization of west side in 2007
 - 70 test borings for soil and groundwater delineation
- 2008-2009 VI investigations at four additional buildings (red squares) plus VI investigation at fourplex near eastern source (3 of 4) (orange)
- Source characterization of east side in 2008 and 2009
 - 46 test borings for soil and groundwater delineation including 10 in Airport Way

PCE in 5 ft soil gas 1,900 to 17,000 $\mu\text{g}/\text{m}^3$ Along Airport Way; TCE up to 310 $\mu\text{g}/\text{m}^3$

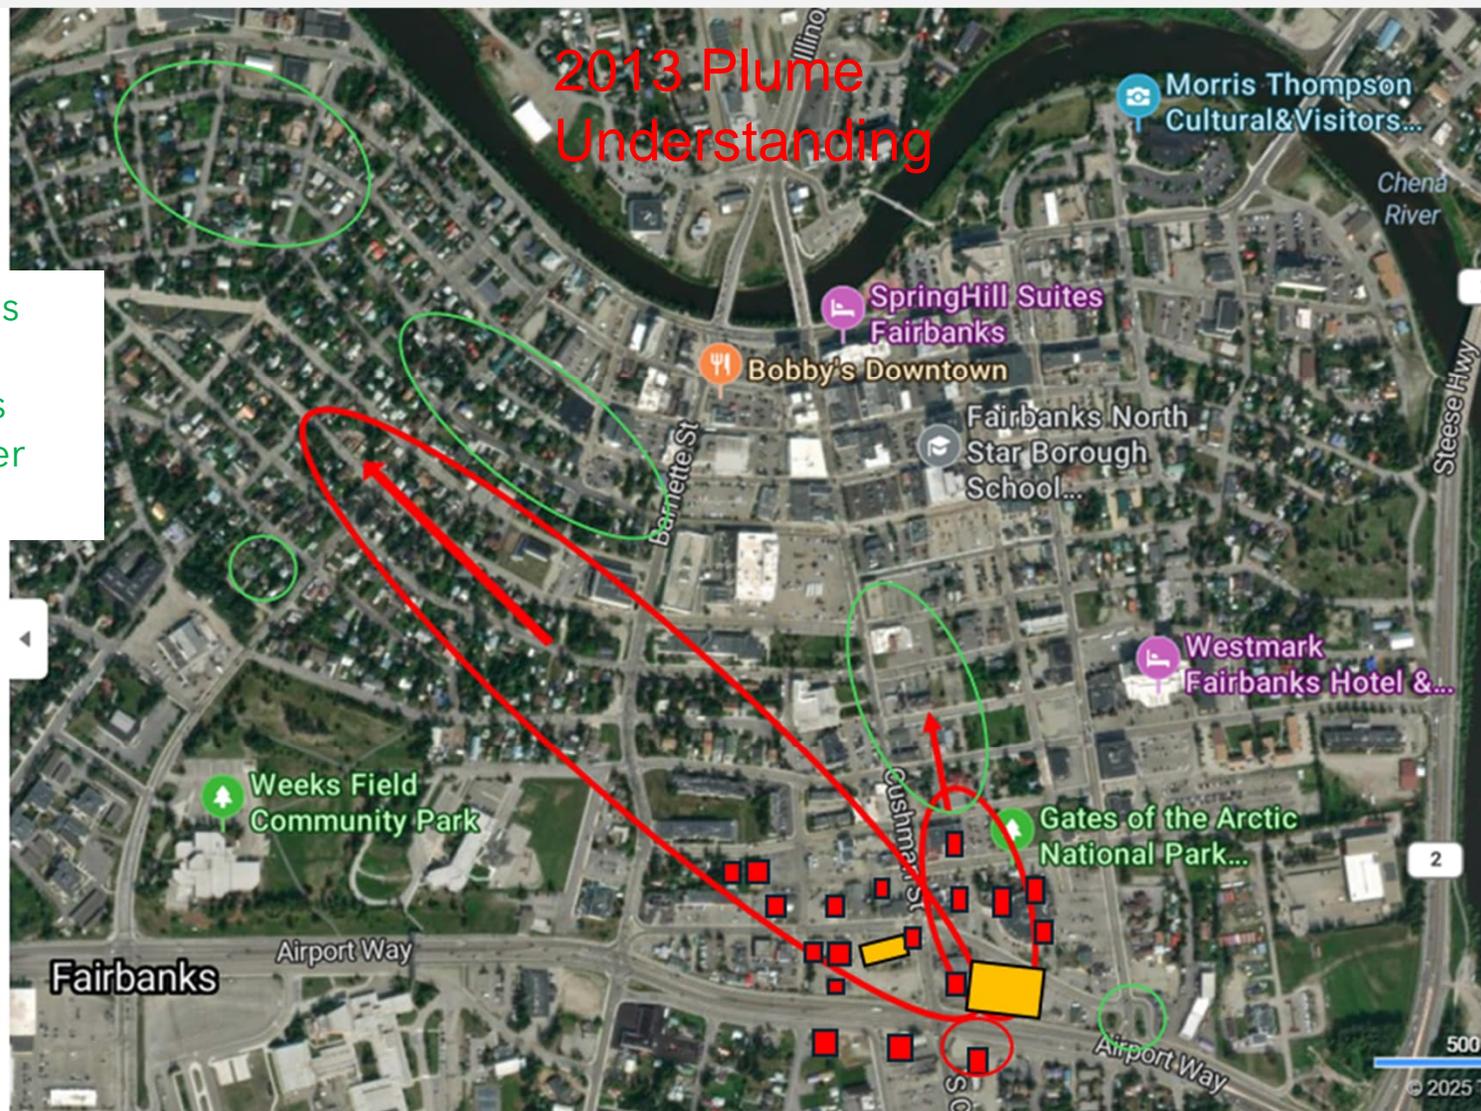
Gaffney PCE History 2010-2015

- Gaffney Road East/West division officially made in 2010
- 2010 Remedial SVE/SSD System installed in West Source area (orange), 2018 Modified to SSD-radon fan
- Seven more indoor air sampling buildings (red squares)

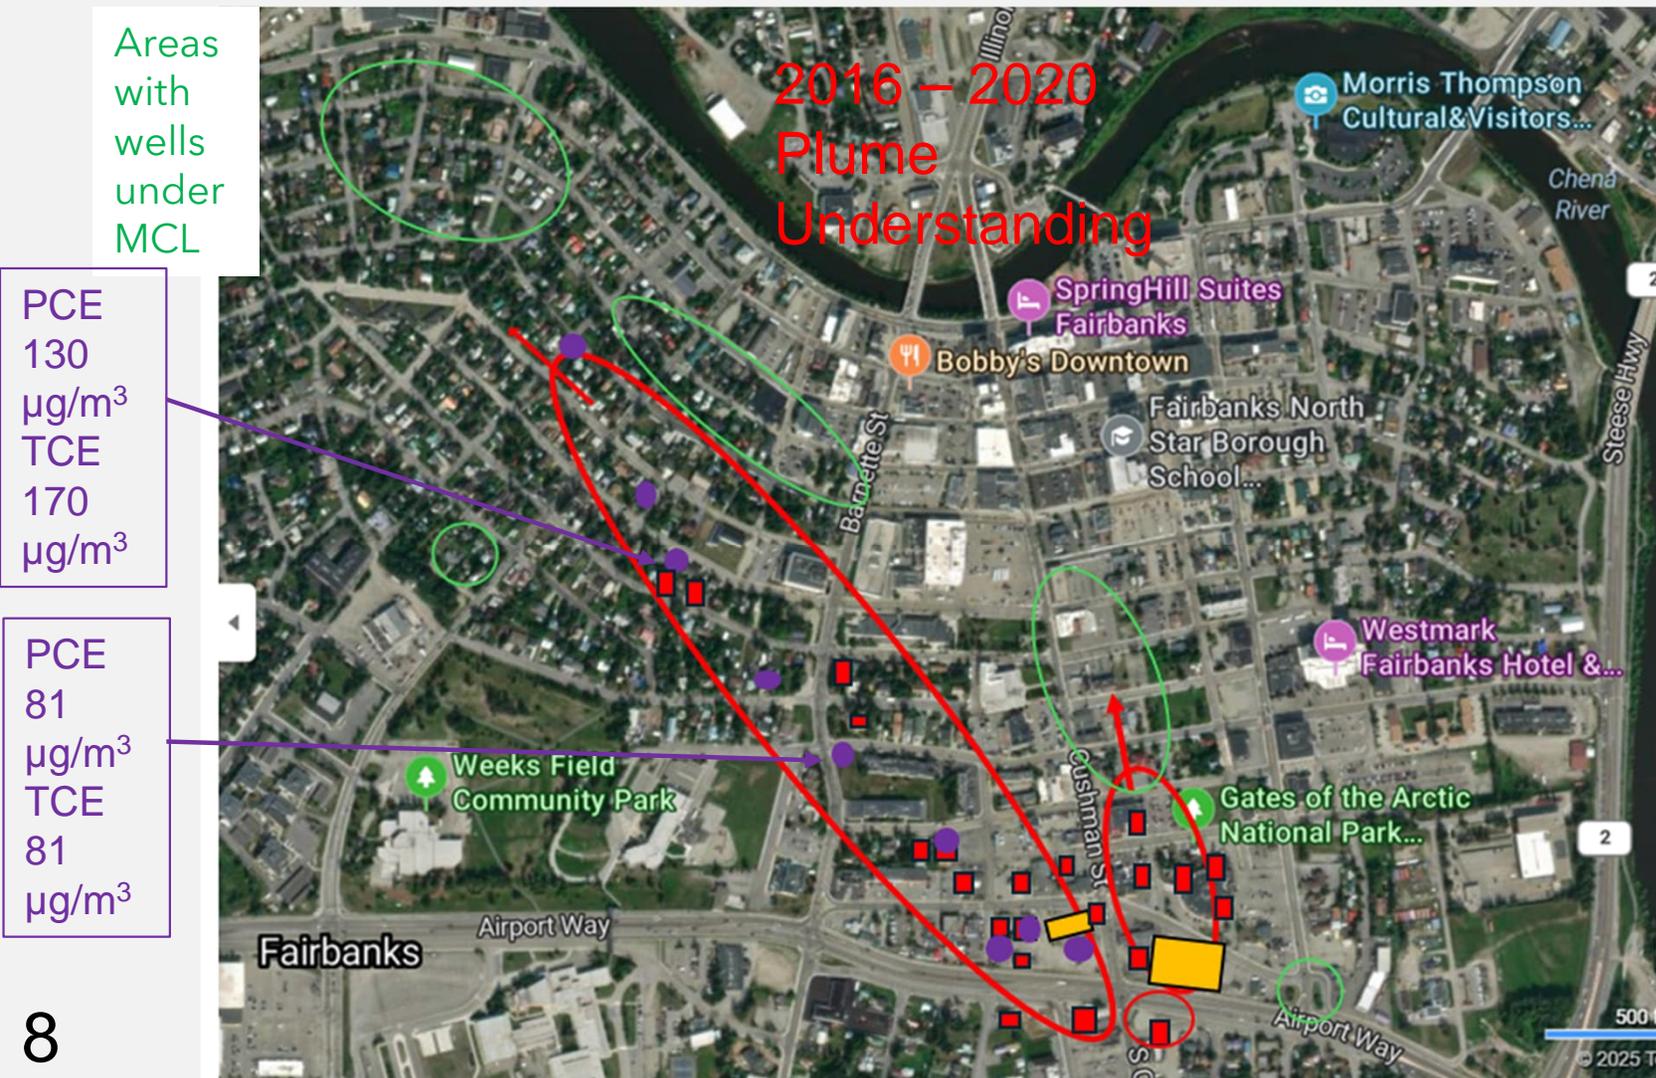
Gaffney PCE History 2015-2020

- Seven new midplume soil gas points installed 2015, Sampled 2015 –17 (purple)
- Groundwater monitoring continuing throughout project history
- Four residences sampled for indoor air in 2017 (red); results low

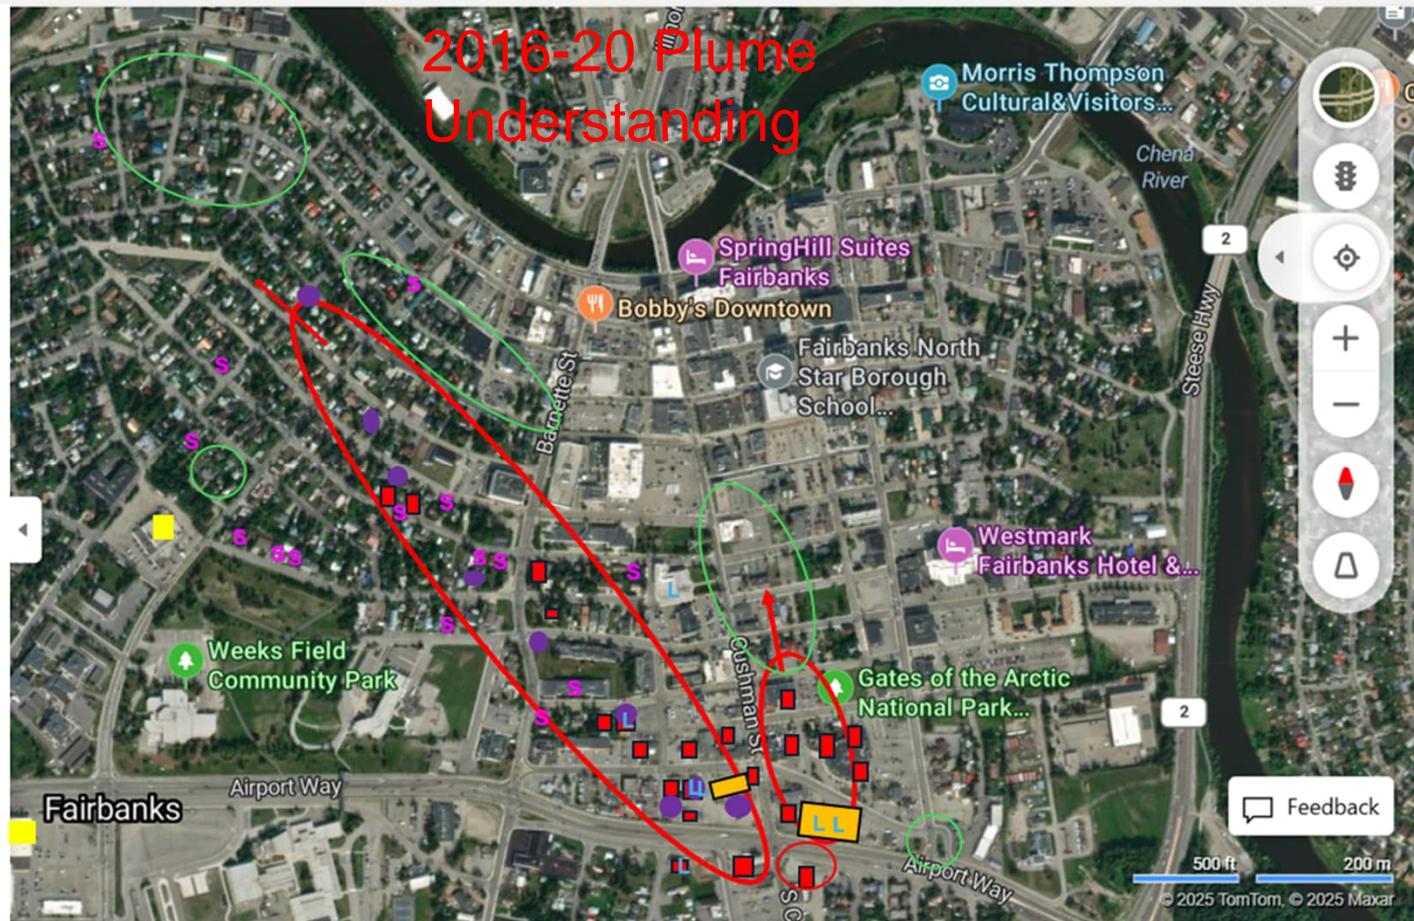
Gaffney PCE History 2020-25

2020 - 2022 EPA Large Building project

- Weekly VOC and continuous (or semi-continuous) radon sampling. Indoor air, outdoor air, soil vapor probes and subslab vapor across 8 structures (7 commercial and one “residential”) “L”
- Two locations with continuous, real-time GC VOC sampling for 6 months

2023-2025 EPA’s Soil Gas Safe project: examining predictions using indicators and tracers (I&T)

- 16 homes passively VOC sampled also supplied with continuous home radon monitors “S”
- VOC Sampling strategy included one standard convenience calendar-based sampling event and up to three I&T-driven sampling events in each of three seasons (7-day Radiello)
- Three one-day convenience passive sampling events and three I&T scheduled passive events

Two other sources of PCE shown

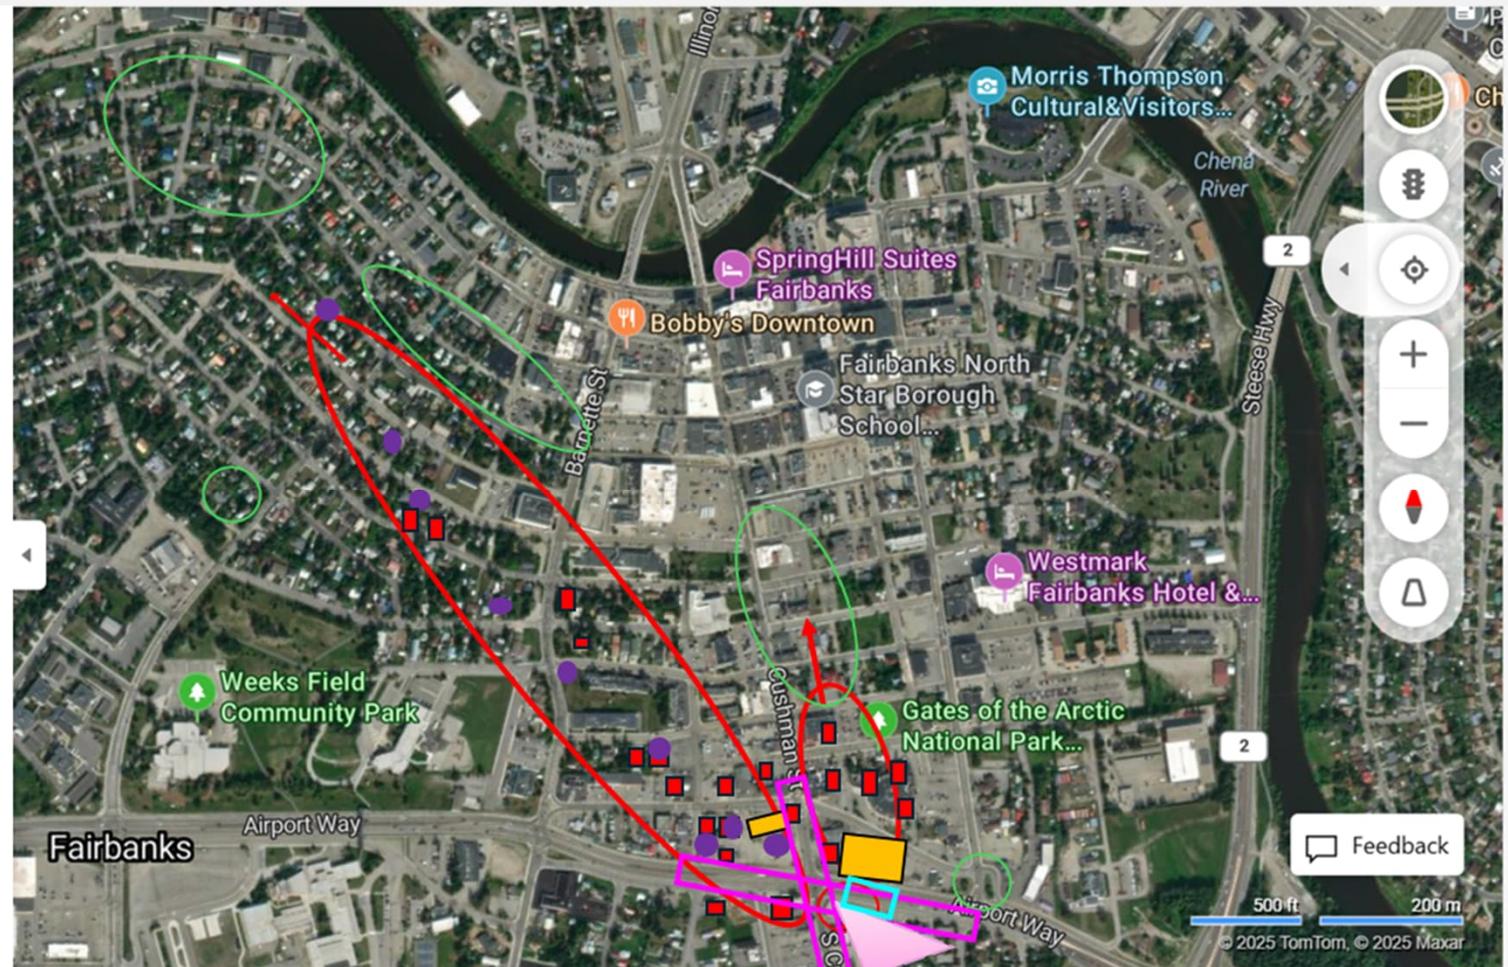
Borings in Road (2009) and DOT Borings 2022-3

- 2009 Borings in Airport Way show PCE concentrations to 10,000 $\mu\text{g}/\text{kg}$ in soil at 5-10 ft vs. cleanup level of 24 $\mu\text{g}/\text{kg}$; widespread concentrations >38 .
- 2022-23 DOT installed 42 borings in preparation for intersection work. Peak concentration 7,110 $\mu\text{g}/\text{kg}$ vs. cleanup level 190 $\mu\text{g}/\text{kg}$, most PCE concentrations 10 - 900 $\mu\text{g}/\text{kg}$. Excavation planned for Summer 2026.

EPA/600/R-14/277 says expect PCE 360 $\mu\text{g}/\text{m}^3$ with bulk soil 0.4 $\mu\text{g}/\text{kg}$ so the bulk soil cleanup levels are not likely to be fully protective for vapor intrusion.

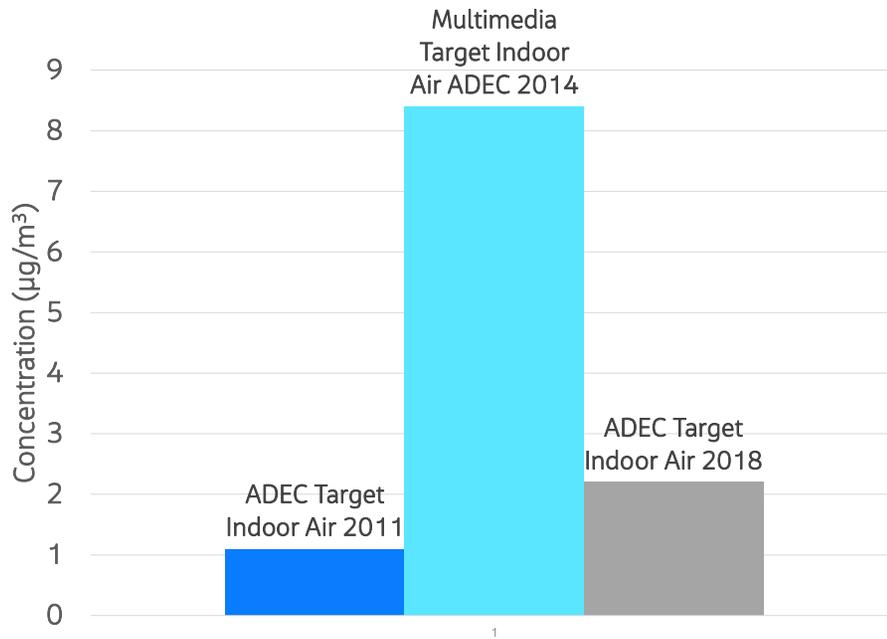
Commercial Target Indoor Air TCE Levels over Time

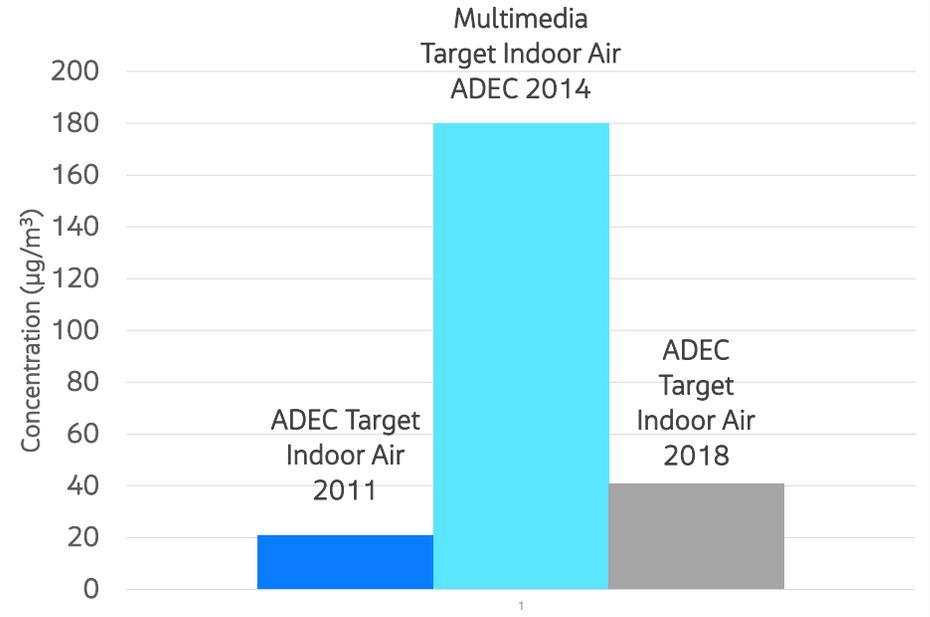
Commercial Target Indoor Air PCE Levels over Time

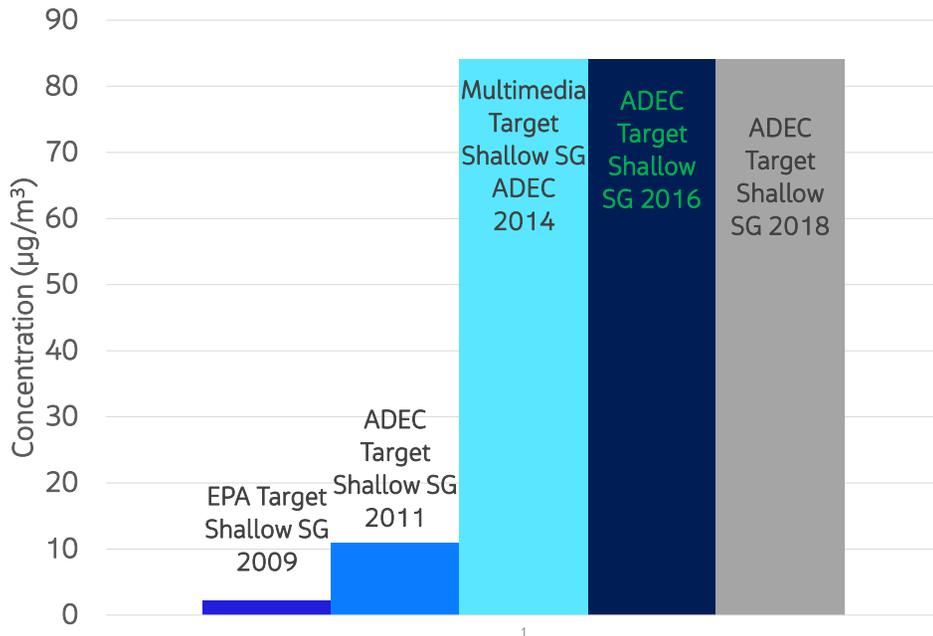
Commercial Target Shallow Soil Gas TCE Levels over Time

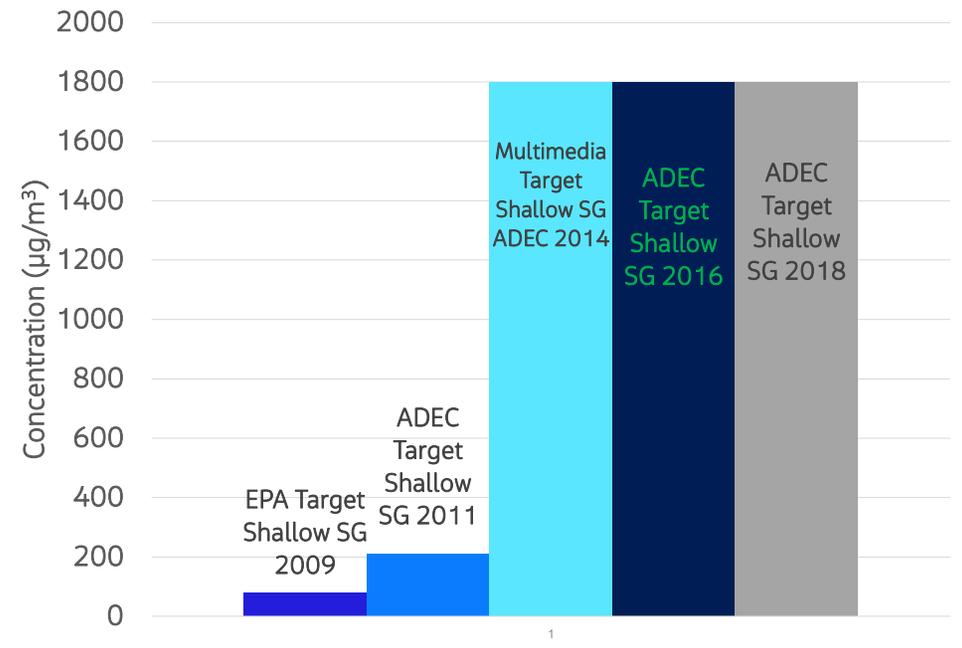
Commercial Target Shallow Soil Gas PCE Levels over Time

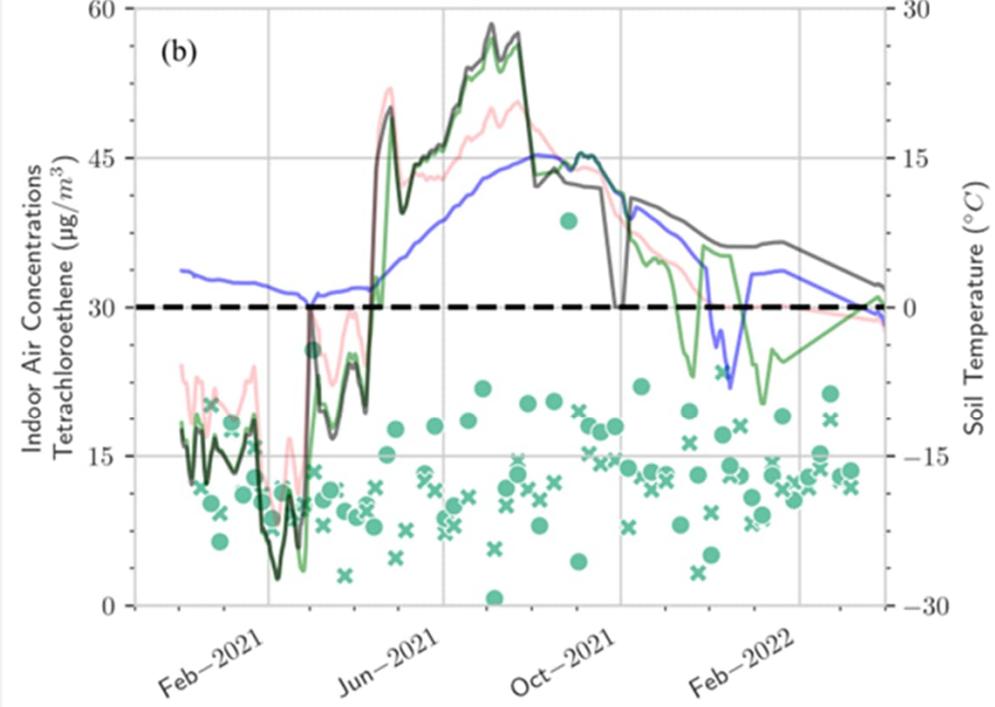
Indoor Air Tetrachloroethene Concentrations at Not for profit and Soil Temperature at Church

- Indoor Air Data Flag**
 - Green markers are detections
 - Orange markers are non-detect reported at MDL
- Indoor Air Locations**
 - Hallway adjacent to kitchen
 - ✕ NW conference room
- Soil Temp. (2 ft bgs) Weekly Moving Average
- Soil Temp. (4.5 ft bgs) Weekly Moving Average
- Soil Temp. (7 ft bgs) Weekly Moving Average
- Soil Temp. (9.5 ft bgs) Weekly Moving Average

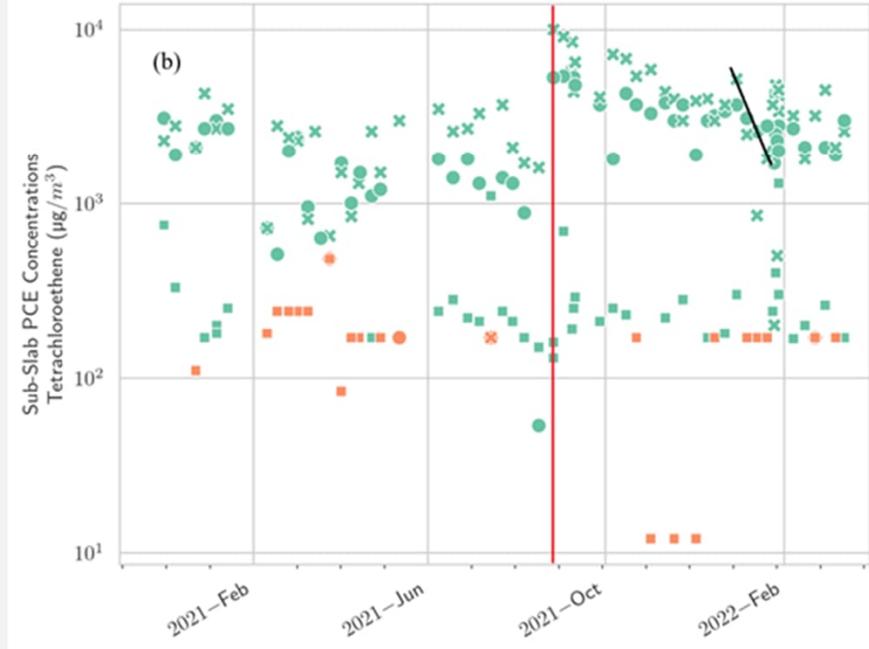
Subslab Concentrations Tetrachloroethene Not for profit

- SubslabDataFlag
 - Green markers are detections
 - Orange markers are non-detect reported at MDL
- SubslabLocations
 - Conference Rm. NW
 - ✕ Mech Rm, SE
 - Dining Rm, E

Red Line Sept Peak
 Black Jan Dip

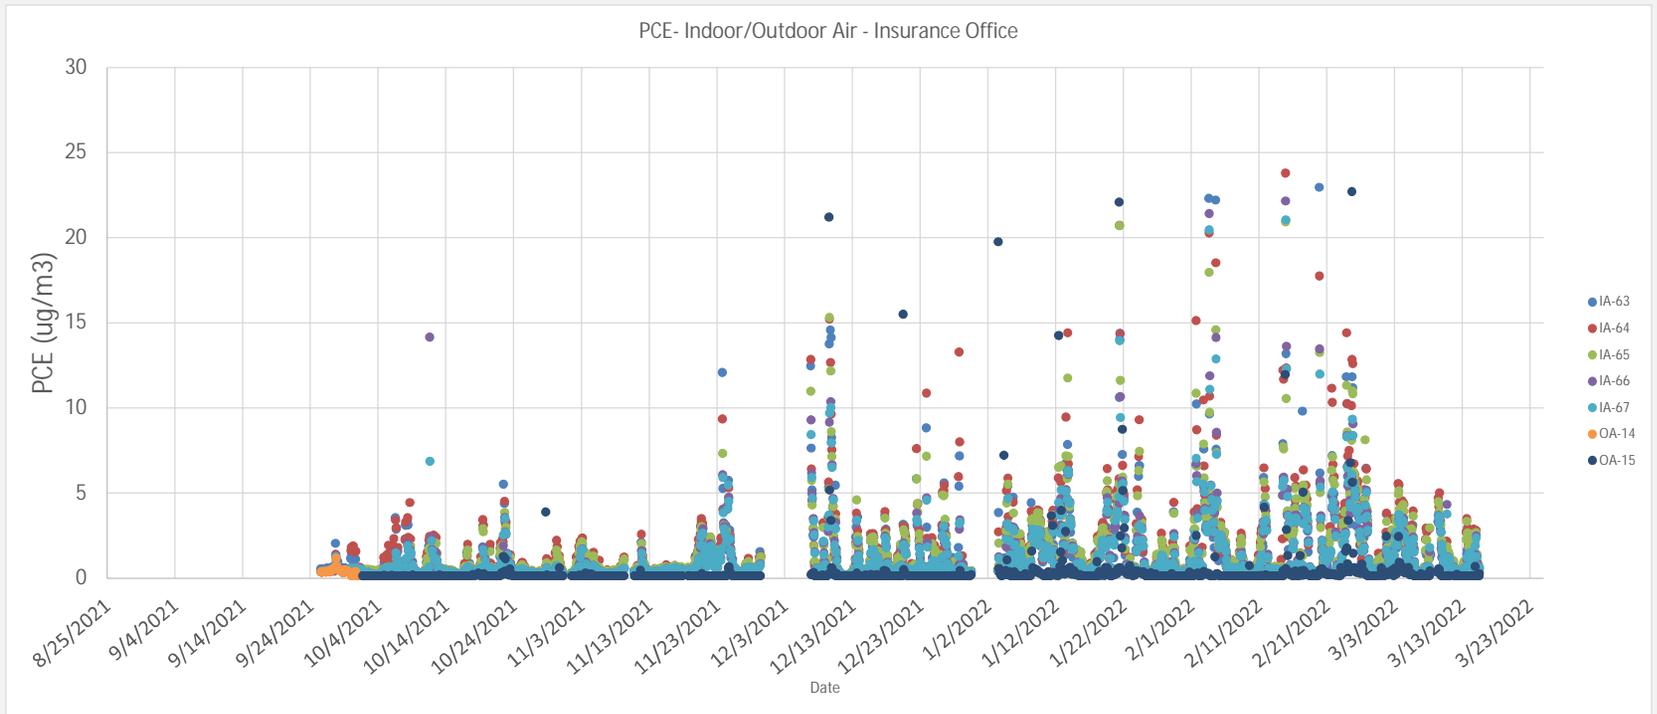
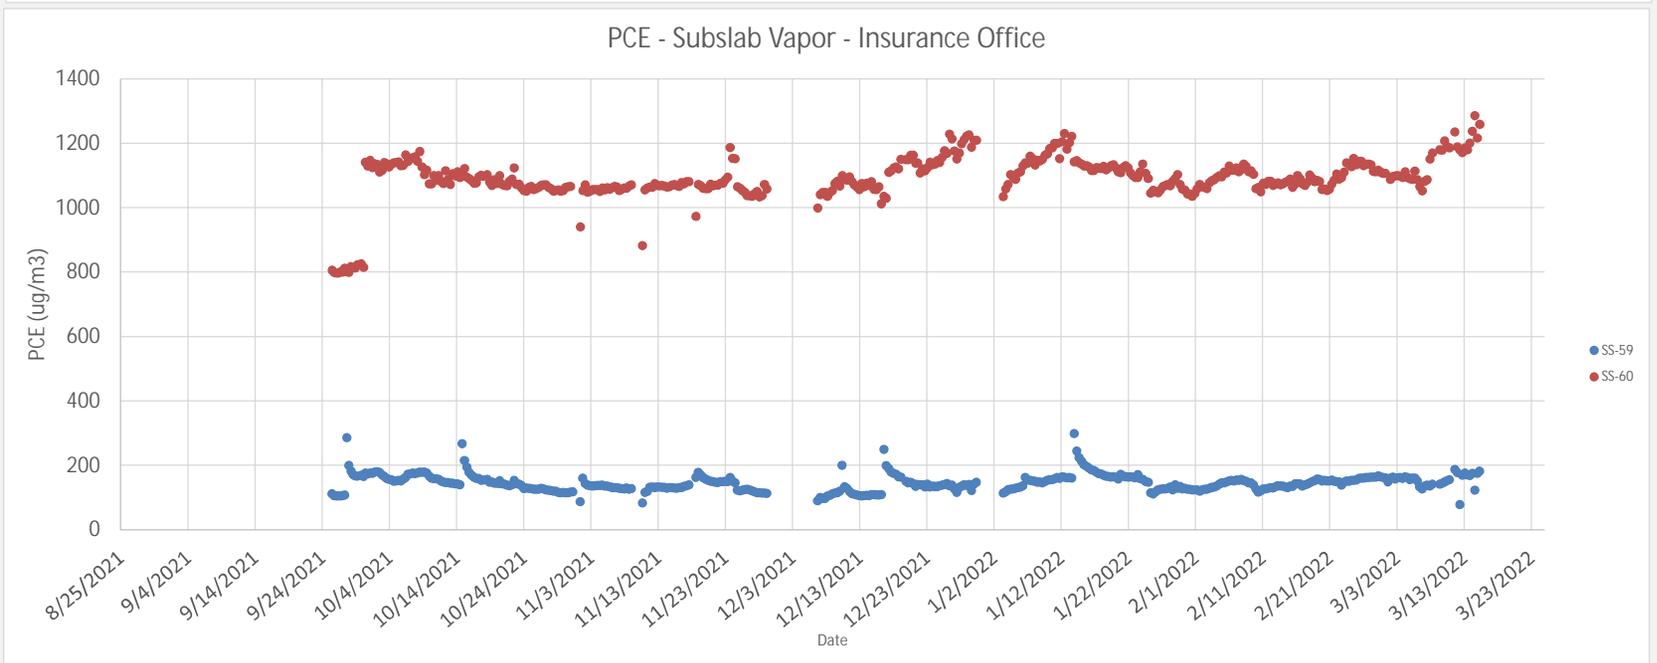
Key Point: subslab PCE is weaker than previous, but indoor higher....
 TCE changes modest; previously 9 rounds of sampling... exact sampling locations may differ. In the basement unpublished data from 2010-2011 agrees closely with 2021-2022 data.

GC PCE Indoor and Subslab Insurance Office

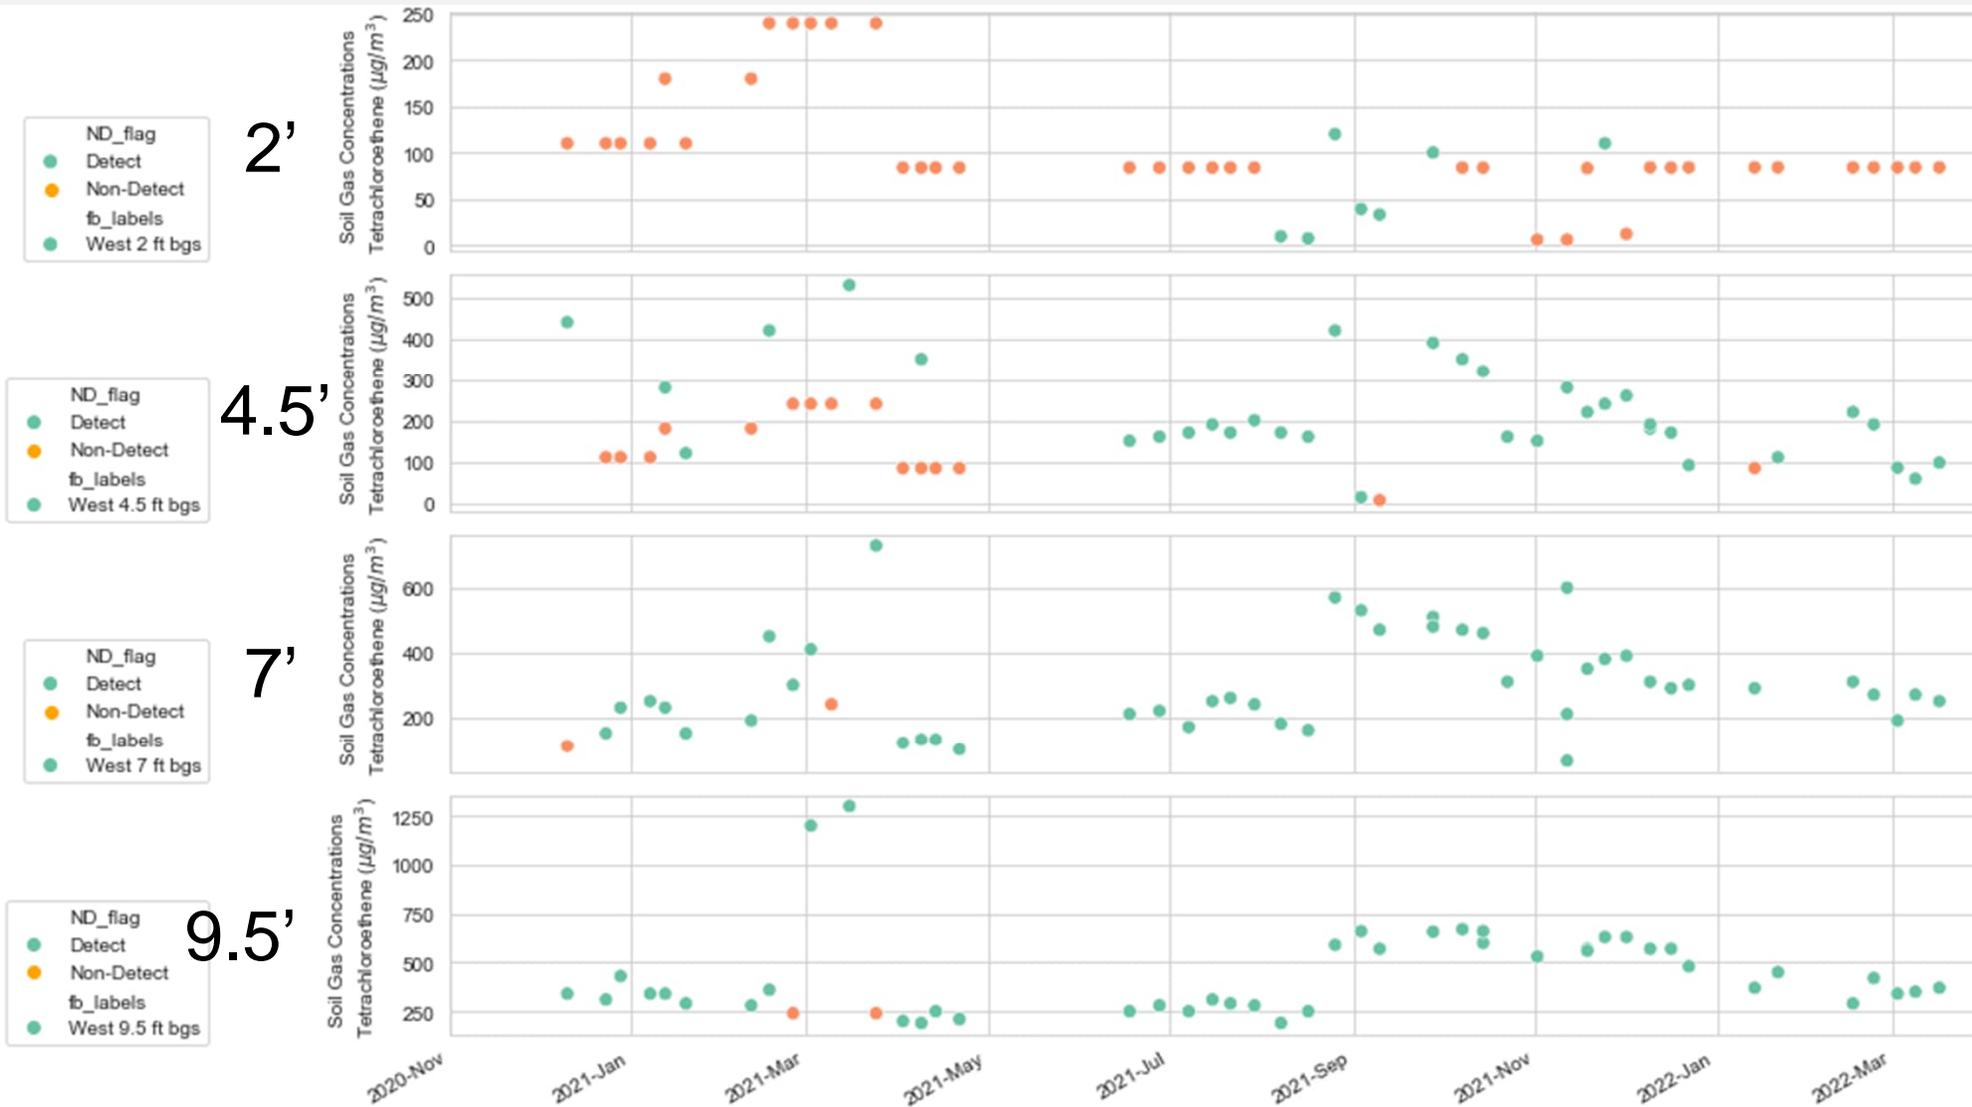
PCE Soil Gas TO-17 , Multi-depth, West Side of Church

Key points: Detection much less frequent shallow; building has basement; Soil gas concentrations peak late summer in this climate

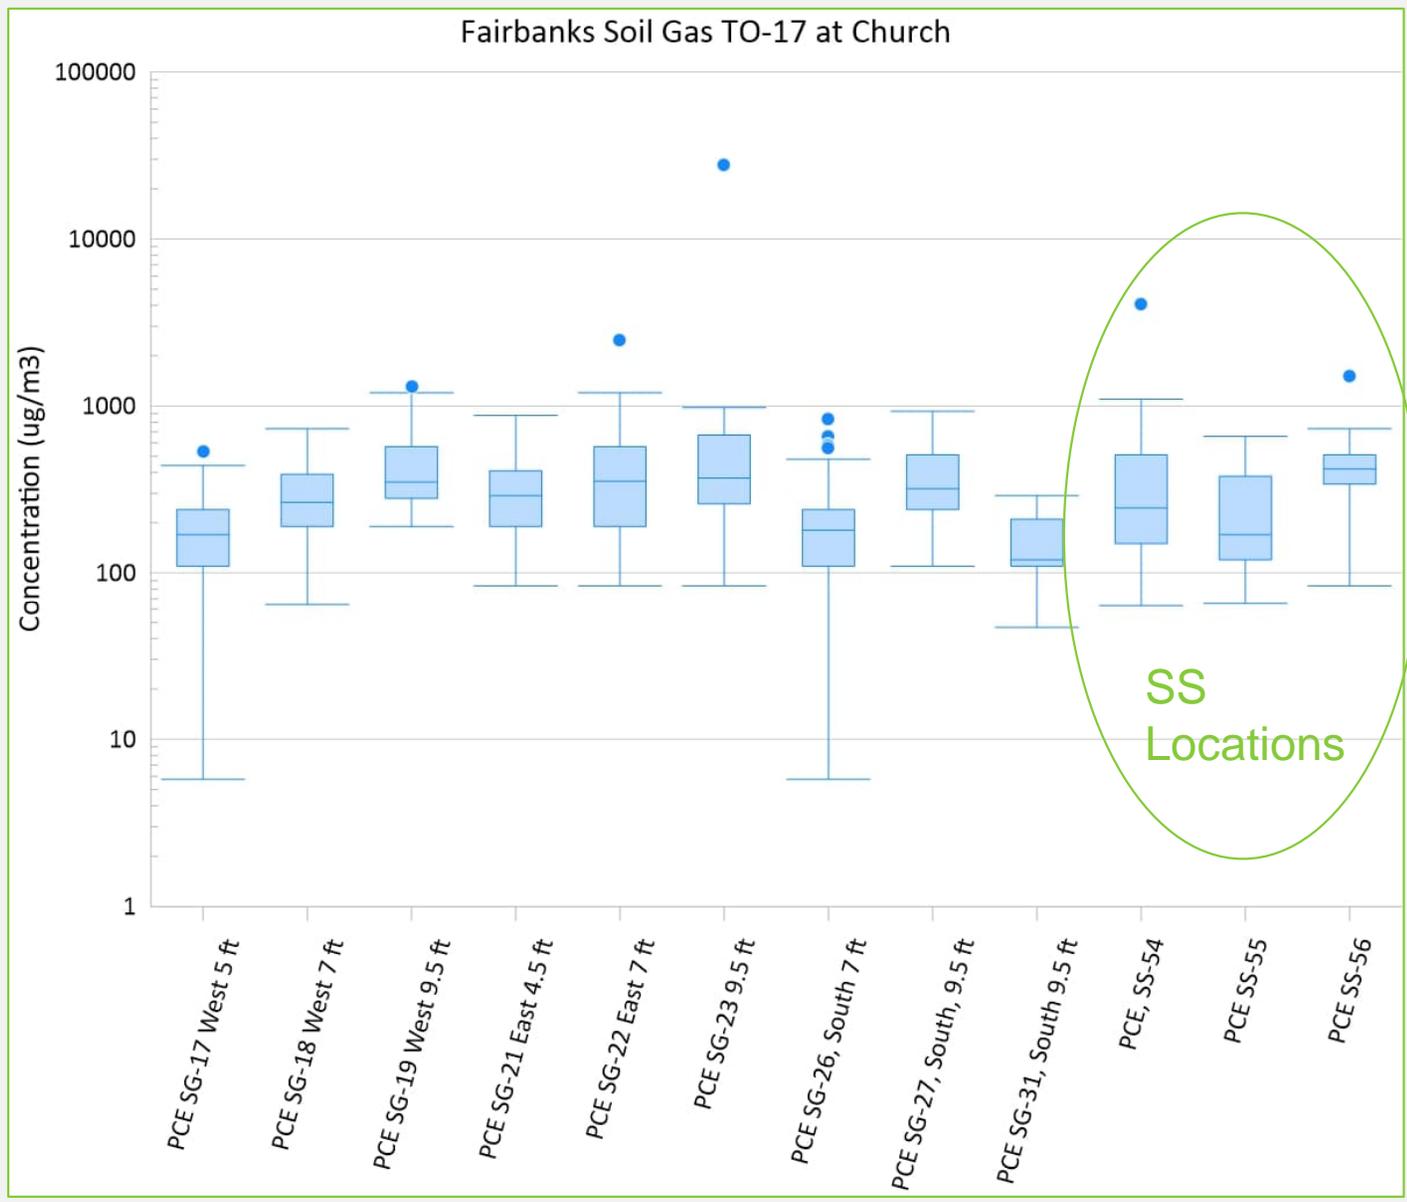
PCE TO-17 Church Soil Gas Temporal and Spatial Variability n=49 to 96 at locations with few nondetects 2020-22

For comparison one point about 100' away VMP-4 (6.5-8.5') sampled six times in 2015 had
PCE 1 to 17 $\mu\text{g}/\text{m}^3$;
TCE 1 to 83 $\mu\text{g}/\text{m}^3$

Key Points: Relatively low temporal and spatial variability when considering only deeper locations. But one 2015 measurement was much lower about 100' away
