In-Depth Discussion of a Case Study of Long-Term Vapor Intrusion Site Management

Gaffney PCE Investigation Context

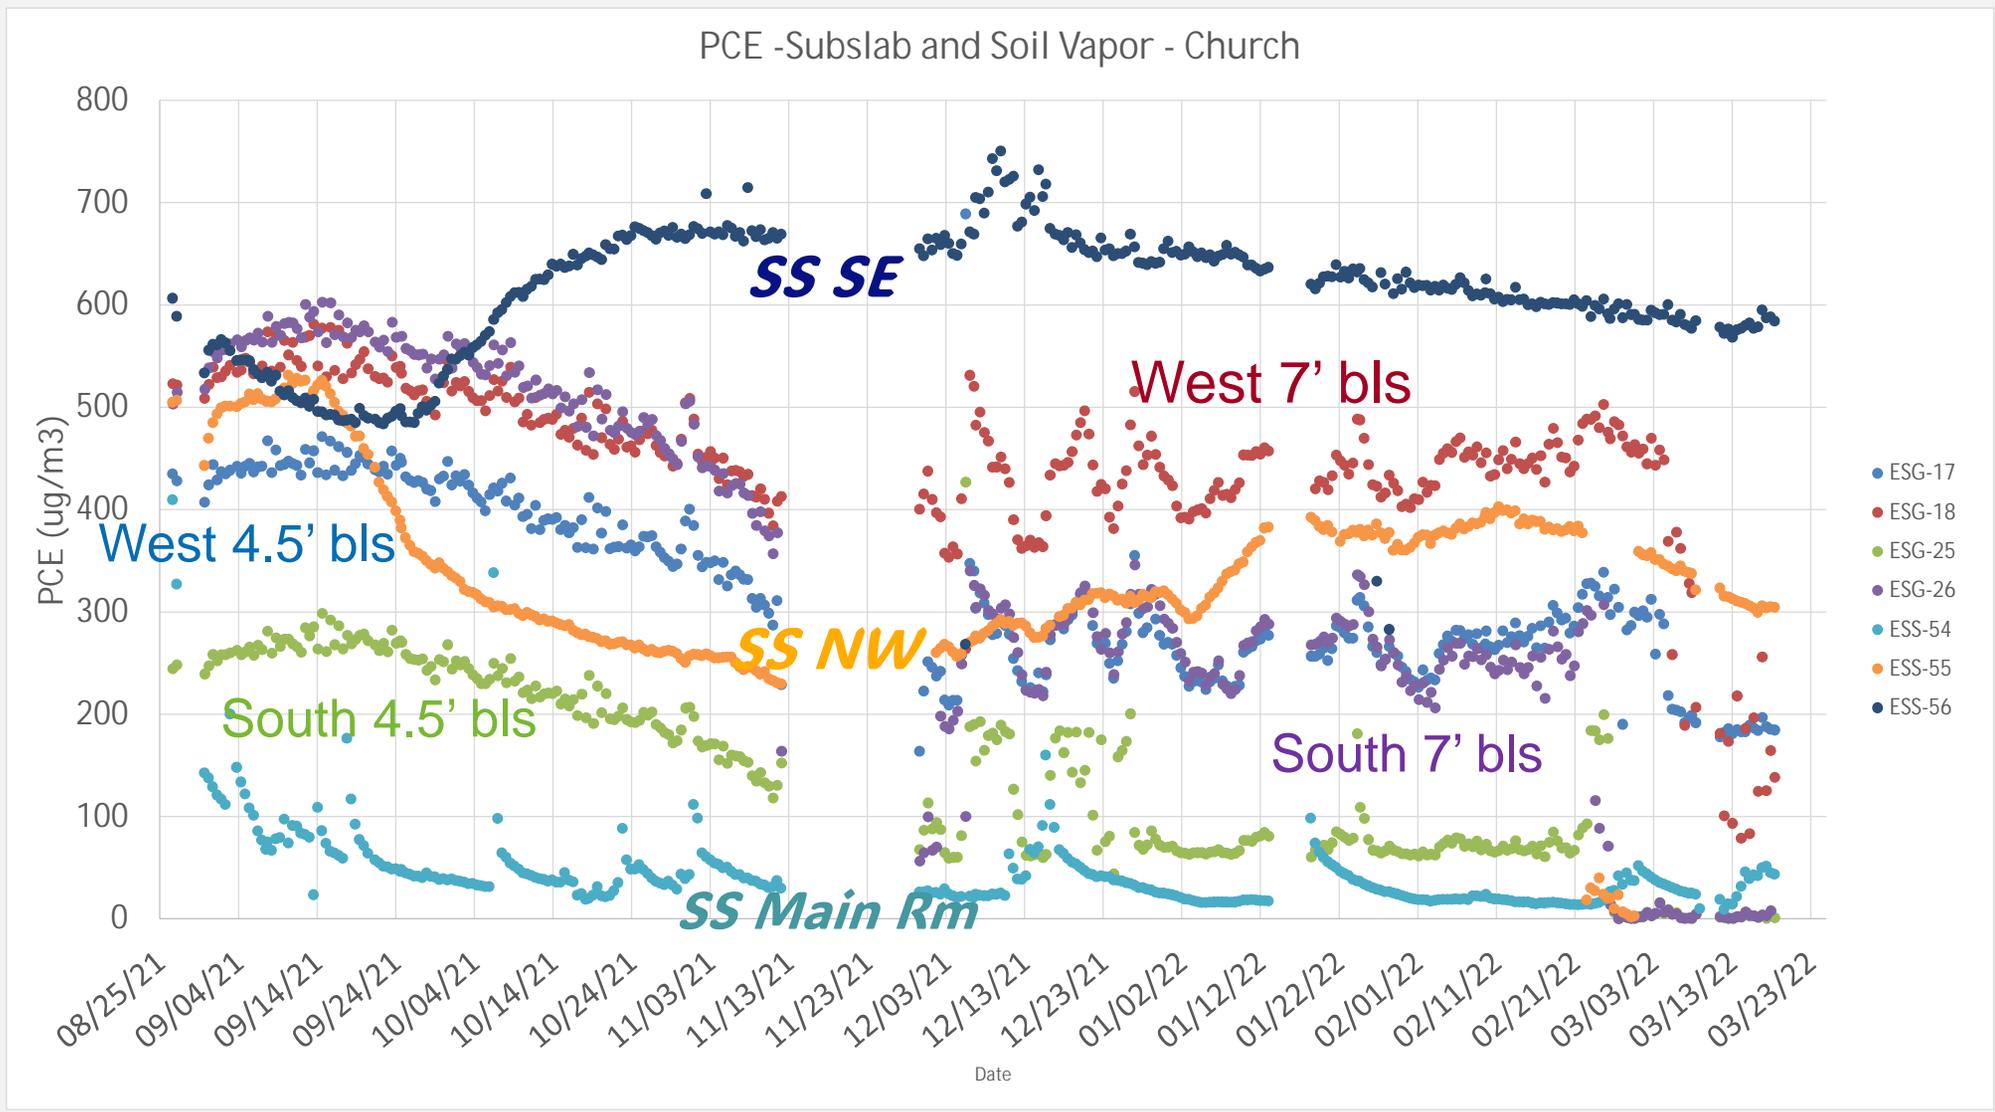
Church GC, PCE, Subslab and External Soil Gas

Key Points: Limited temporal variability (3x); External and subslab overlap, most locations decline after Sept high

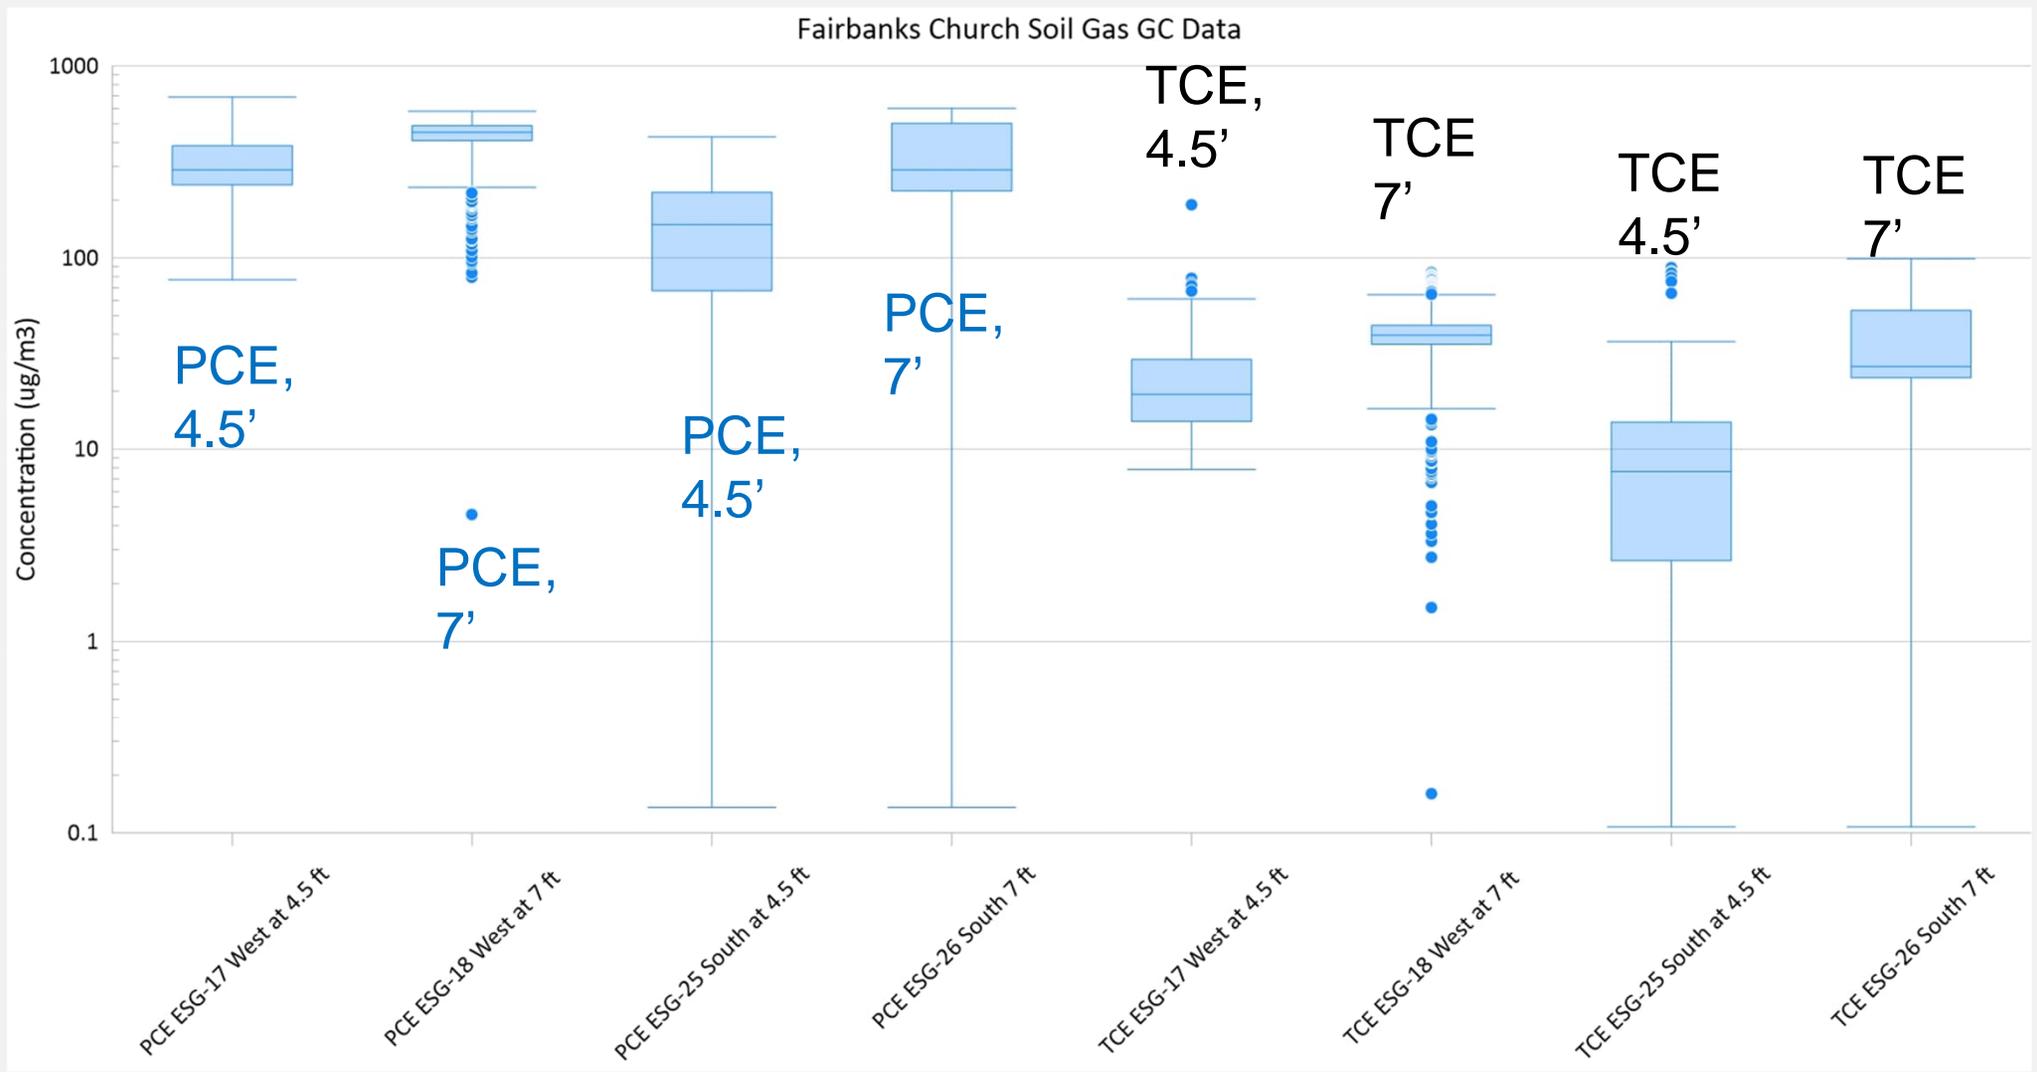
Fairbanks Temporal and Spatial Variability Box Soil Gas Plot GC Data; n=369 to 373

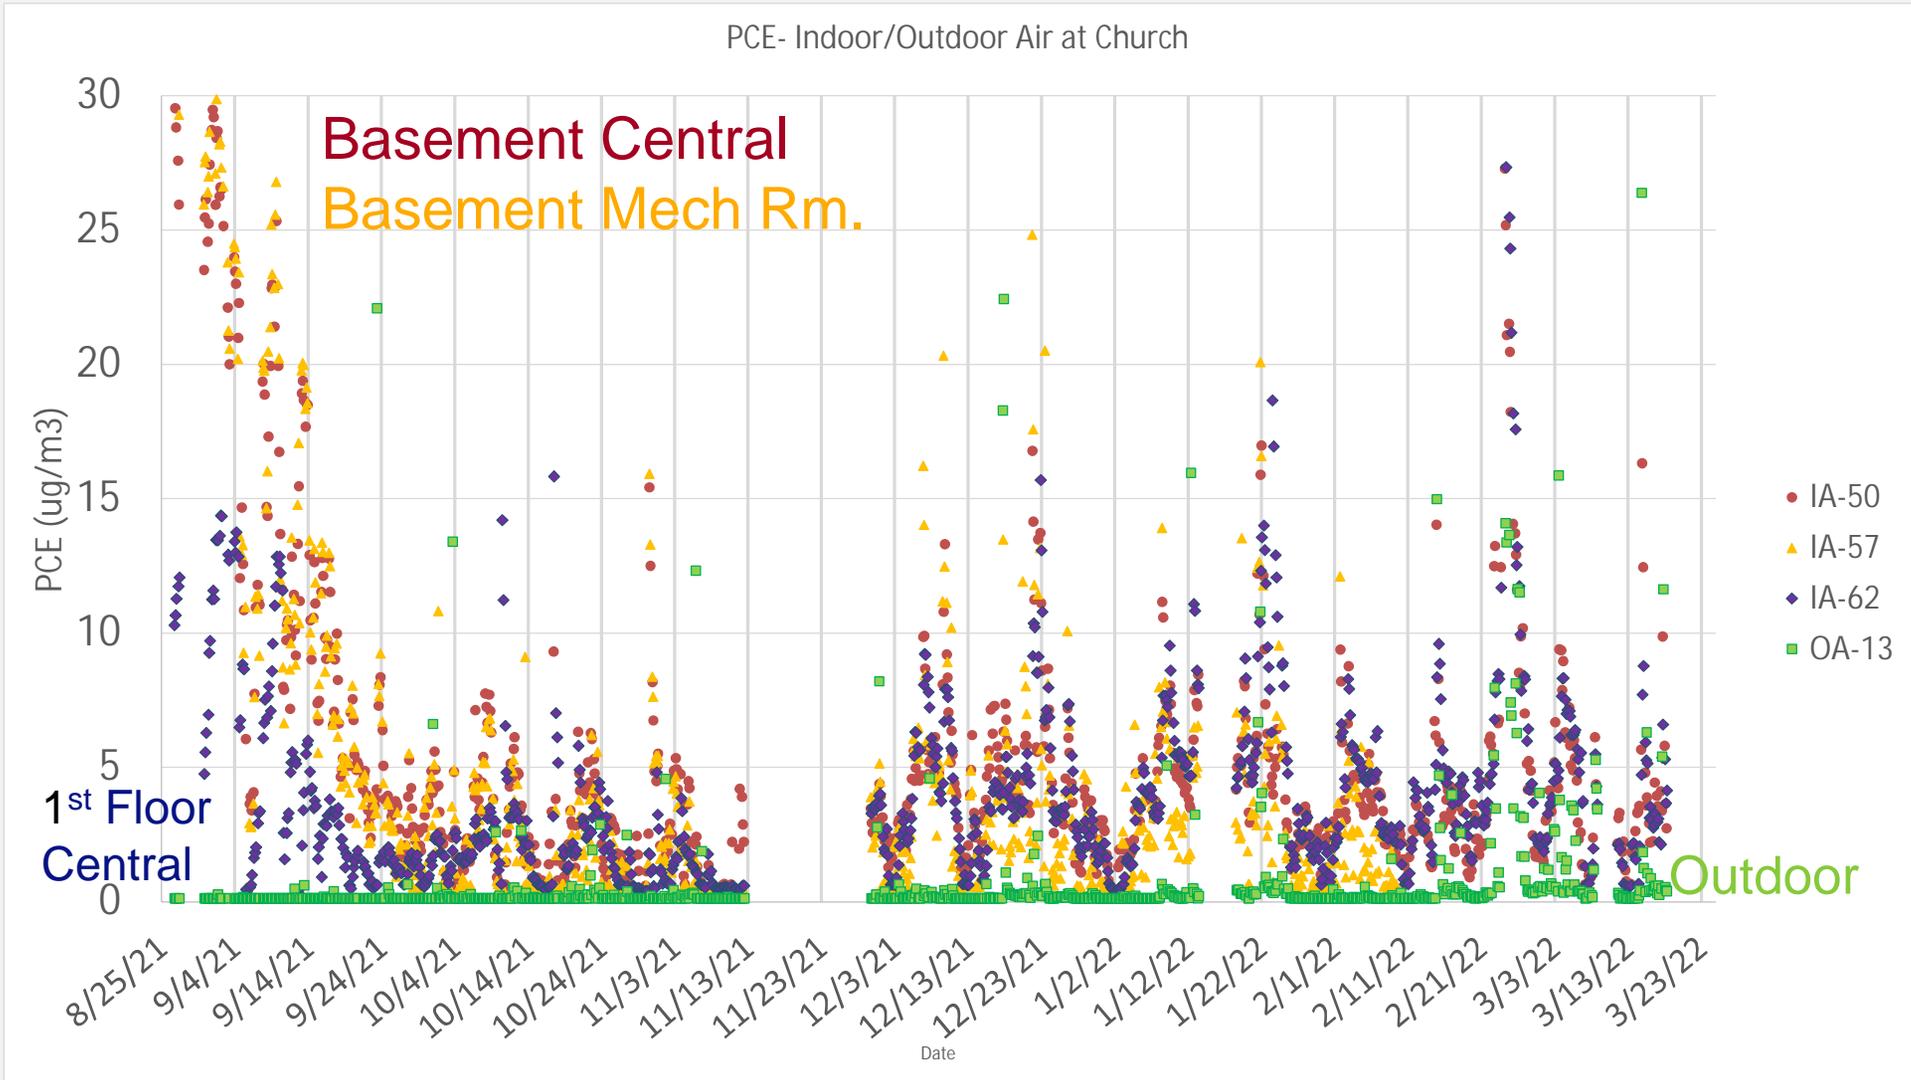
Church GC, PCE, Indoors

Key Points: Dramatic Temporal Variability, Declines from September High, Outdoor usually low but sometimes comparable to indoors

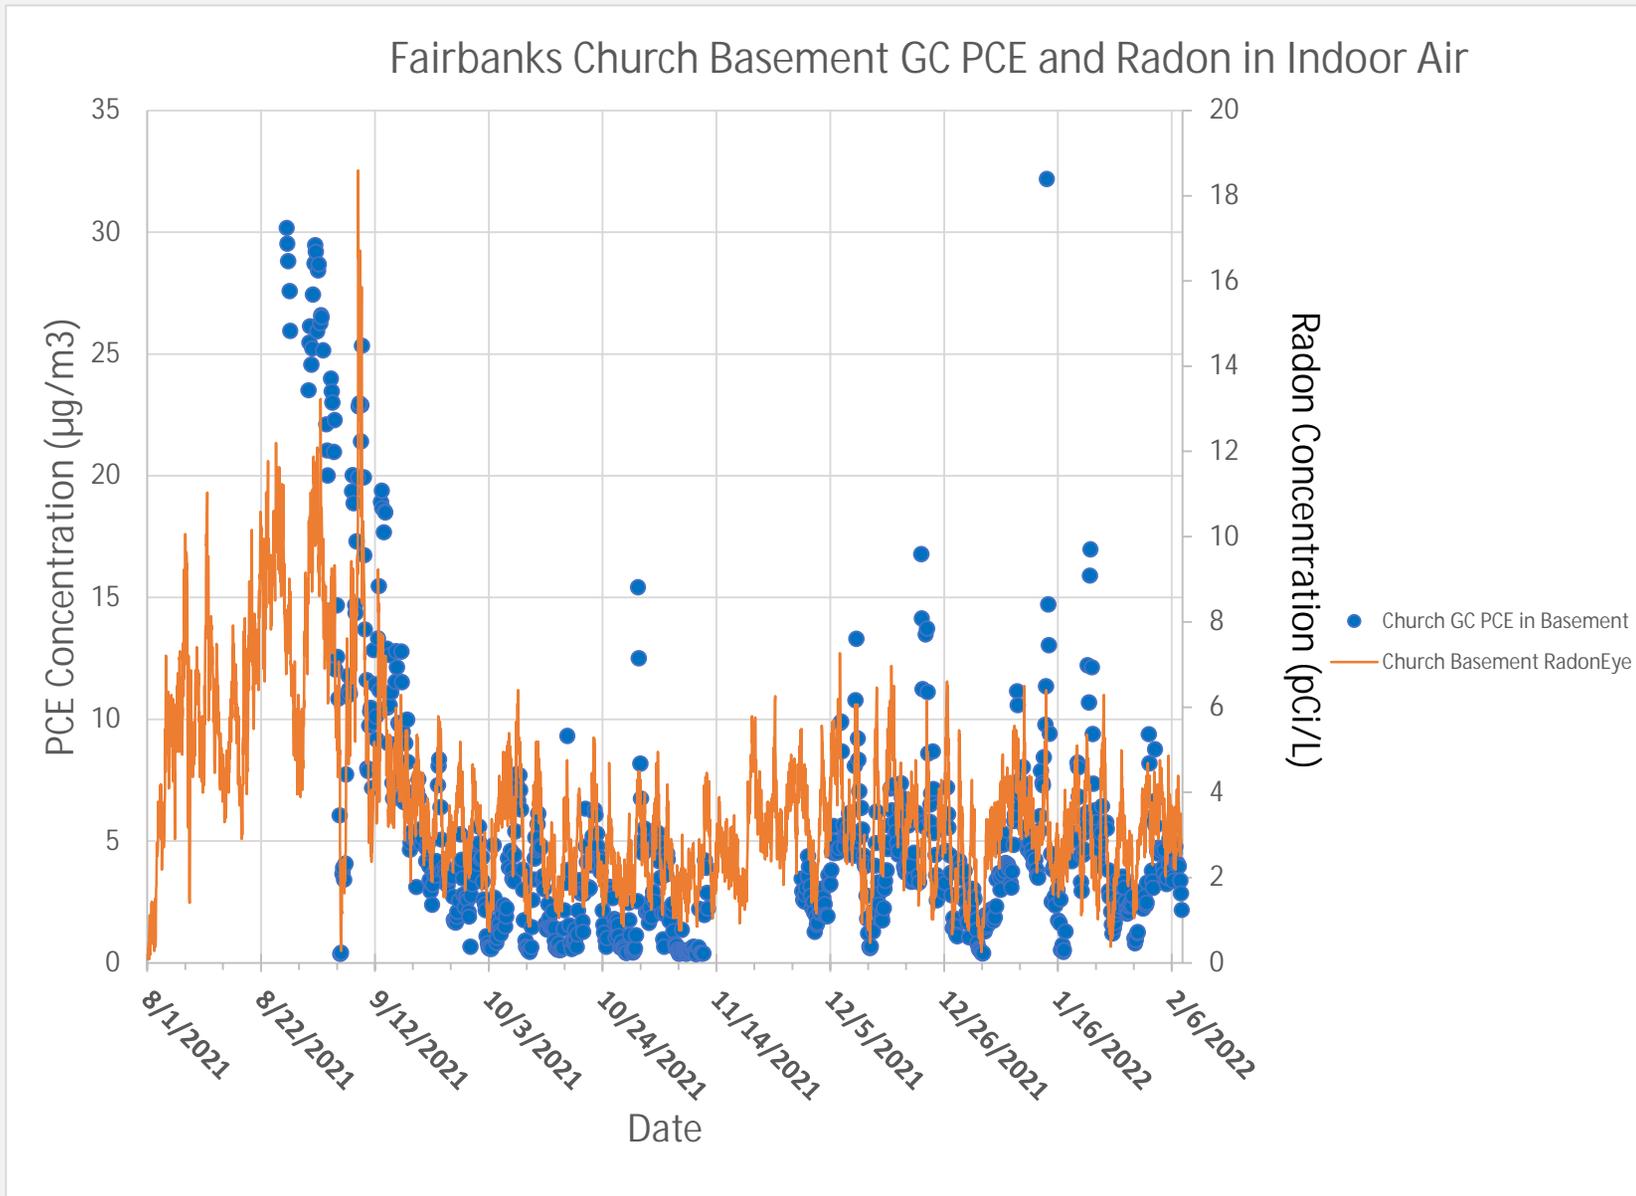
Church Basement PCE and Radon vs. Time

Key Point: Strong correlation supports use of Rn as a tracer

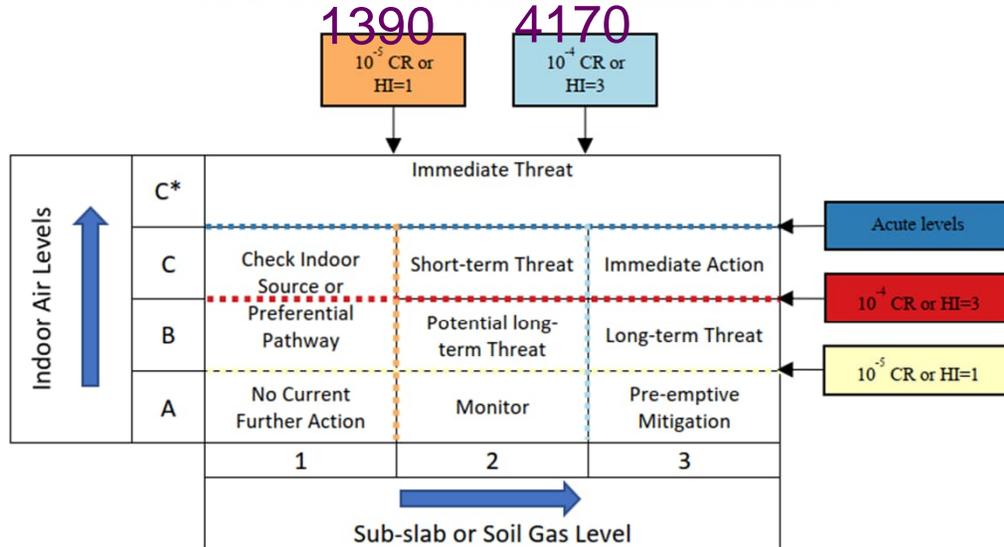
Table 8-1. Risk-Based Decision Matrix for VI Sites

How Would the Church Be Evaluated if You used Region V Matrix – PCE - Residential

1. Based on averages no current further action either with exterior soil gas or subslab
2. Based on maximums "Potential long-term threat"

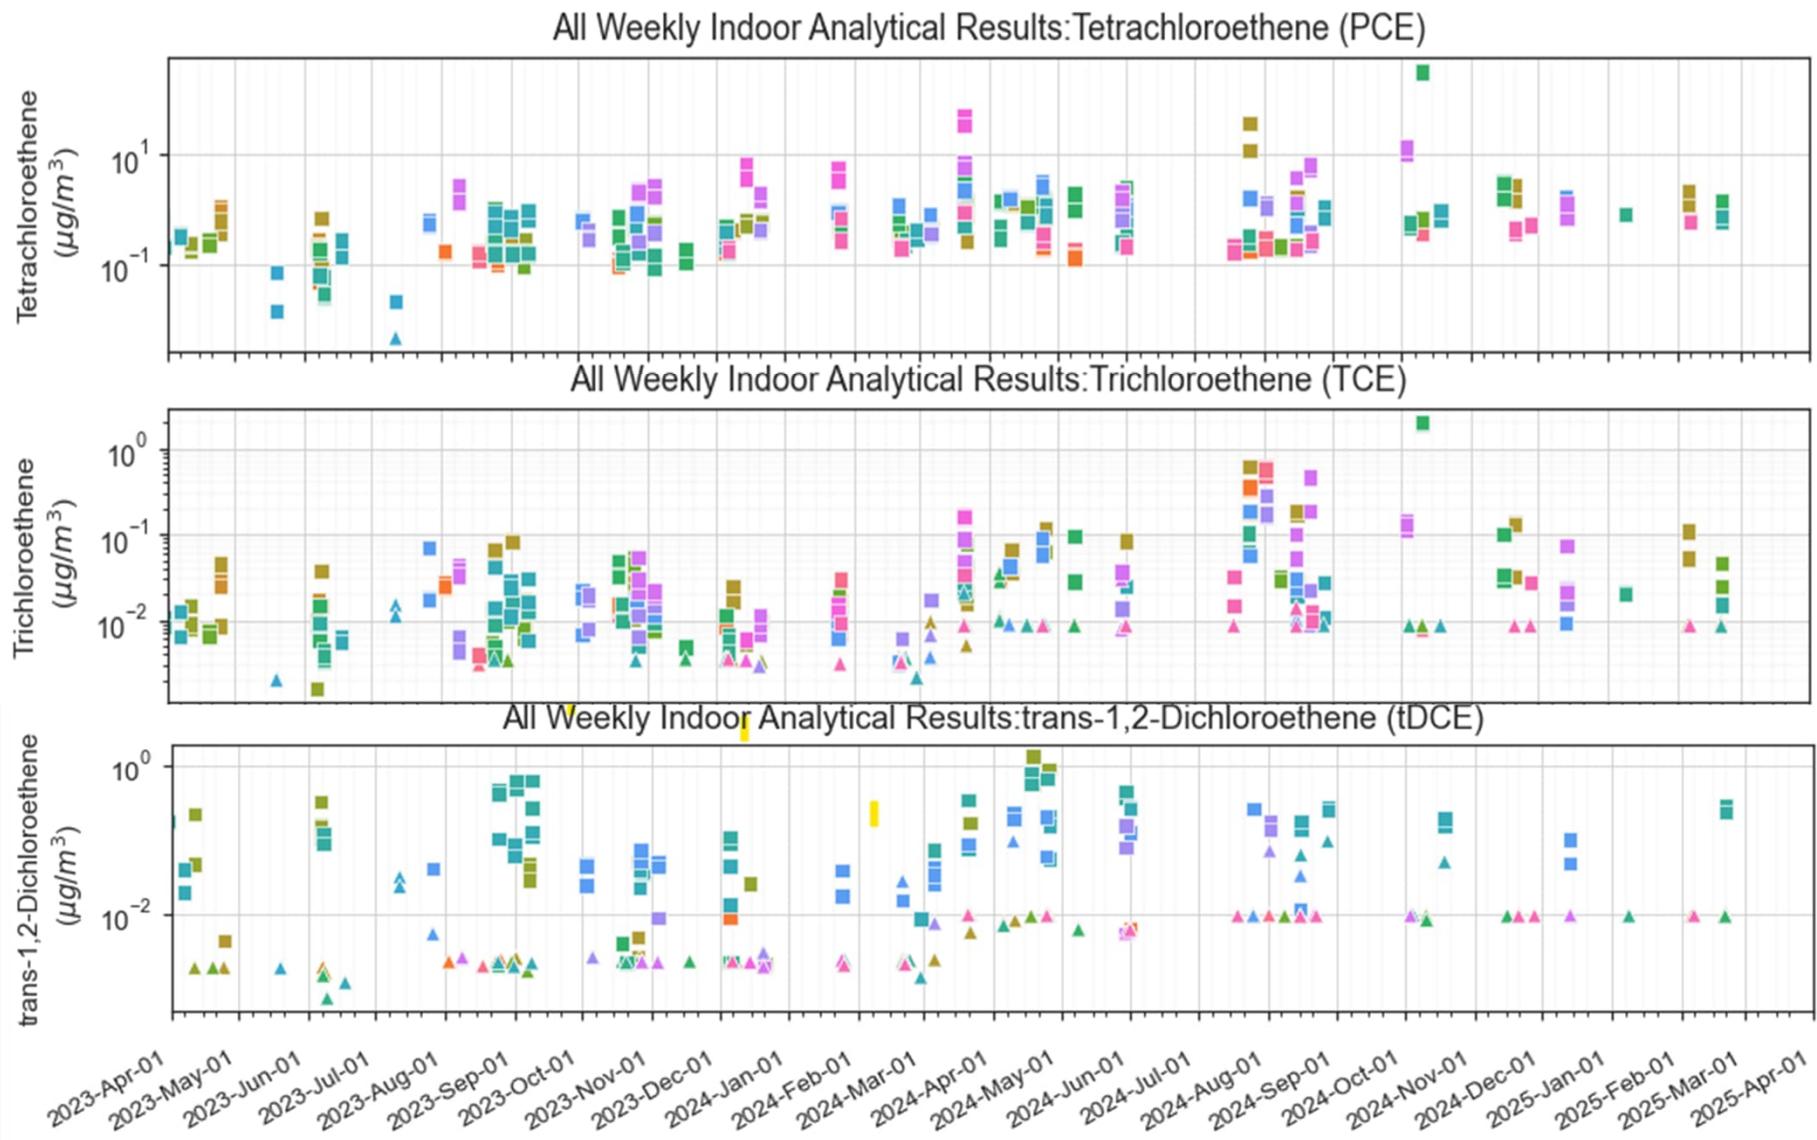
Soil Gas Safe Project Indoor Air, Weekly Duration Samples From All 16 Residences

Key Points: Note log scale, and distinct seasonal patterns; Spring and Fall Highs; Very Few Samples Exceed Alaska Target Levels

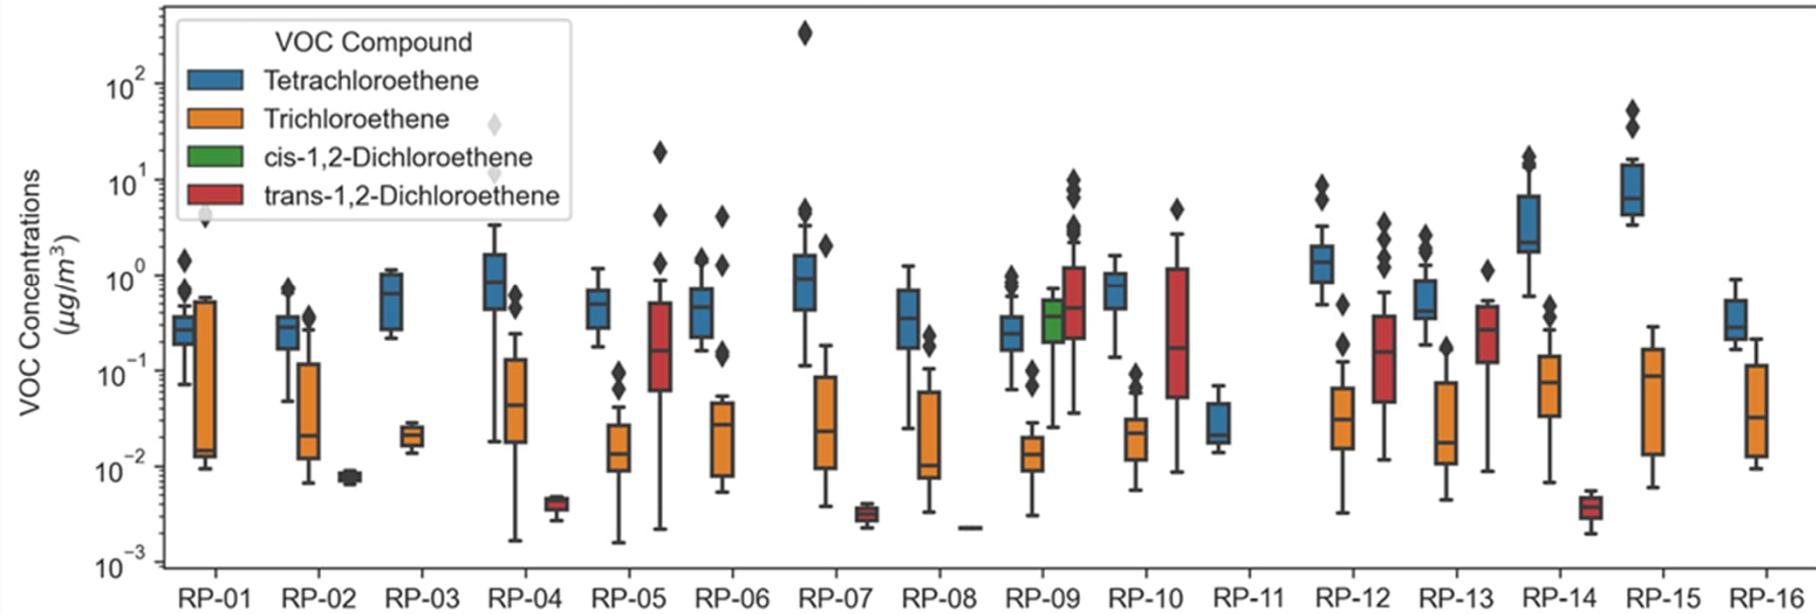
(a) VOC Summary Statistics by Residential Structure

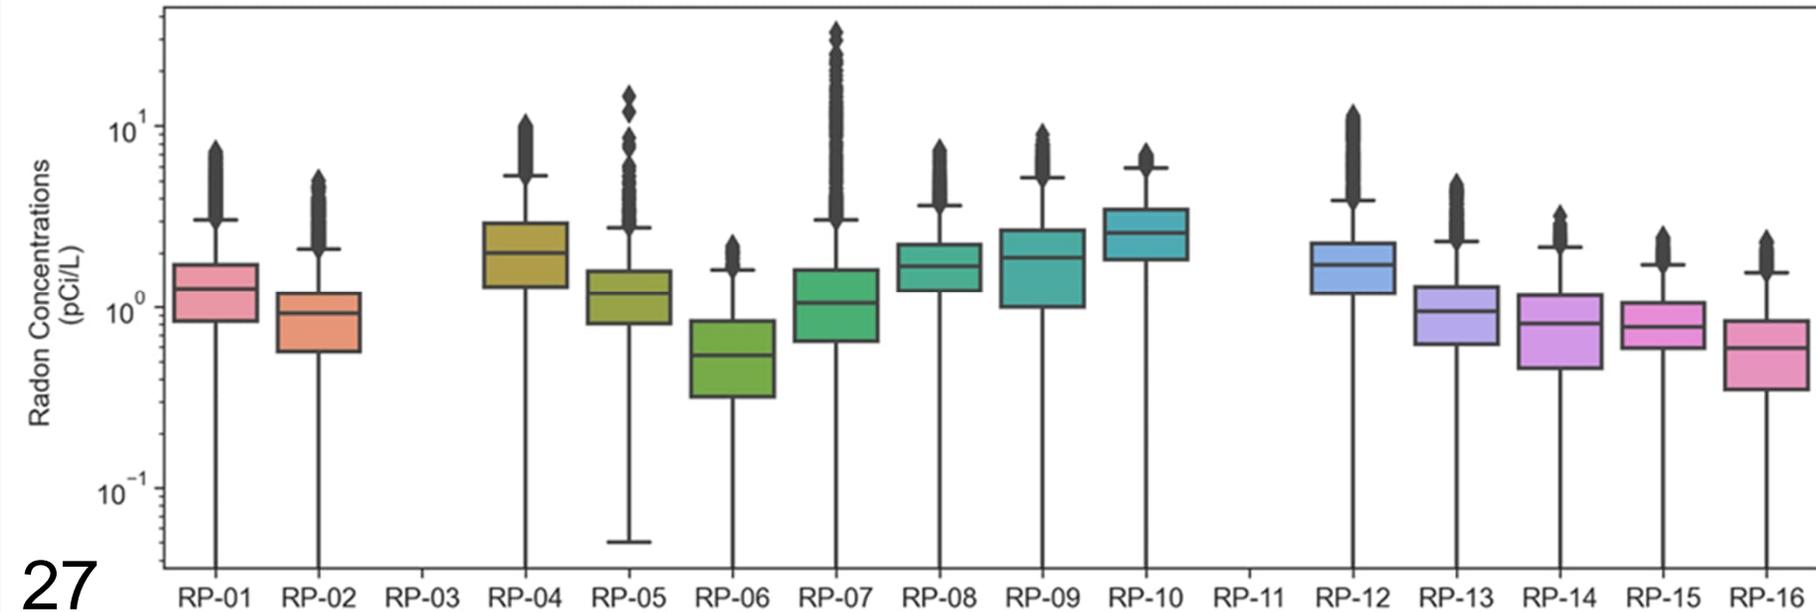
(b) Radon Summary Statistics by Residential Structure

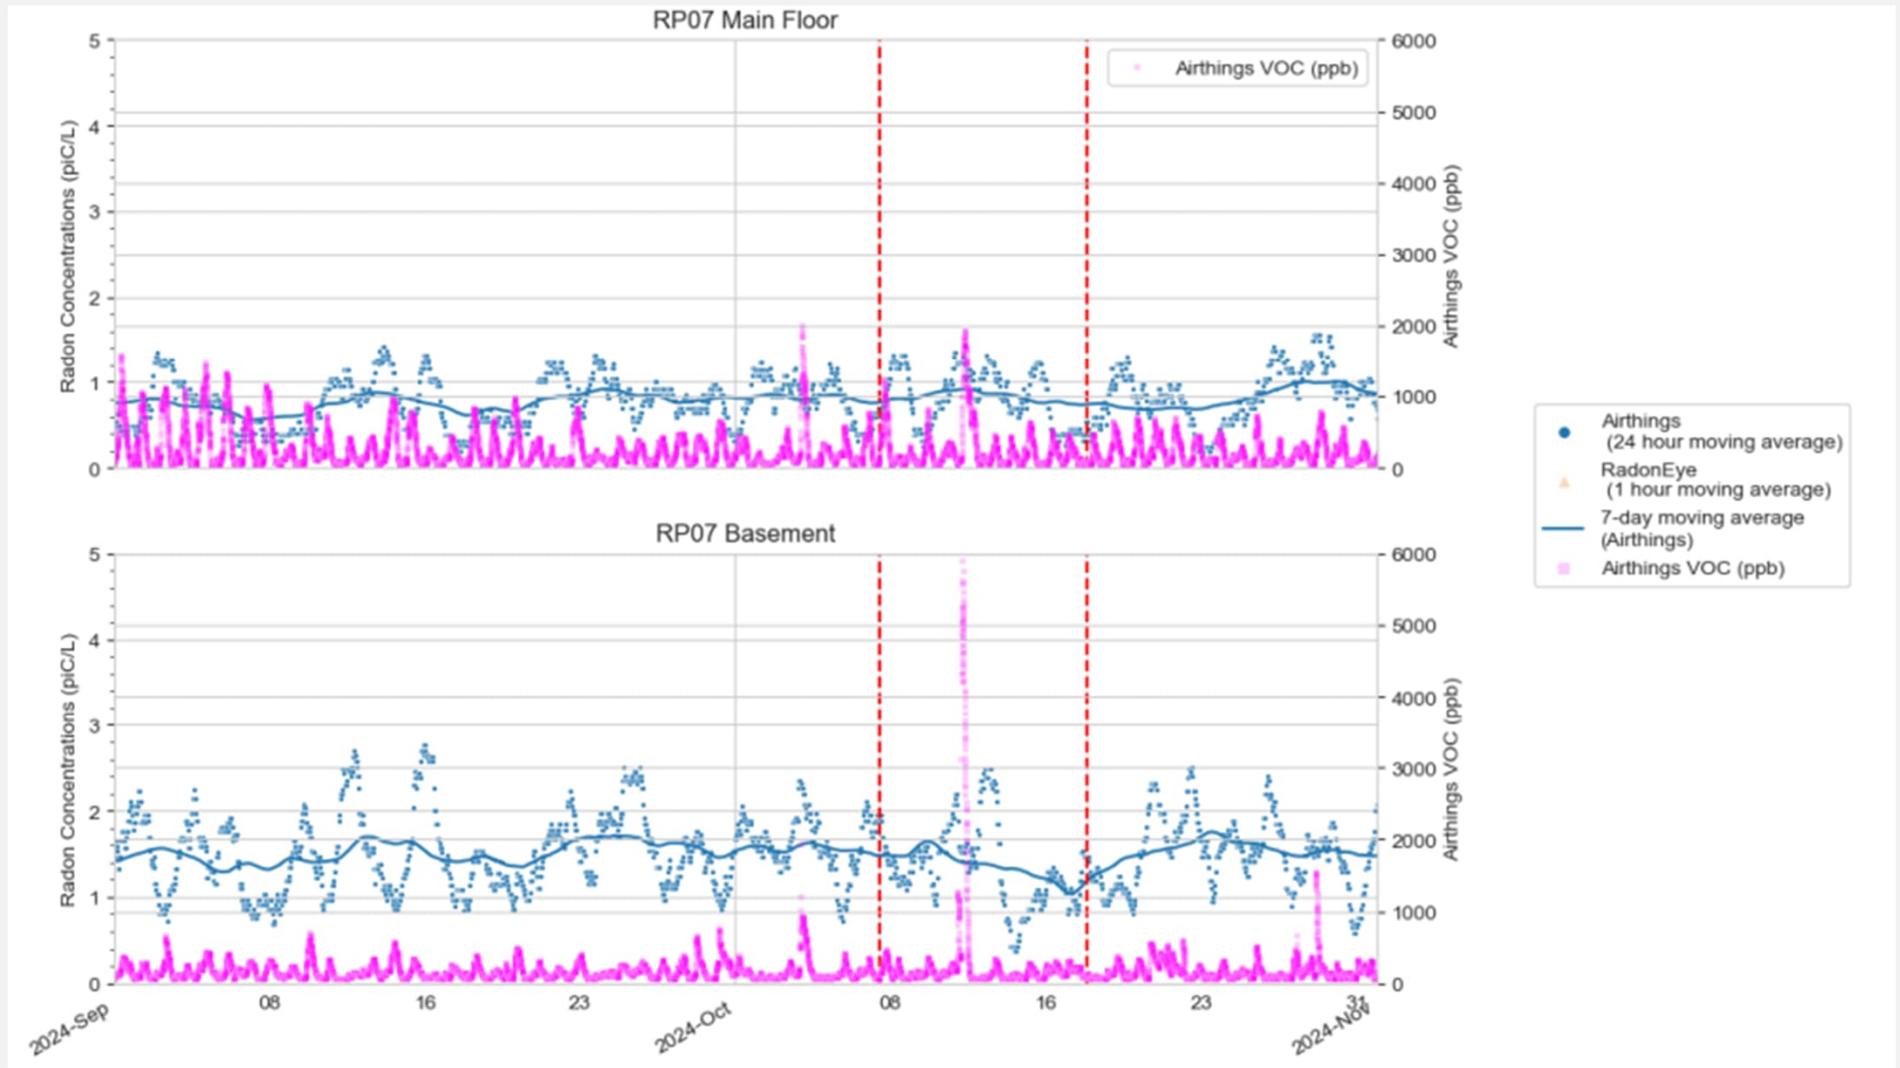
- Extreme values PCE (340 and 320 $\mu\text{g}/\text{m}^3$) and TCE (2.04 and 1.99 $\mu\text{g}/\text{m}^3$) observed in week long I&T guided samples 10/10 to 10/18/24

- These exceeded other samples collected in the house (15 previous rounds) by more than an order of magnitude.
- An extremely sharp peak reaching 6000 ppb was observed in the total VOC detector results (Airthings), especially in the basement on 10/12/24 that corresponded to a peak in the radon concentration.

- The radon peak on 10/12 as well as other radon peaks were attributed to sharp drops in barometric pressure
- The 10/4 and 10/12 peaks correspond to a sharp wind speed peak. The residence has two above grade stories and a basement that includes a heated garage and main room entered through a sloping driveway cut. The sloping driveway cut suspected as a potential mechanism for strong pressure differentials exerted by winds on the garage door directly beneath occupied space.

RP-07 Period of Extreme Sample vs Radon and Airthings Total VOCs

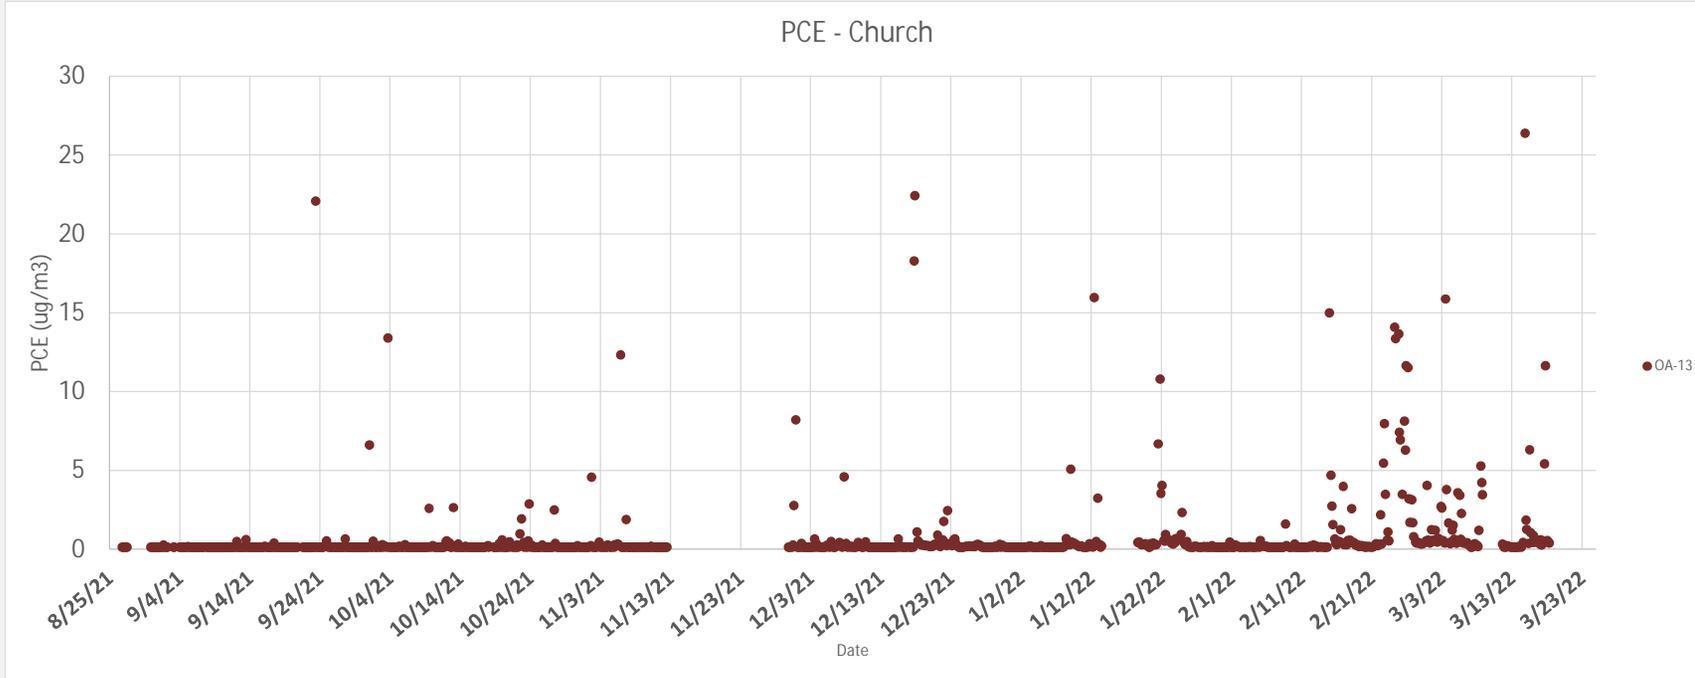
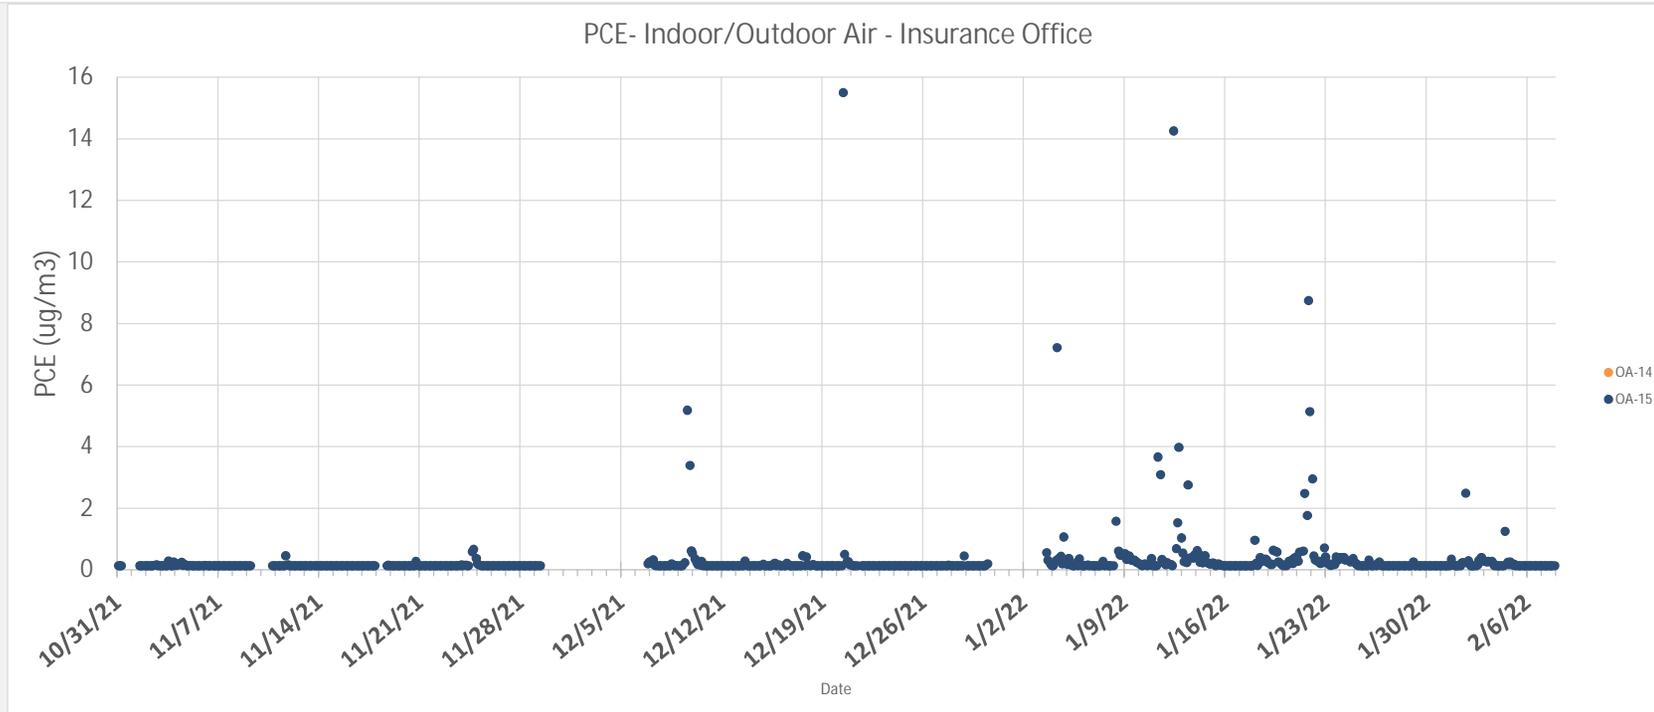
Occasional Elevated Ambient Air PCE - GC

Probably related to inversions

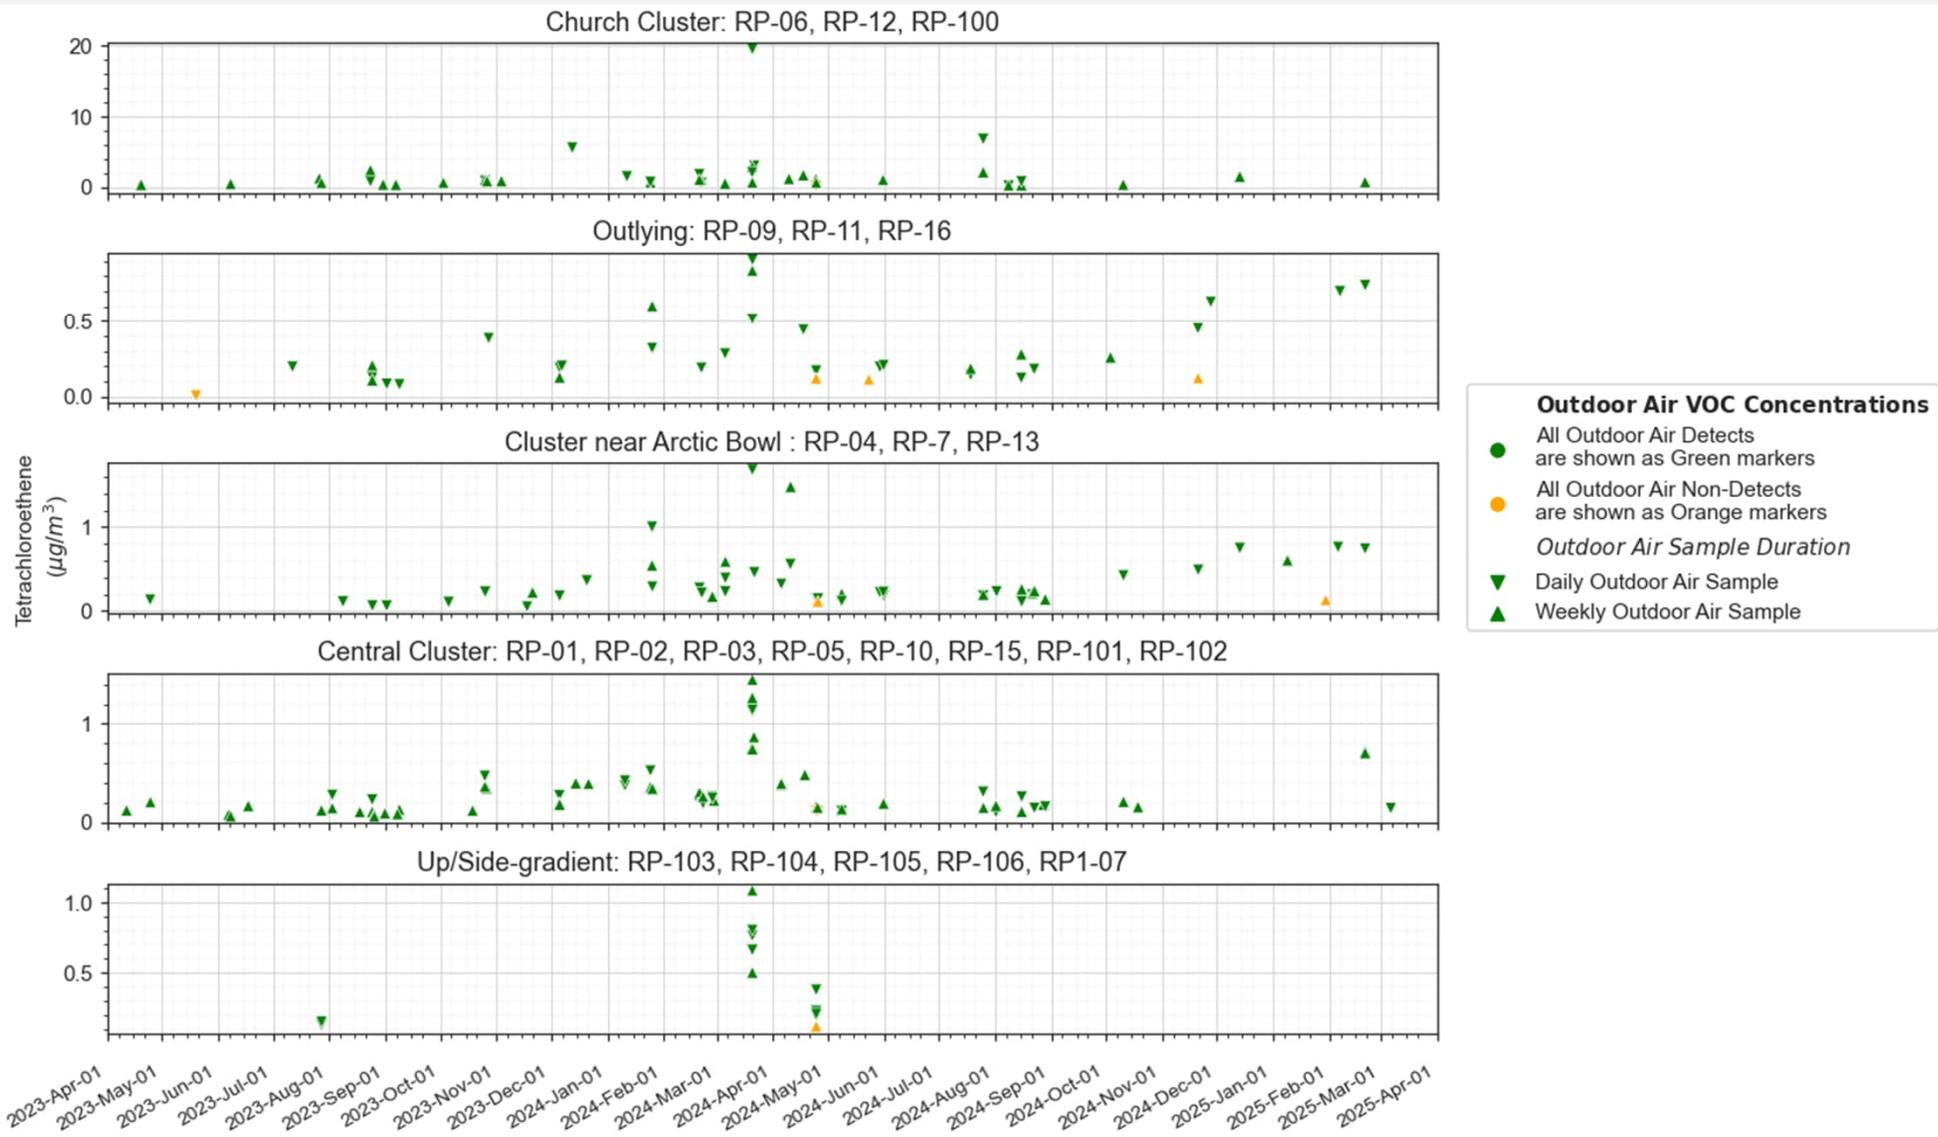
Elevated PCE on part of Site – Passive Samples

- All Outdoor Air Detects are shown as Green markers
- All Outdoor Air Non-Detects are shown as Orange markers
- Outdoor Air Sample Duration*
- ▼ Daily Outdoor Air Sample
- ▲ Weekly Outdoor Air Sample

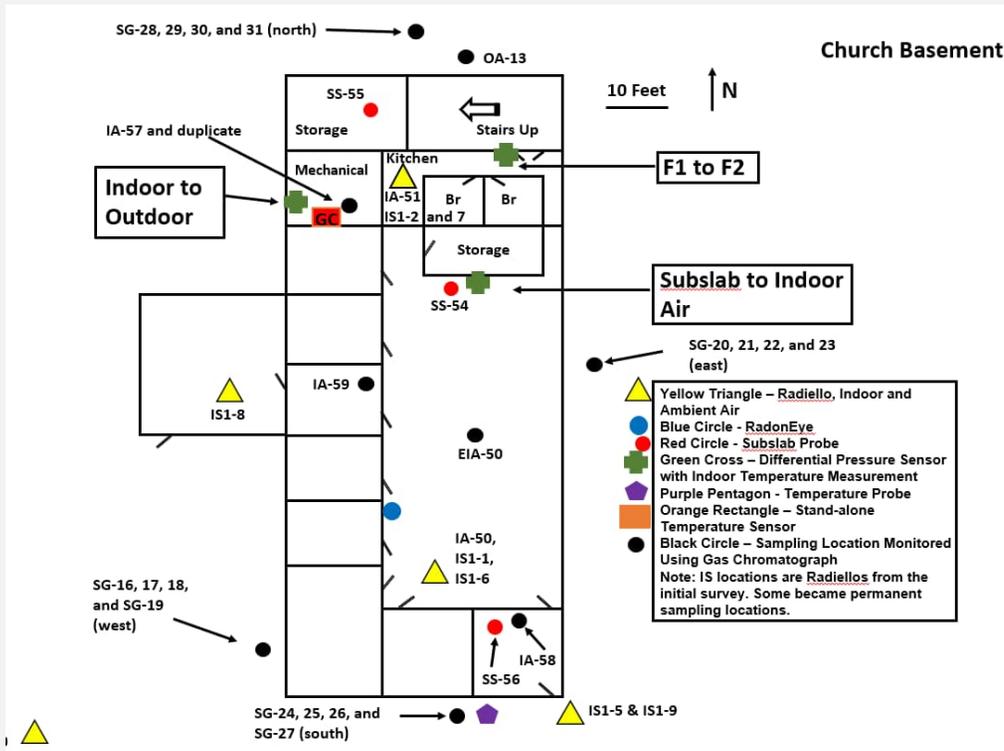
Fairbanks Gaffney Church

Subslab (GC)	3	F1, main room, central	SS-54
		F1, storage room, NW	SS-55
		F1, storage room, SE	SS-56

West, 2'	SG-16
West, 4.5' (GC location)	SG-17
West, 7' (GC location)	SG-18
West, 9.5'	SG-19
East, 2'	SG-20
East, 4.5'	SG-21
East, 7'	SG-22
East, 9.5'	SG-23
South, 2'	SG-24
South, 4.5' (GC location)	SG-25
South, 7' (GC location)	SG-26
South, 9.5'	SG-27
North, 2'	SG-28
North, 4.5'	SG-29
North, 7'	SG-30
North, 9.5'	SG-31

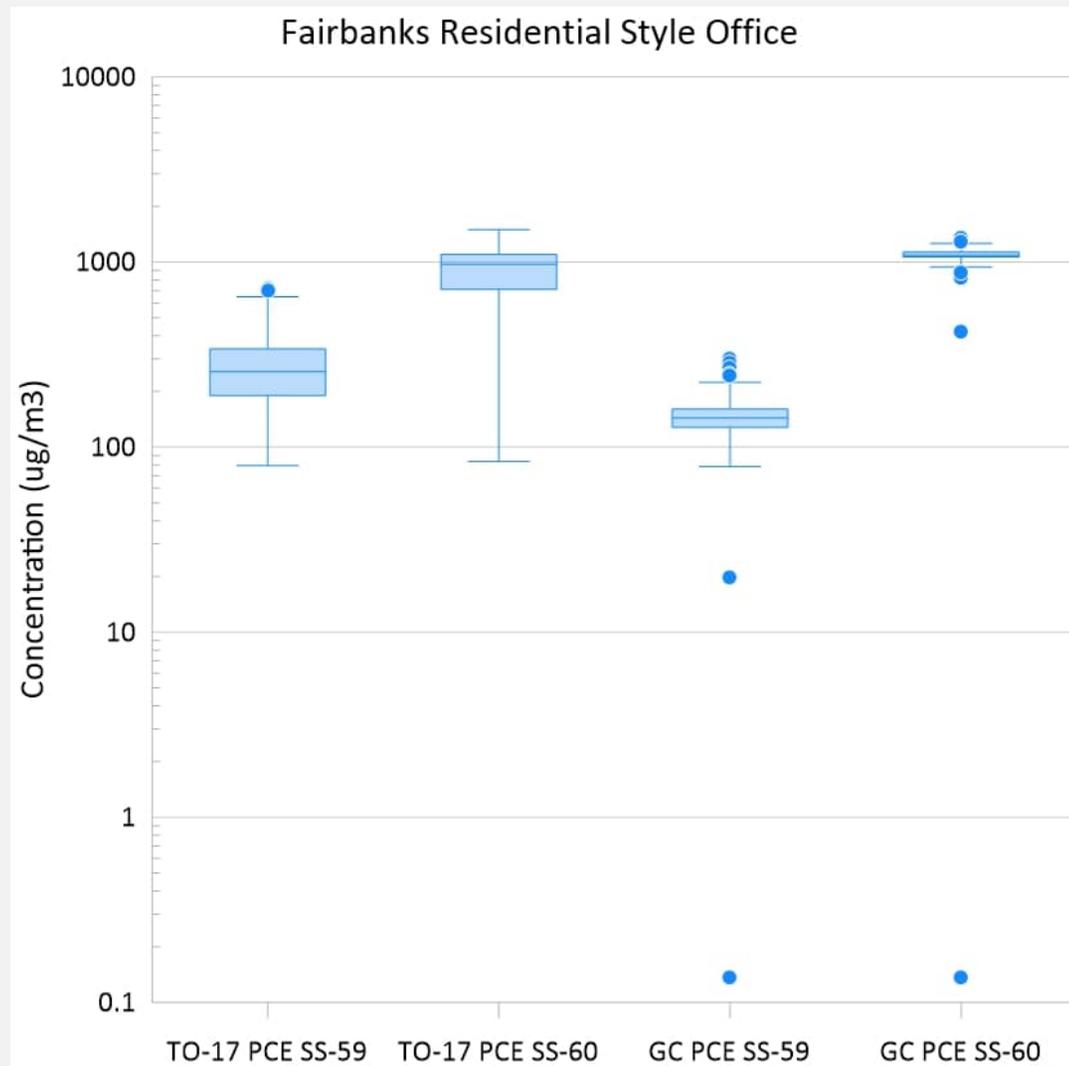
**Fairbanks
Residential Style
Office: Temporal
and Spatial
Variability, GC n=
440-441 over 6
months; TO-17 n=
84-88 over 13
months**
