In-Depth Discussion of a Case Study of Long-Term Vapor Intrusion Site Management

Gaffney PCE Investigation Context

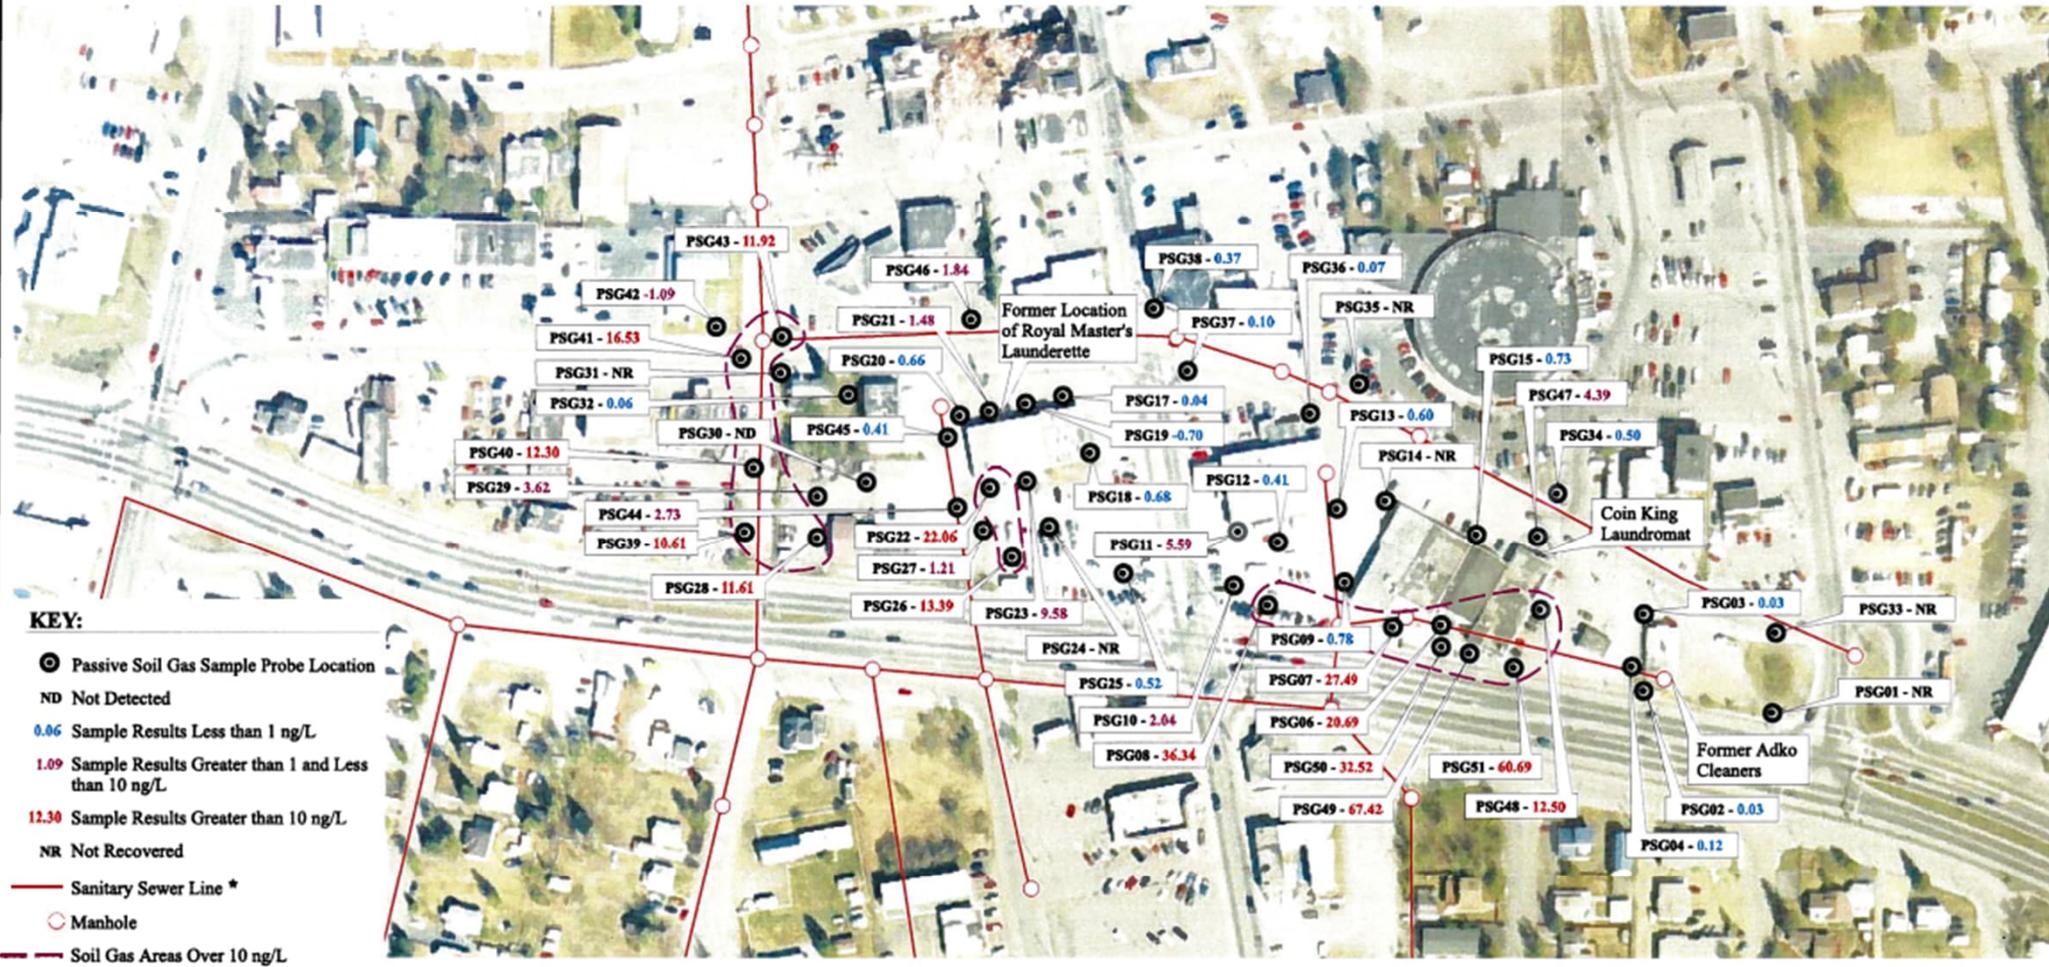
1999 Passive Soil Gas

Note: All results in nanograms/Liter (ng/L).
Sample locations with no recovery indicate that sample probe was damaged or lost.

* Locations approximated from Proposed & Existing Sanitary Sewer Utilities, 1970

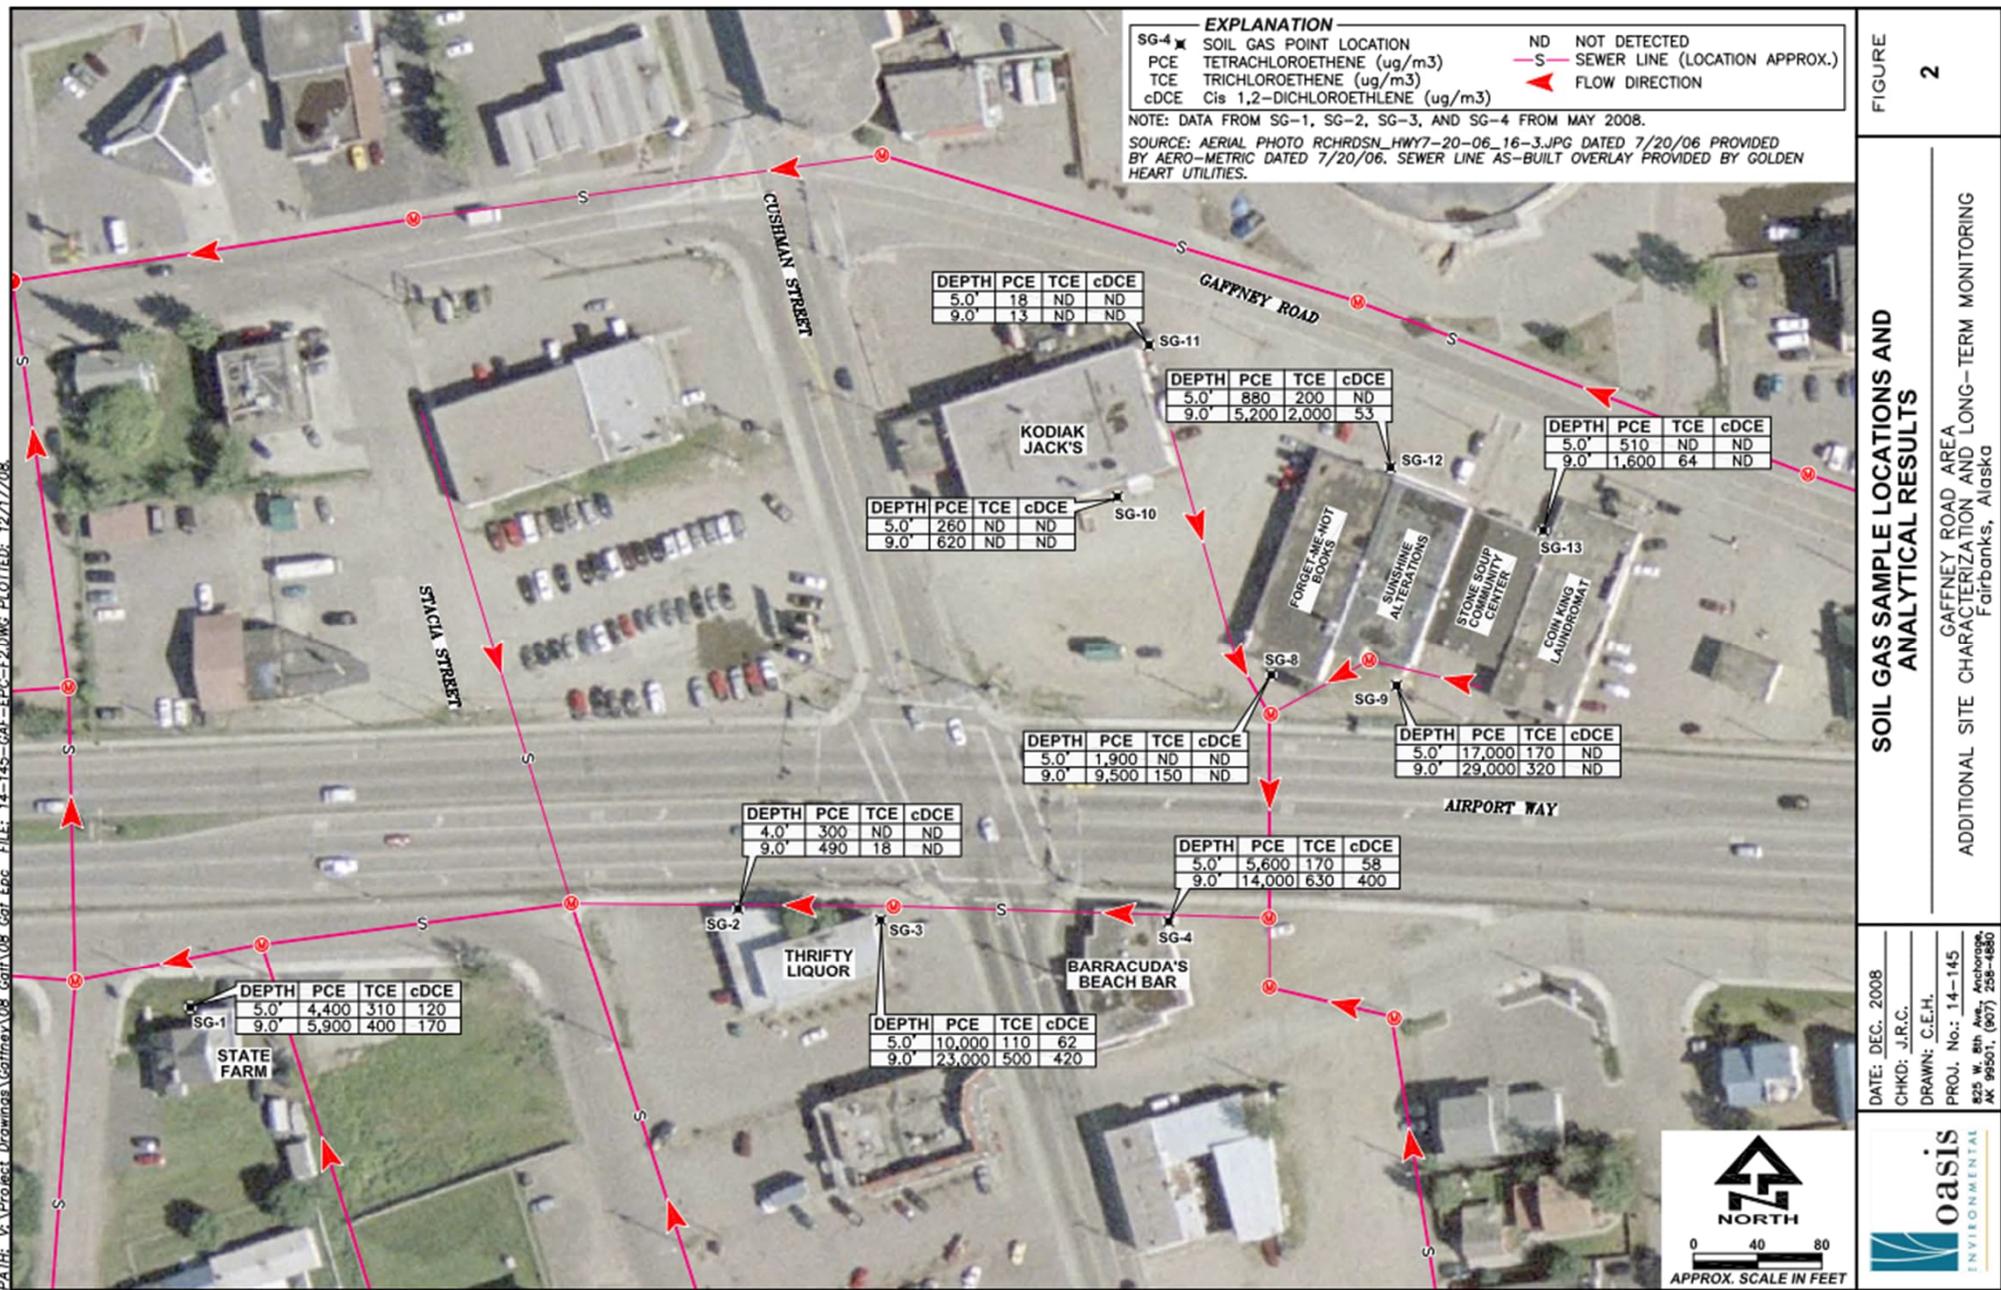
2008 Active External Soil Gas

FIGURE 2
SOIL GAS SAMPLE LOCATIONS AND ANALYTICAL RESULTS
GAFFNEY ROAD AREA
ADDITIONAL SITE CHARACTERIZATION AND LONG-TERM MONITORING
Fairbanks, Alaska

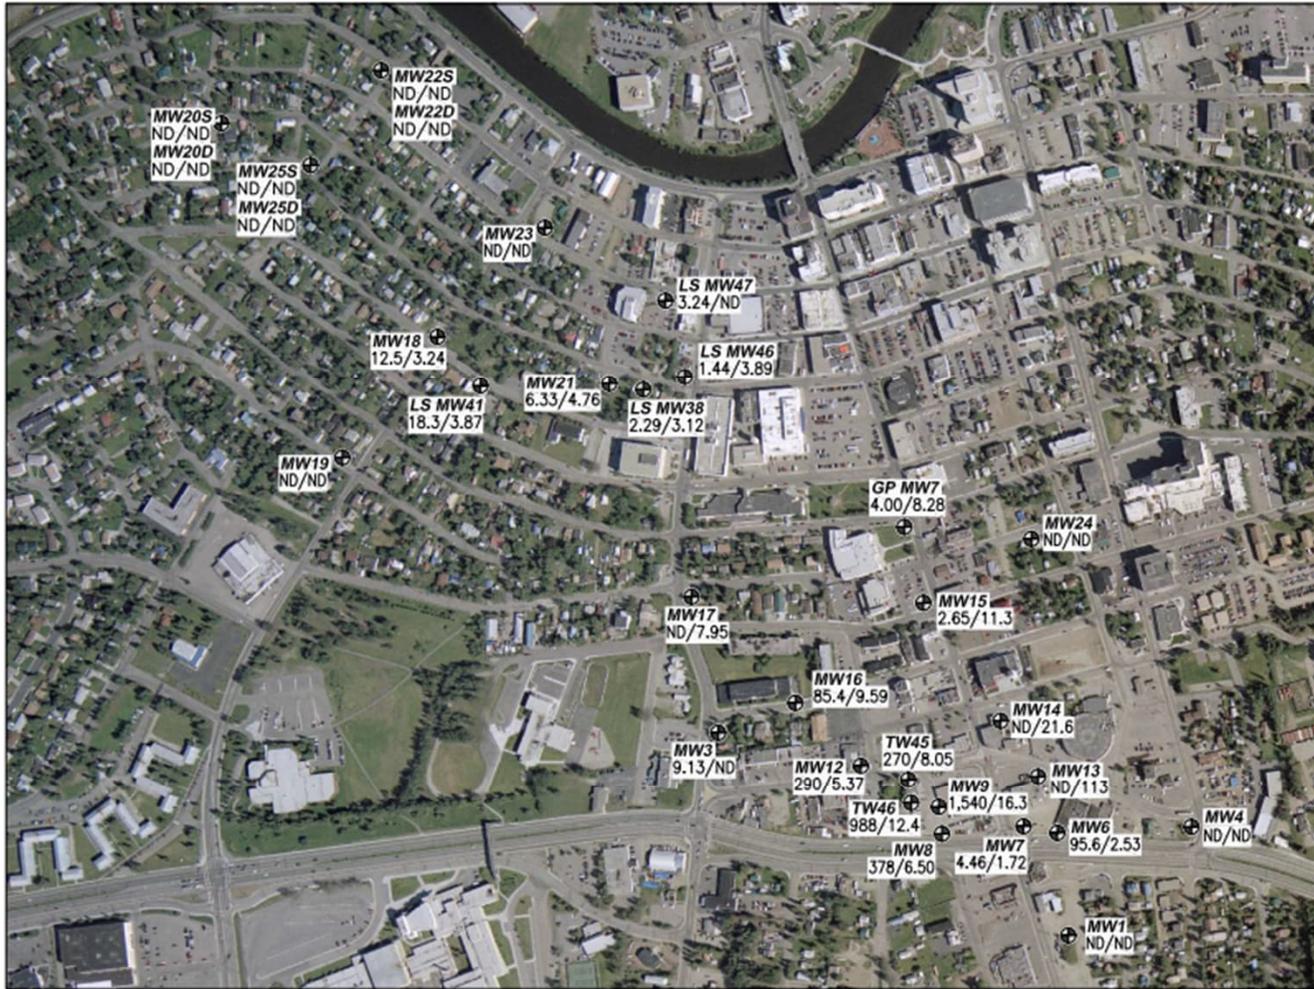
2007 GW Data and Well Field

EXPLANATION	
MW8	MONITORING WELL LOCATION (LETTER S DESIGNATES A SHALLOW WELL, LETTER D FOR DEEP)
378/6.50	TRICHLOROETHENE RESULTS (ug/L)
ND	TETRACHLOROETHENE RESULTS (ug/L)
ND	NOT DETECTED

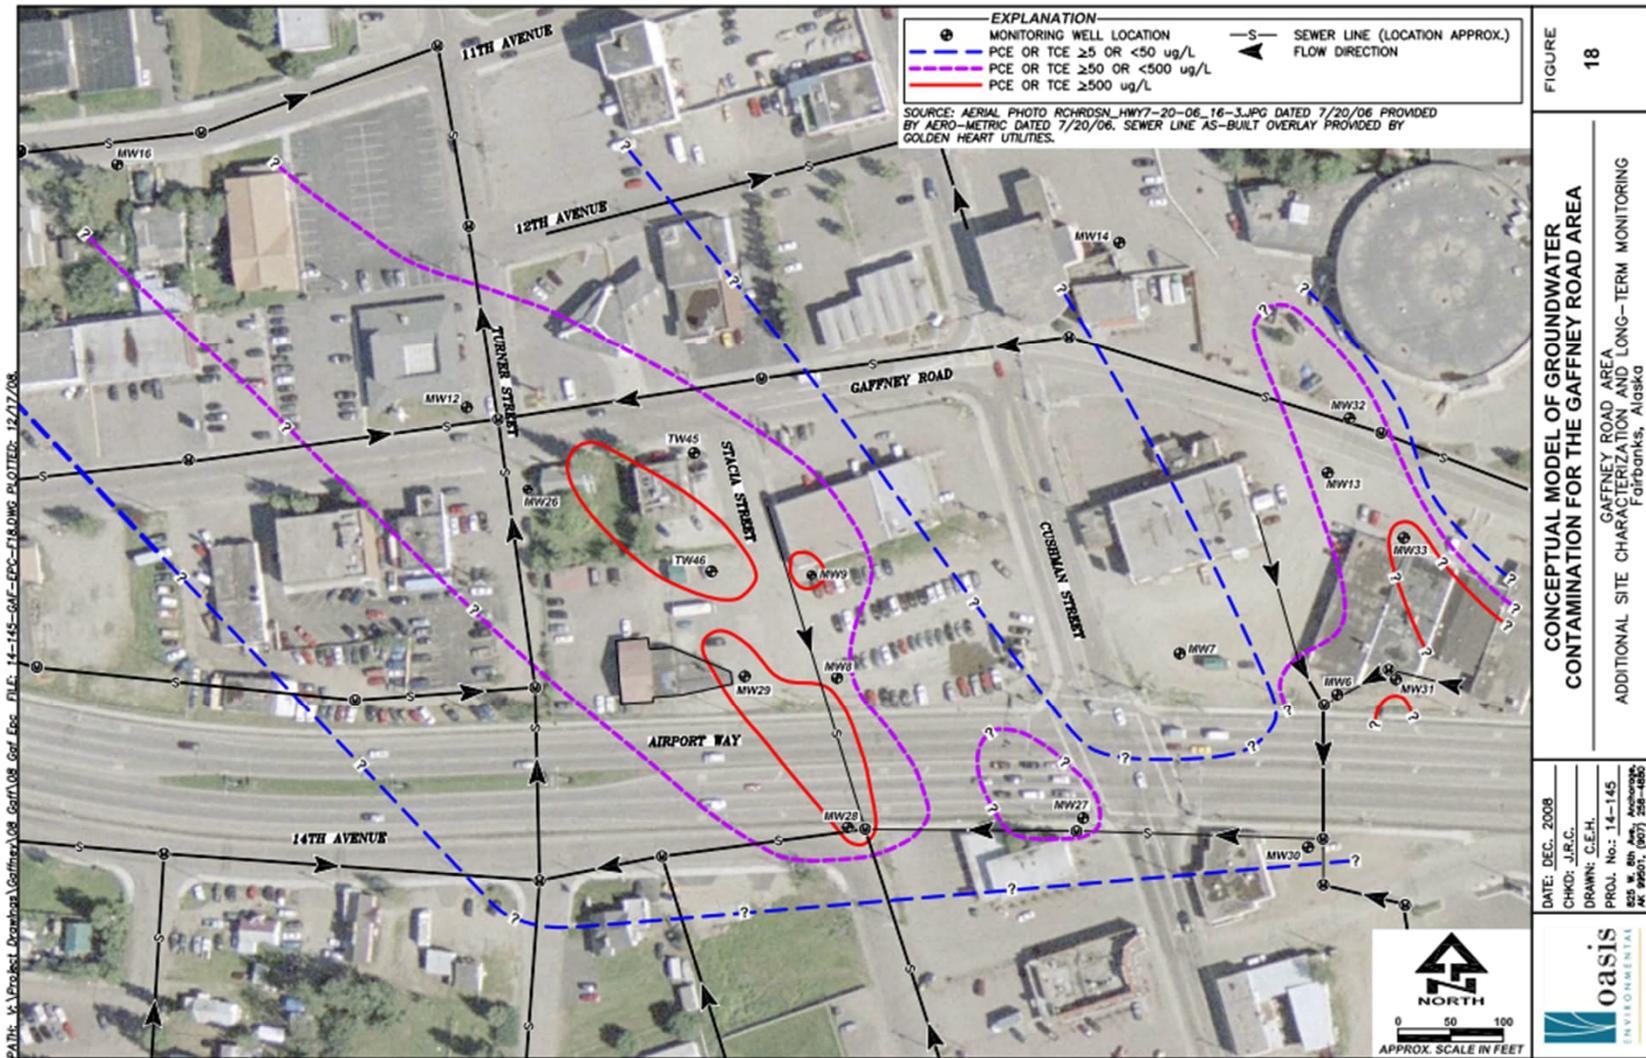
FIGURE 18

2008 Plume Map – As In Original Report

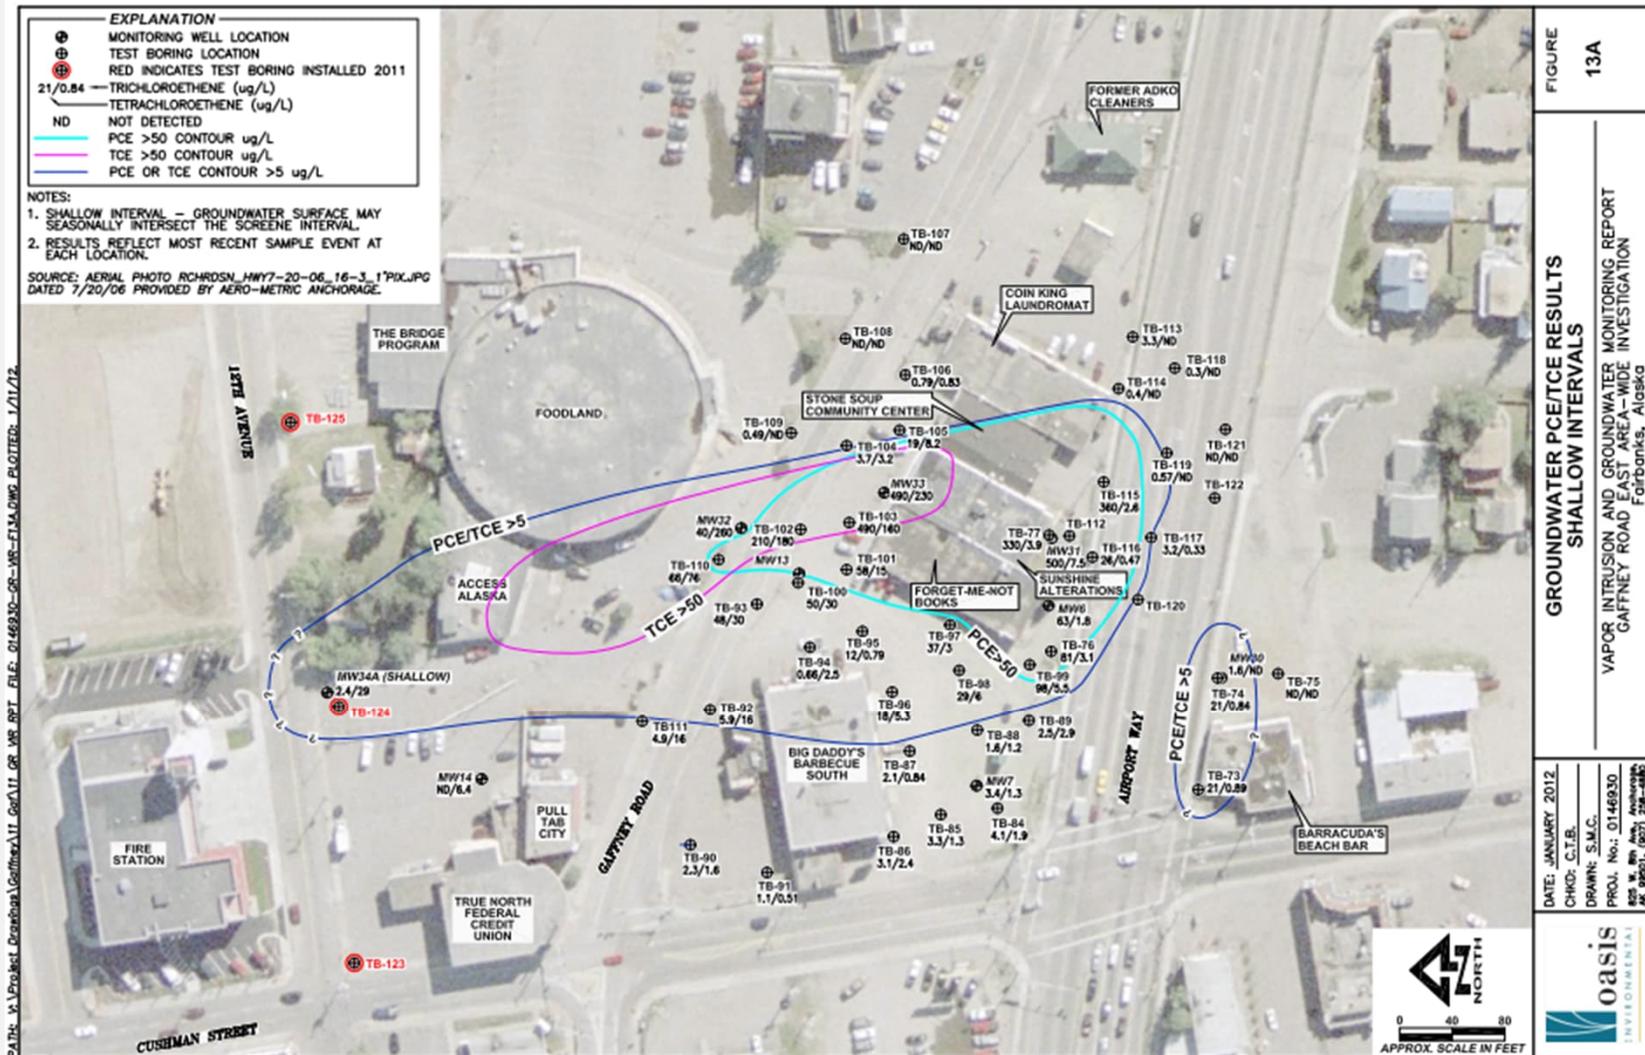
FIGURE 13A

GROUNDWATER PCE/TCE RESULTS SHALLOW INTERVALS
 VAPOR INTRUSION AND GROUNDWATER MONITORING REPORT
 GAFFNEY ROAD EAST AREA—WIDE INVESTIGATION
 Fairbanks, Alaska

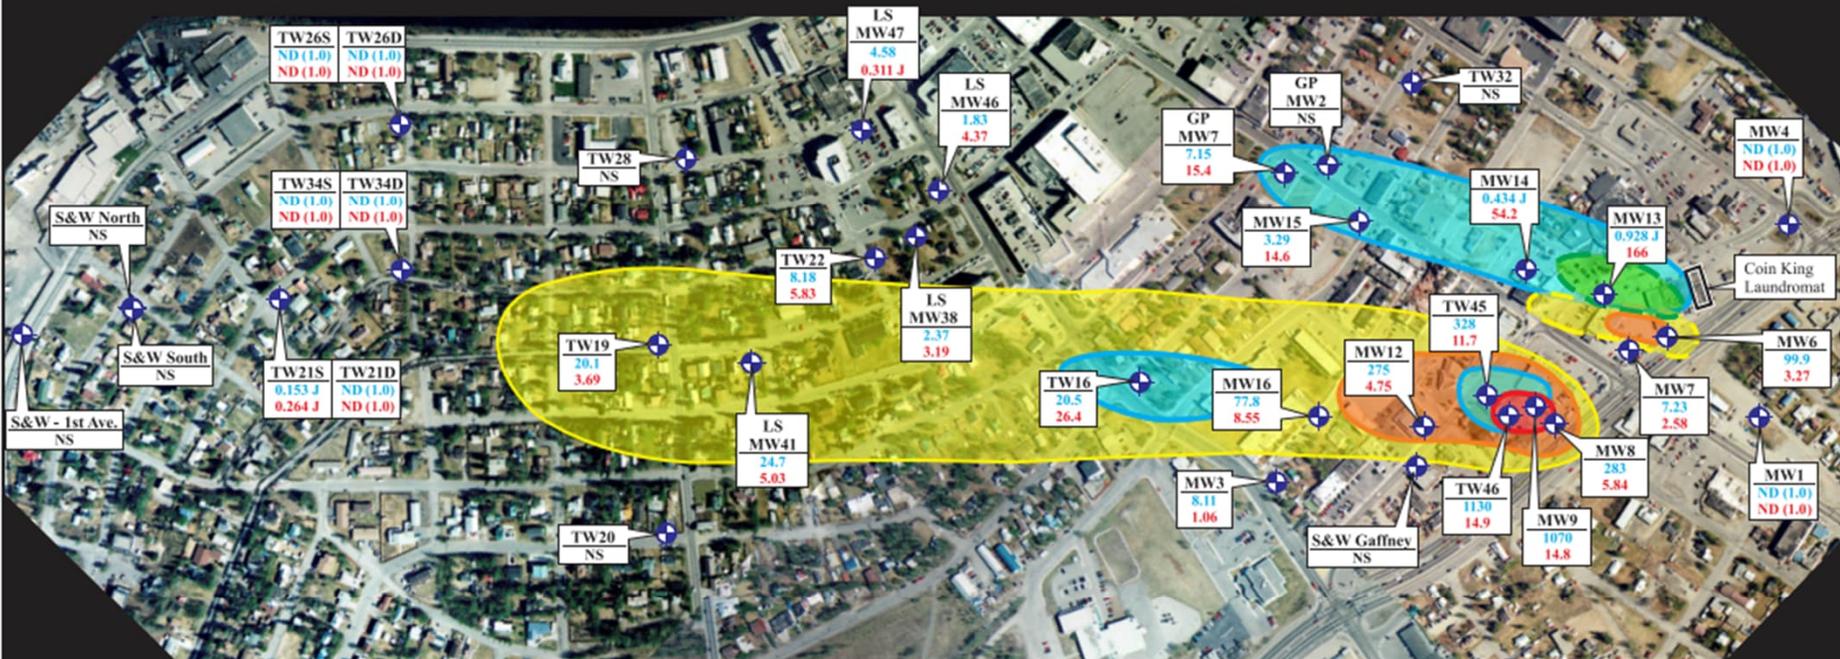
2012 EPA Preliminary Assessment Plume Map (E&E)

KEY: ◆ Permanent Monitoring Well
5.2 PCE Concentration
3.8 TCE Concentration
 ND Not Detected
 NS Not Sampled
 J Analyte Detected at Estimated Concentrations Above the Method Detection Limit but Below the Practical Quantitation Limit

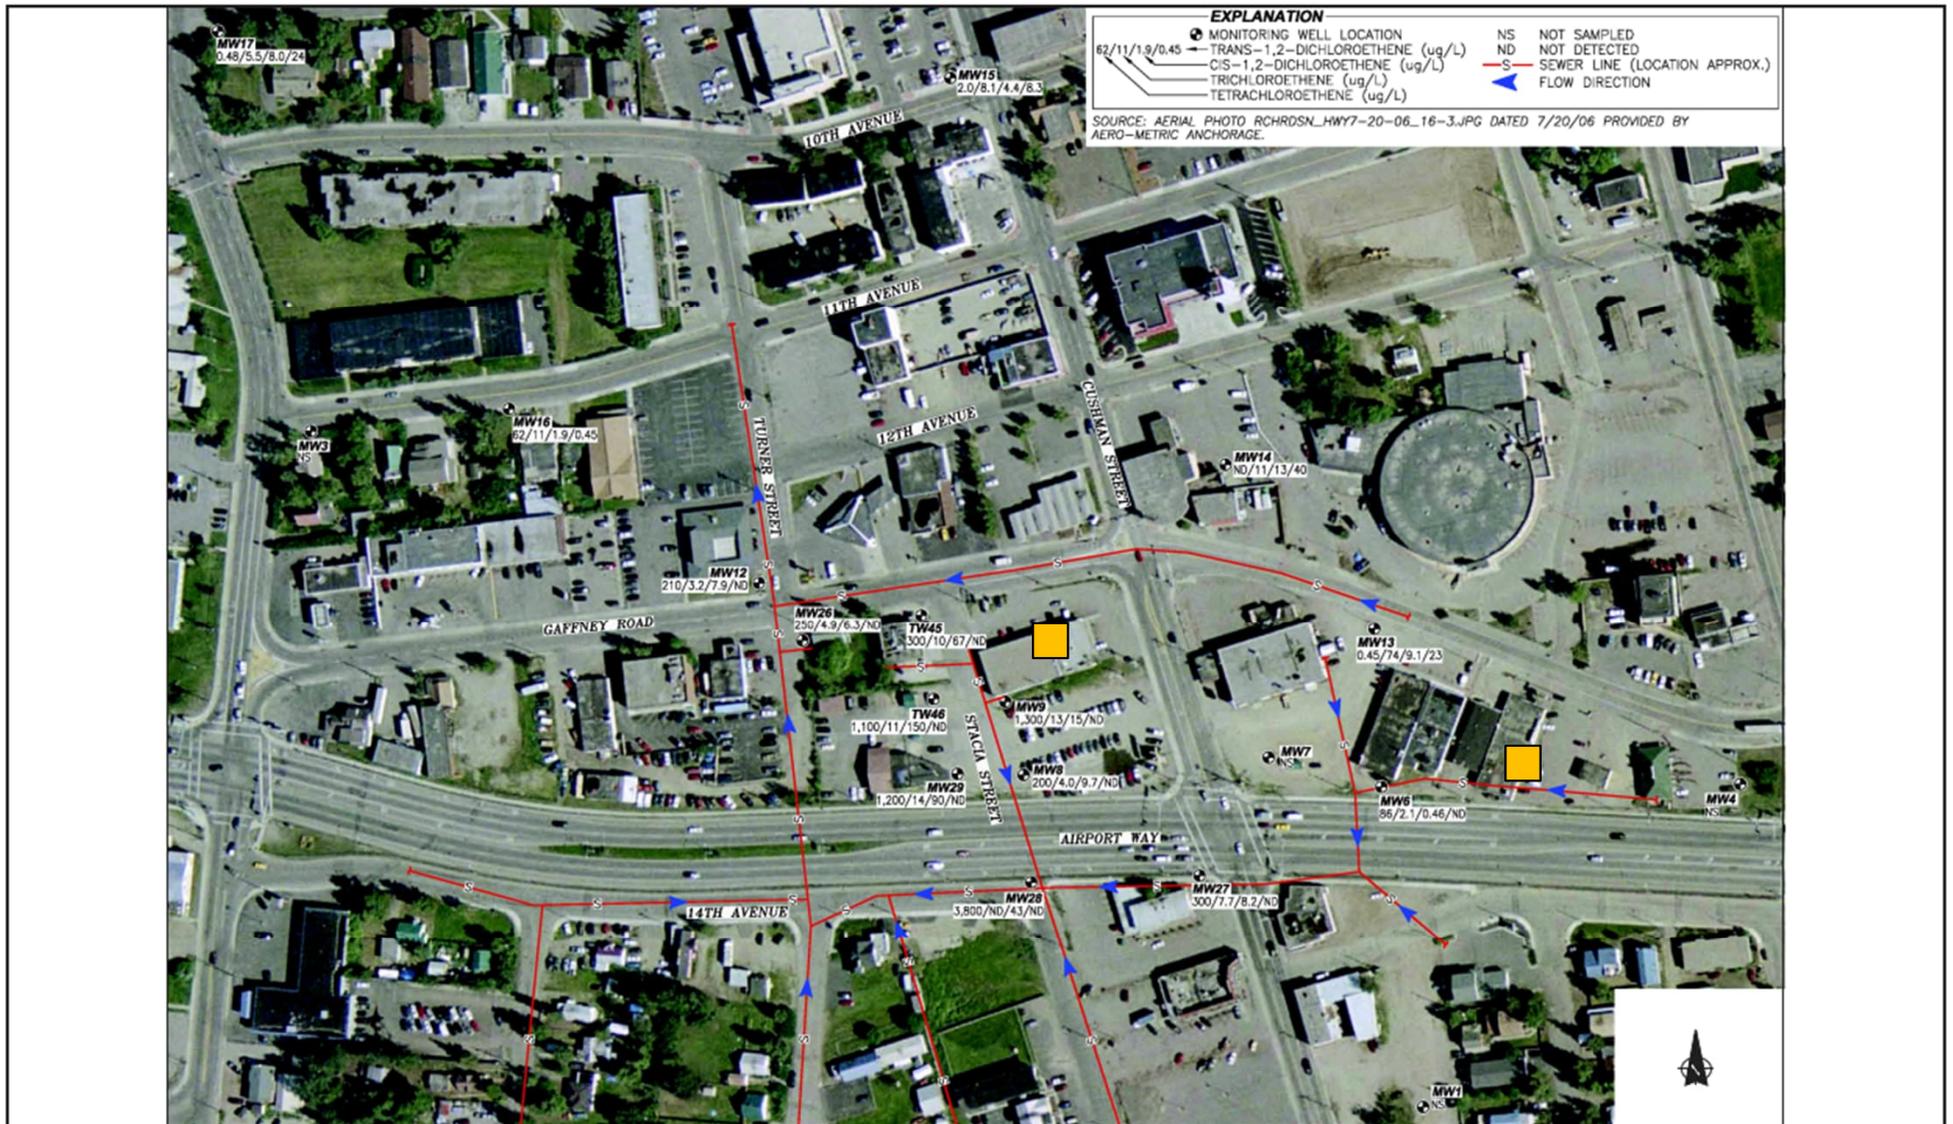
Figure 2-6

2012 EPA Preliminary Assessment Sewer Map

GAFFNEY ROAD AREA SOURCE CHARACTERIZATION MONITORING WELL LOCATIONS, OASIS ENVIRONMENTAL

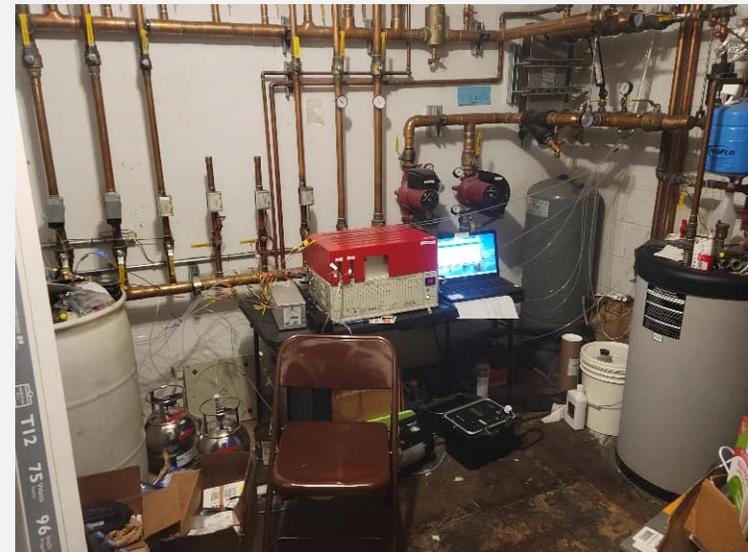
RadonEye

- Weekly VOC and Continuous Radon Sampling, December 2020 – March 2022
 - Indoor Air, Subslab, Outdoor Air
- Two locations with Continuous VOC
 - Church (8/21 – Present)
 - Insurance Office (9/21 – Present)
- Two intensive sampling studies (Twice Daily for 8 days)
 - August 2021 (Warm)
 - January 2022 (Cold)
- Continuous differential pressure
