Multiple Commercial Buildings: Continuous Monitoring Data Patterns for Resolving Key VI Questions

Mark Kram, Ph.D. (Groundswell) Blayne Hartman, Ph.D. (HEG) Cliff Frescura (Groundswell)

AEHS/EPA Workshop #5; March 17th, 2020

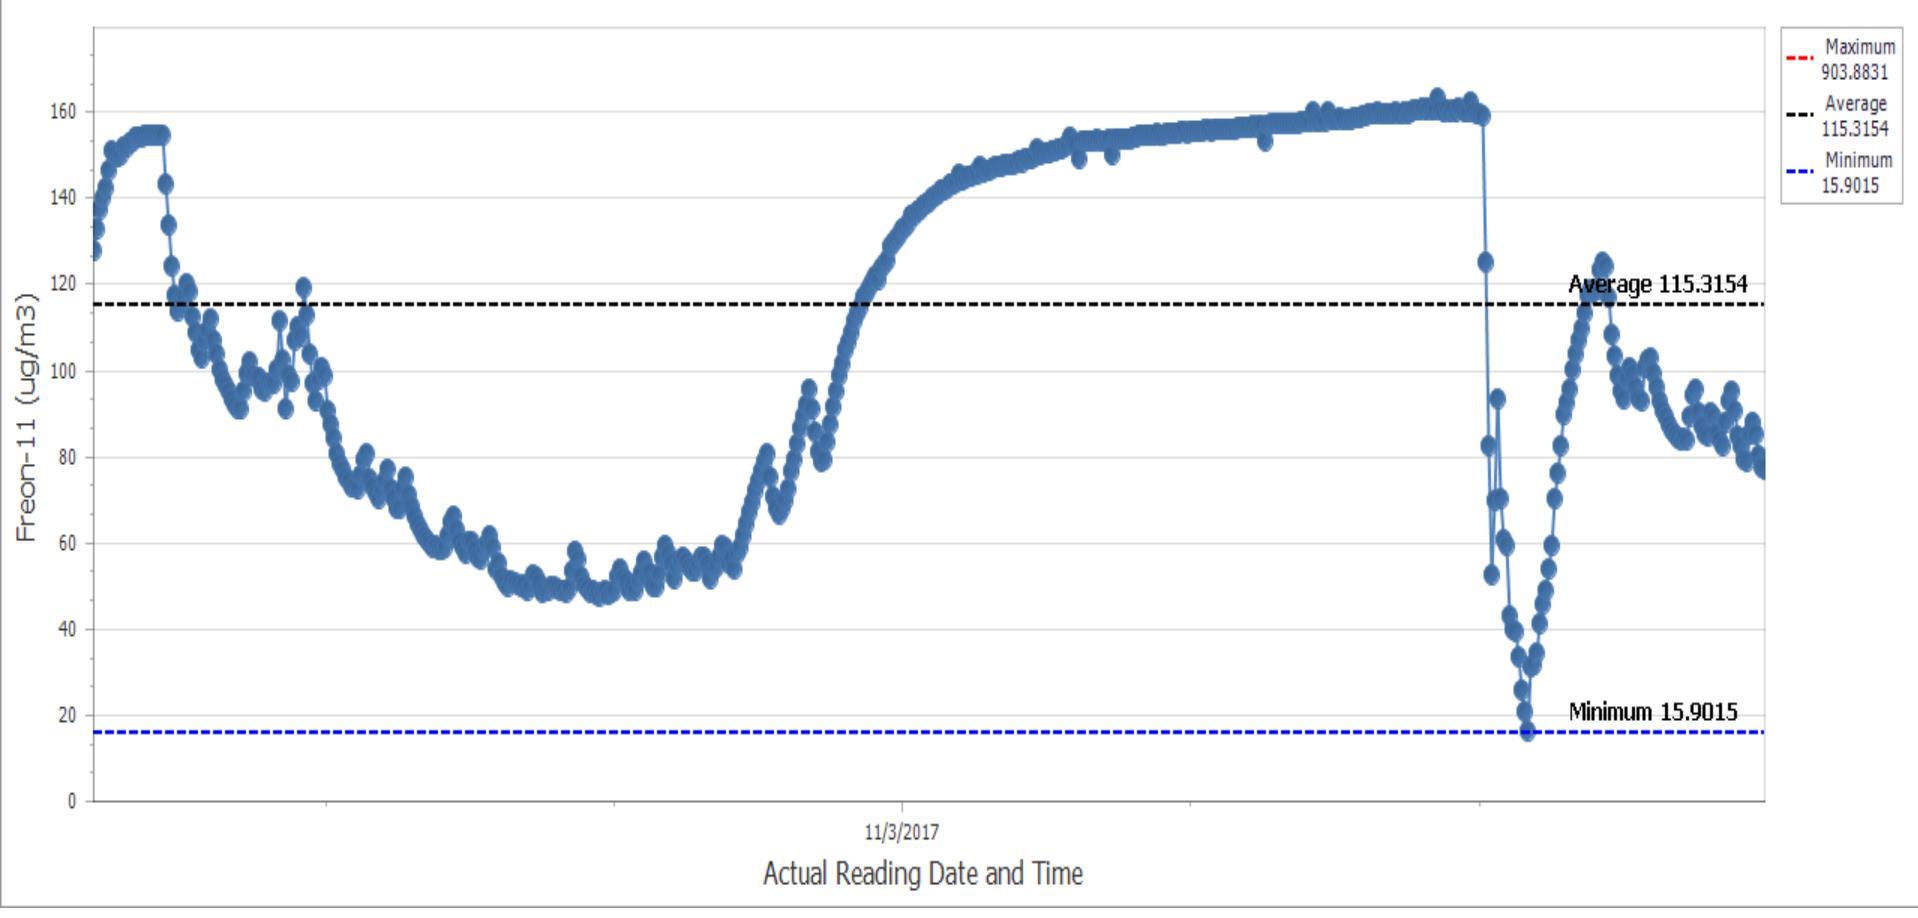
Data Pattern = Opportunity Freon 11 – Agency Office Bldg – 1 Day

DCP Port-01 (Port1) Freon-11 (ug/m3)

Freon in Soil Vapor Transported Indoors via HVAC

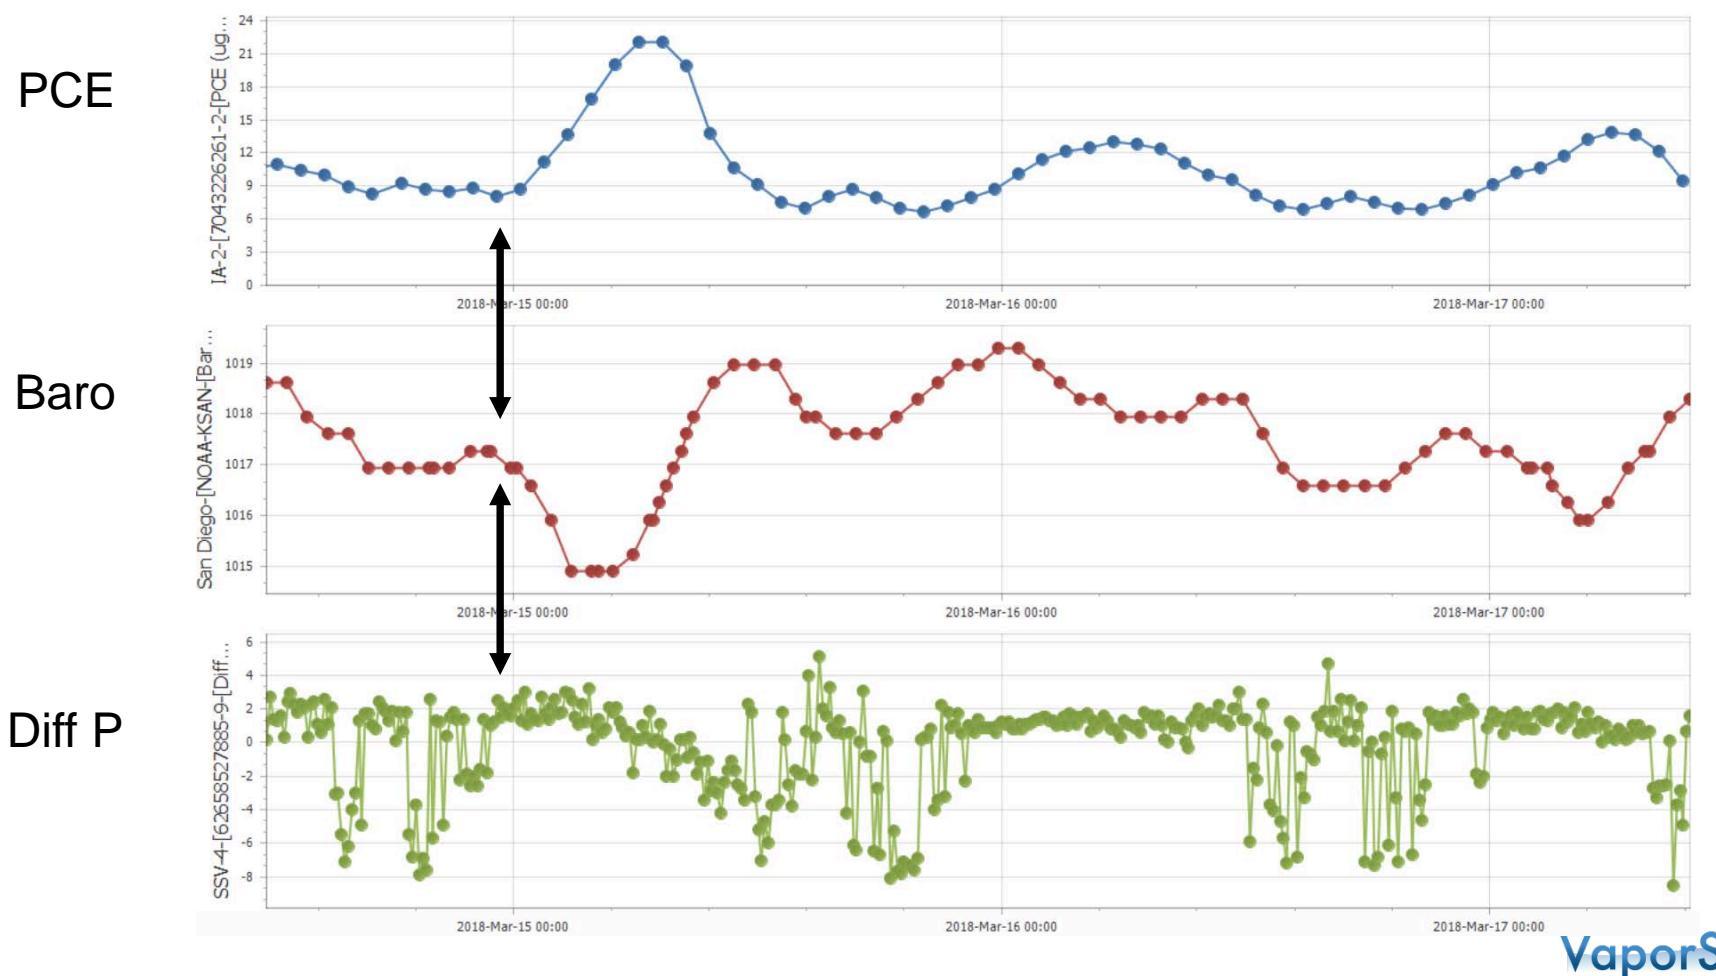
Former Drycleaner 1

IA-2-[7043226261-2-[PCE (ug/m3) vs. San Diego-[NOAA-KSAN-[Barometric Pressure (mBar) vs. SSV-4-[62658527885-9-[Diff Pressure (Pa)

2018-03-10 09:52:20 AM to 2018-03-17 09:52:20 AM

- Bank in strip mall; former drycleaner
- ~6K sq ft., 4 partitioned businesses
- Shallow depth to source
- Slab-on-grade
- Interbedded sands, silty sands, and silty gravel
- 3C climate zone; Southern CA
- Wind/pressure varied
- Advective flux

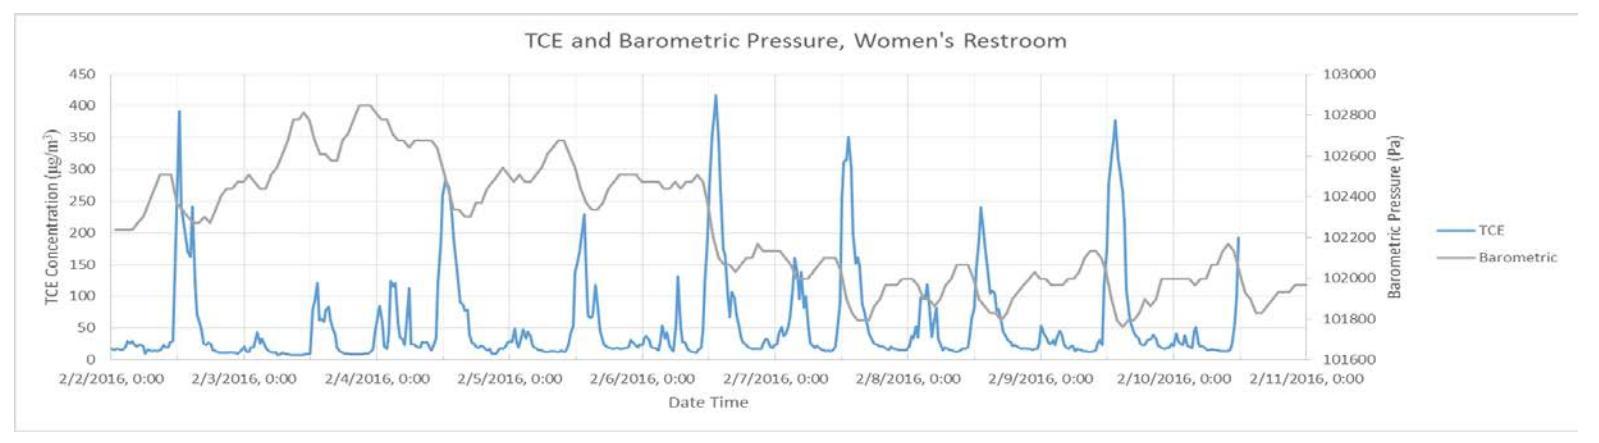
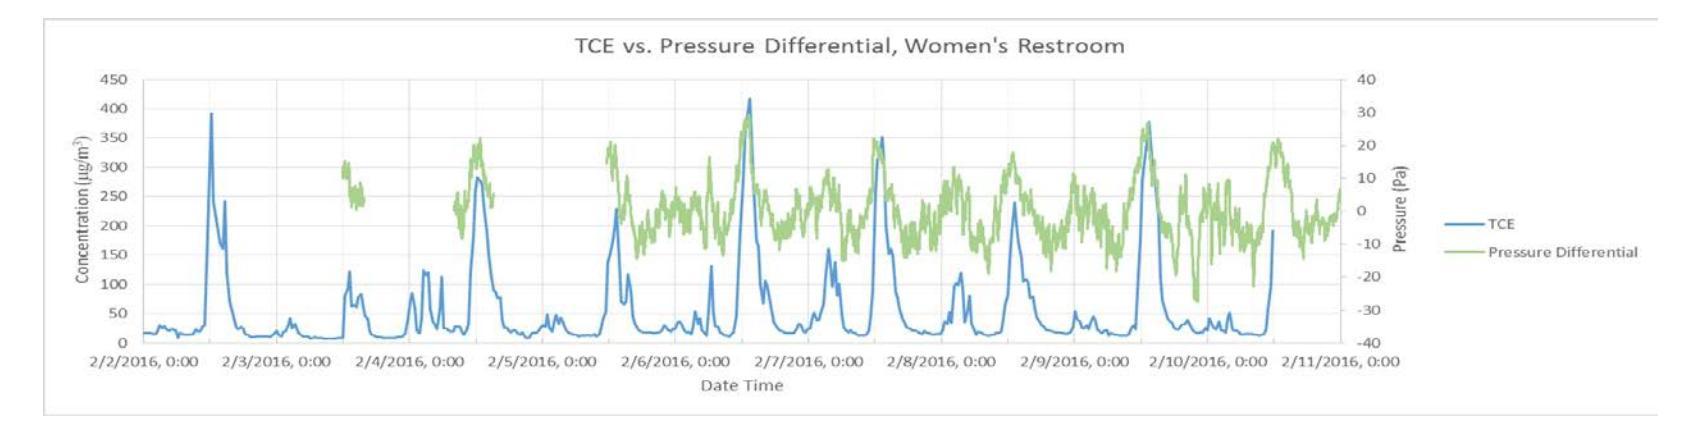
Natural Fluctuations

Daily BP Change - Slight Pressure Diff - VI

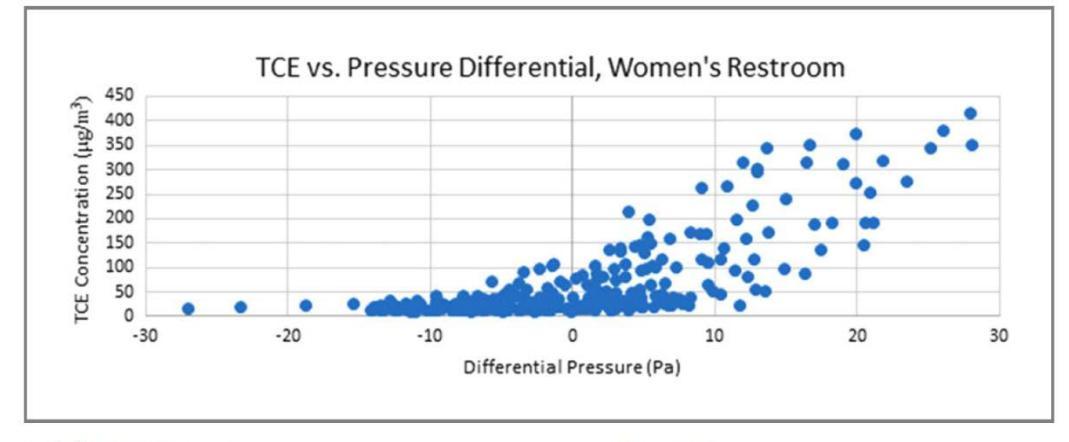
Exhibit 4. Indoor TCE concentration versus pressure differential

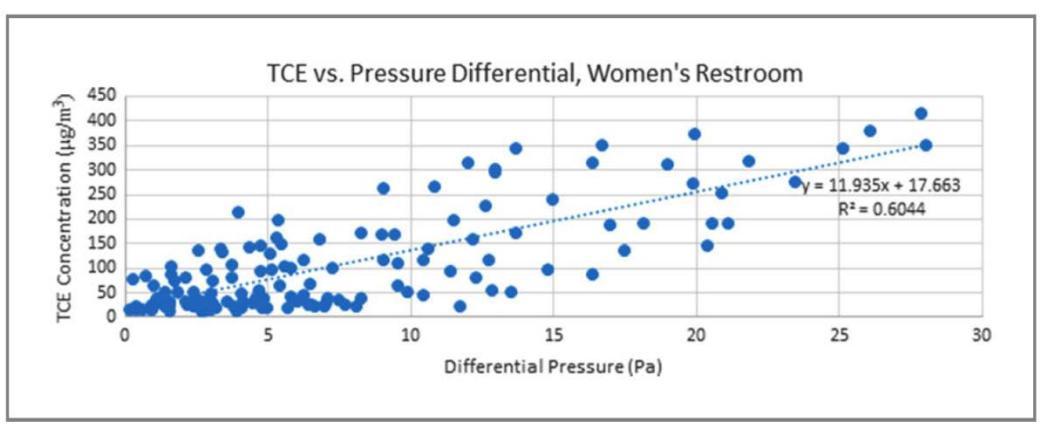
Exhibit 5. Indoor TCE concentration versus pressure differential values greater than zero

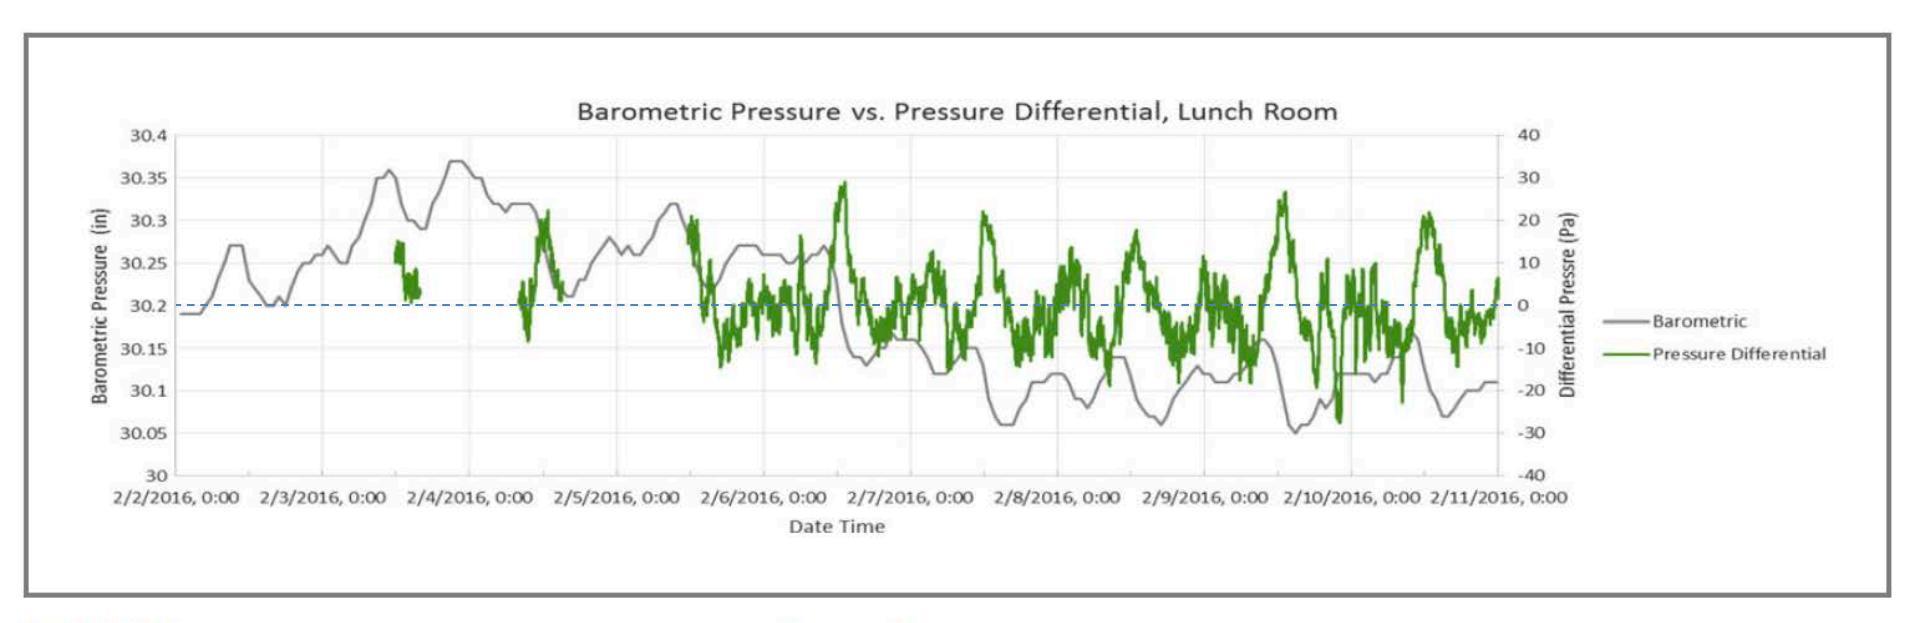
Exhibit 6. Barometric pressure versus pressure differential

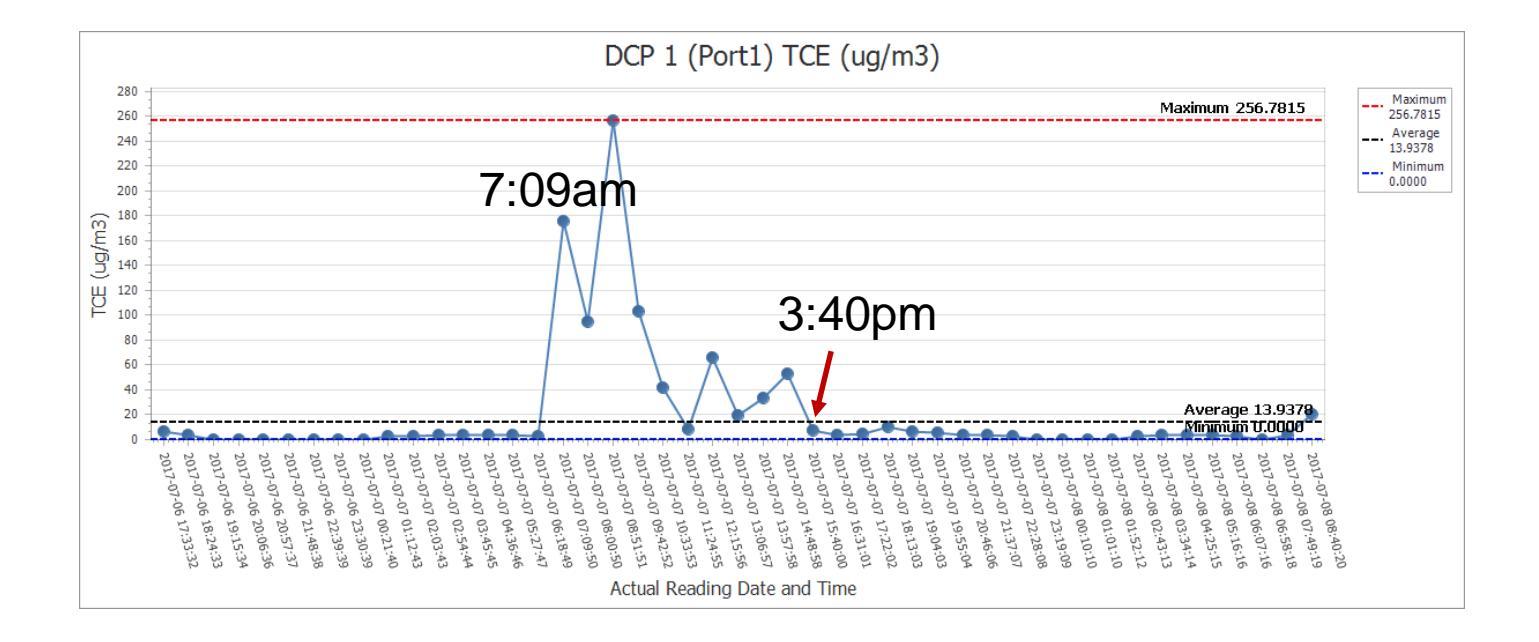
Furniture Facility Rapid Resolution

- Building for Sale
- Owner "Low-Balled" by \$2M Assumed VI (SS TCE/PCE and Canisters)
- Indoor TCE Only During Work Hours; Pattern Ubiquitous

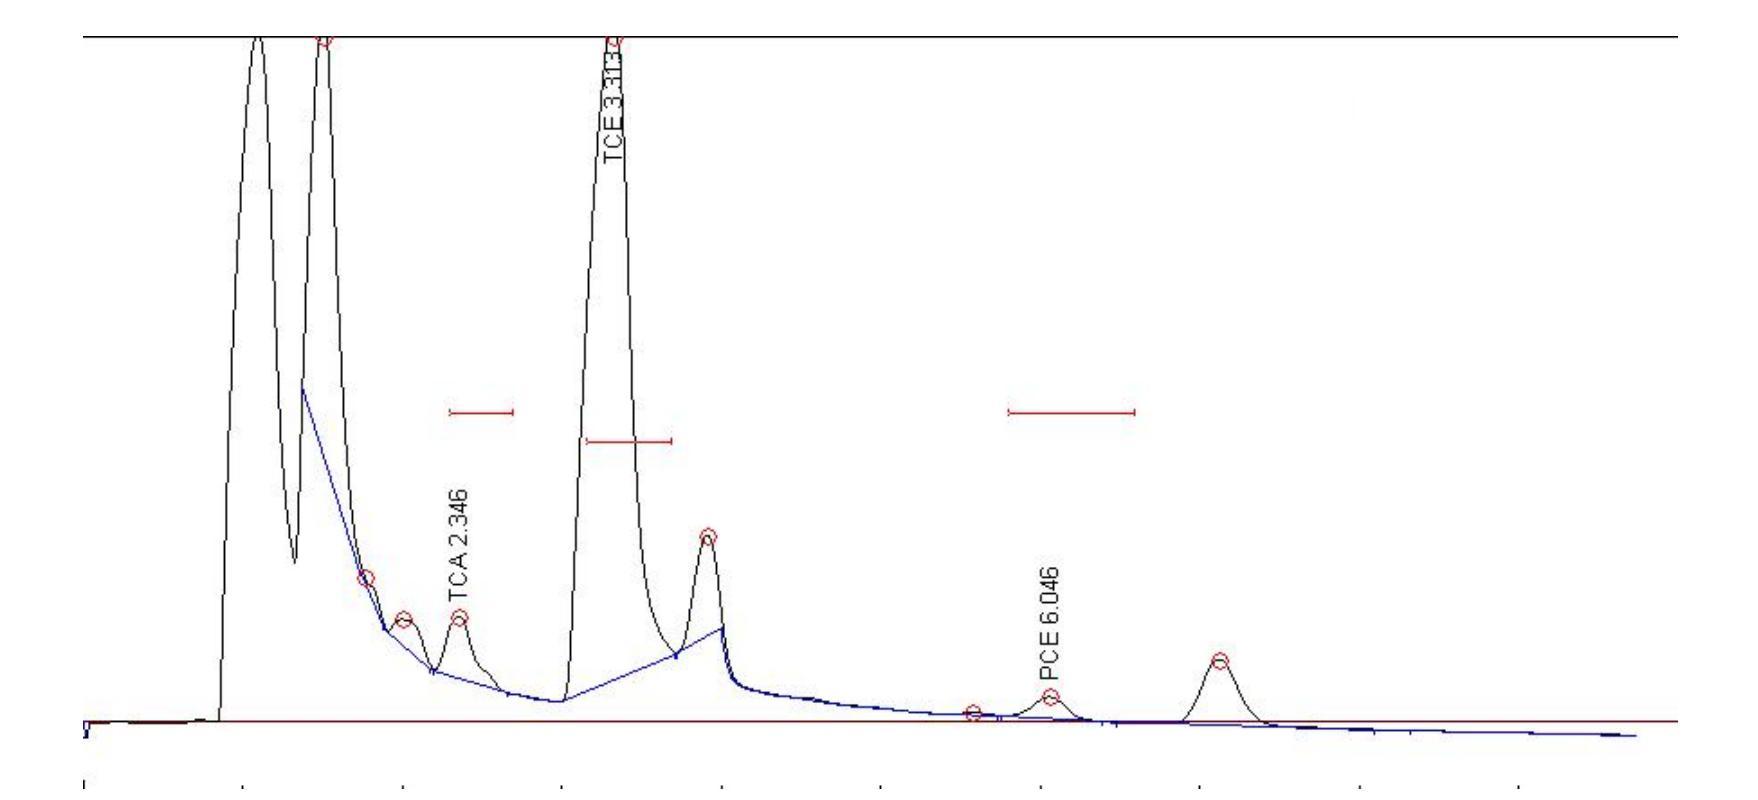
Furniture Facility Silicone Spray Chromatogram

Chromatogram Proves TCE in Material!

- Concluded No VI (via MLE)
- Traditional Methods = Mystery, Costs, Exposures
- Continuous Monitoring = Accurate Sourcing
- Uncertainties Quickly Resolved, Remedy Obvious
- Protected Occupants
- Saved Owner \$2M w/3 Field Days!
